The 2023 Kahramanmaras earthquakes of February 6th in Turkey

Evangelia GARINI and **George GAZETAS**

School of Civil Engineering, Geotechnical Department
National Technical University of Athens, Greece

THE 2023 TURKIYE-SYRIA EARTHQUAKES

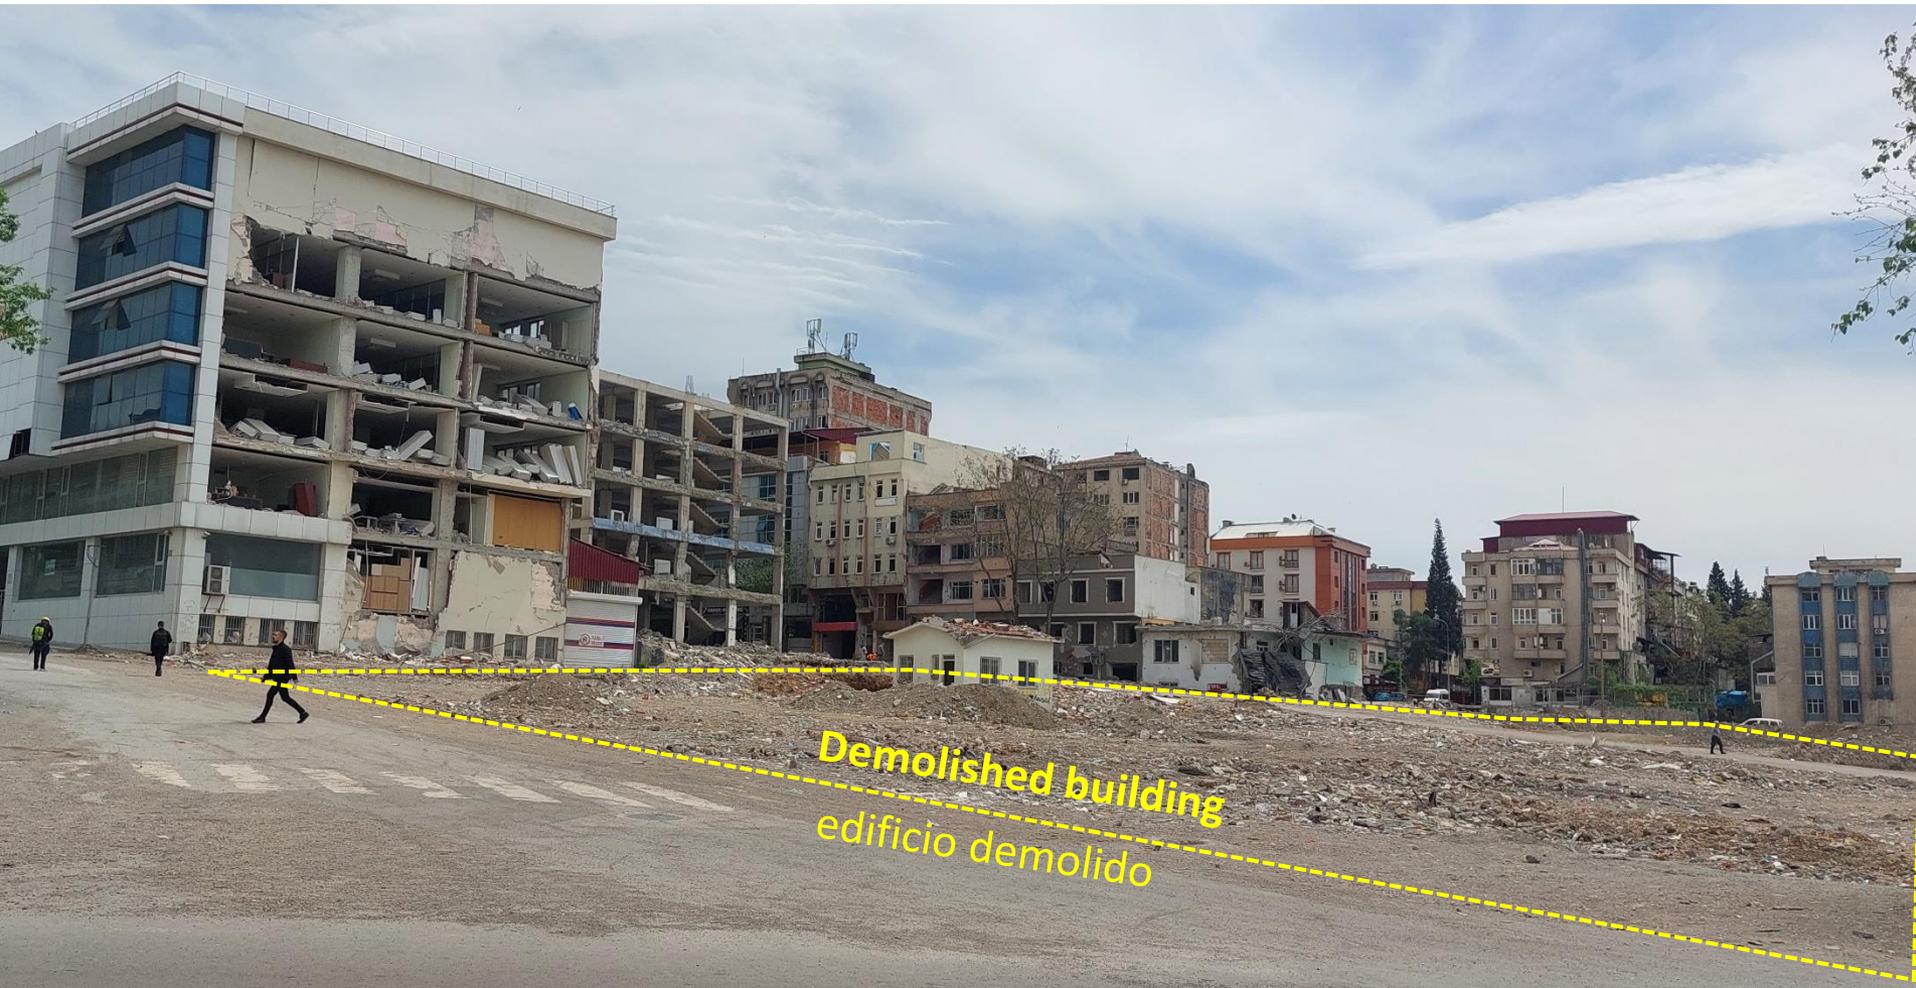
Kahramanmaras

9-story RC building
edificio RC de 9 pisos

Structural damage
concentrated on the
ground and 1st floors

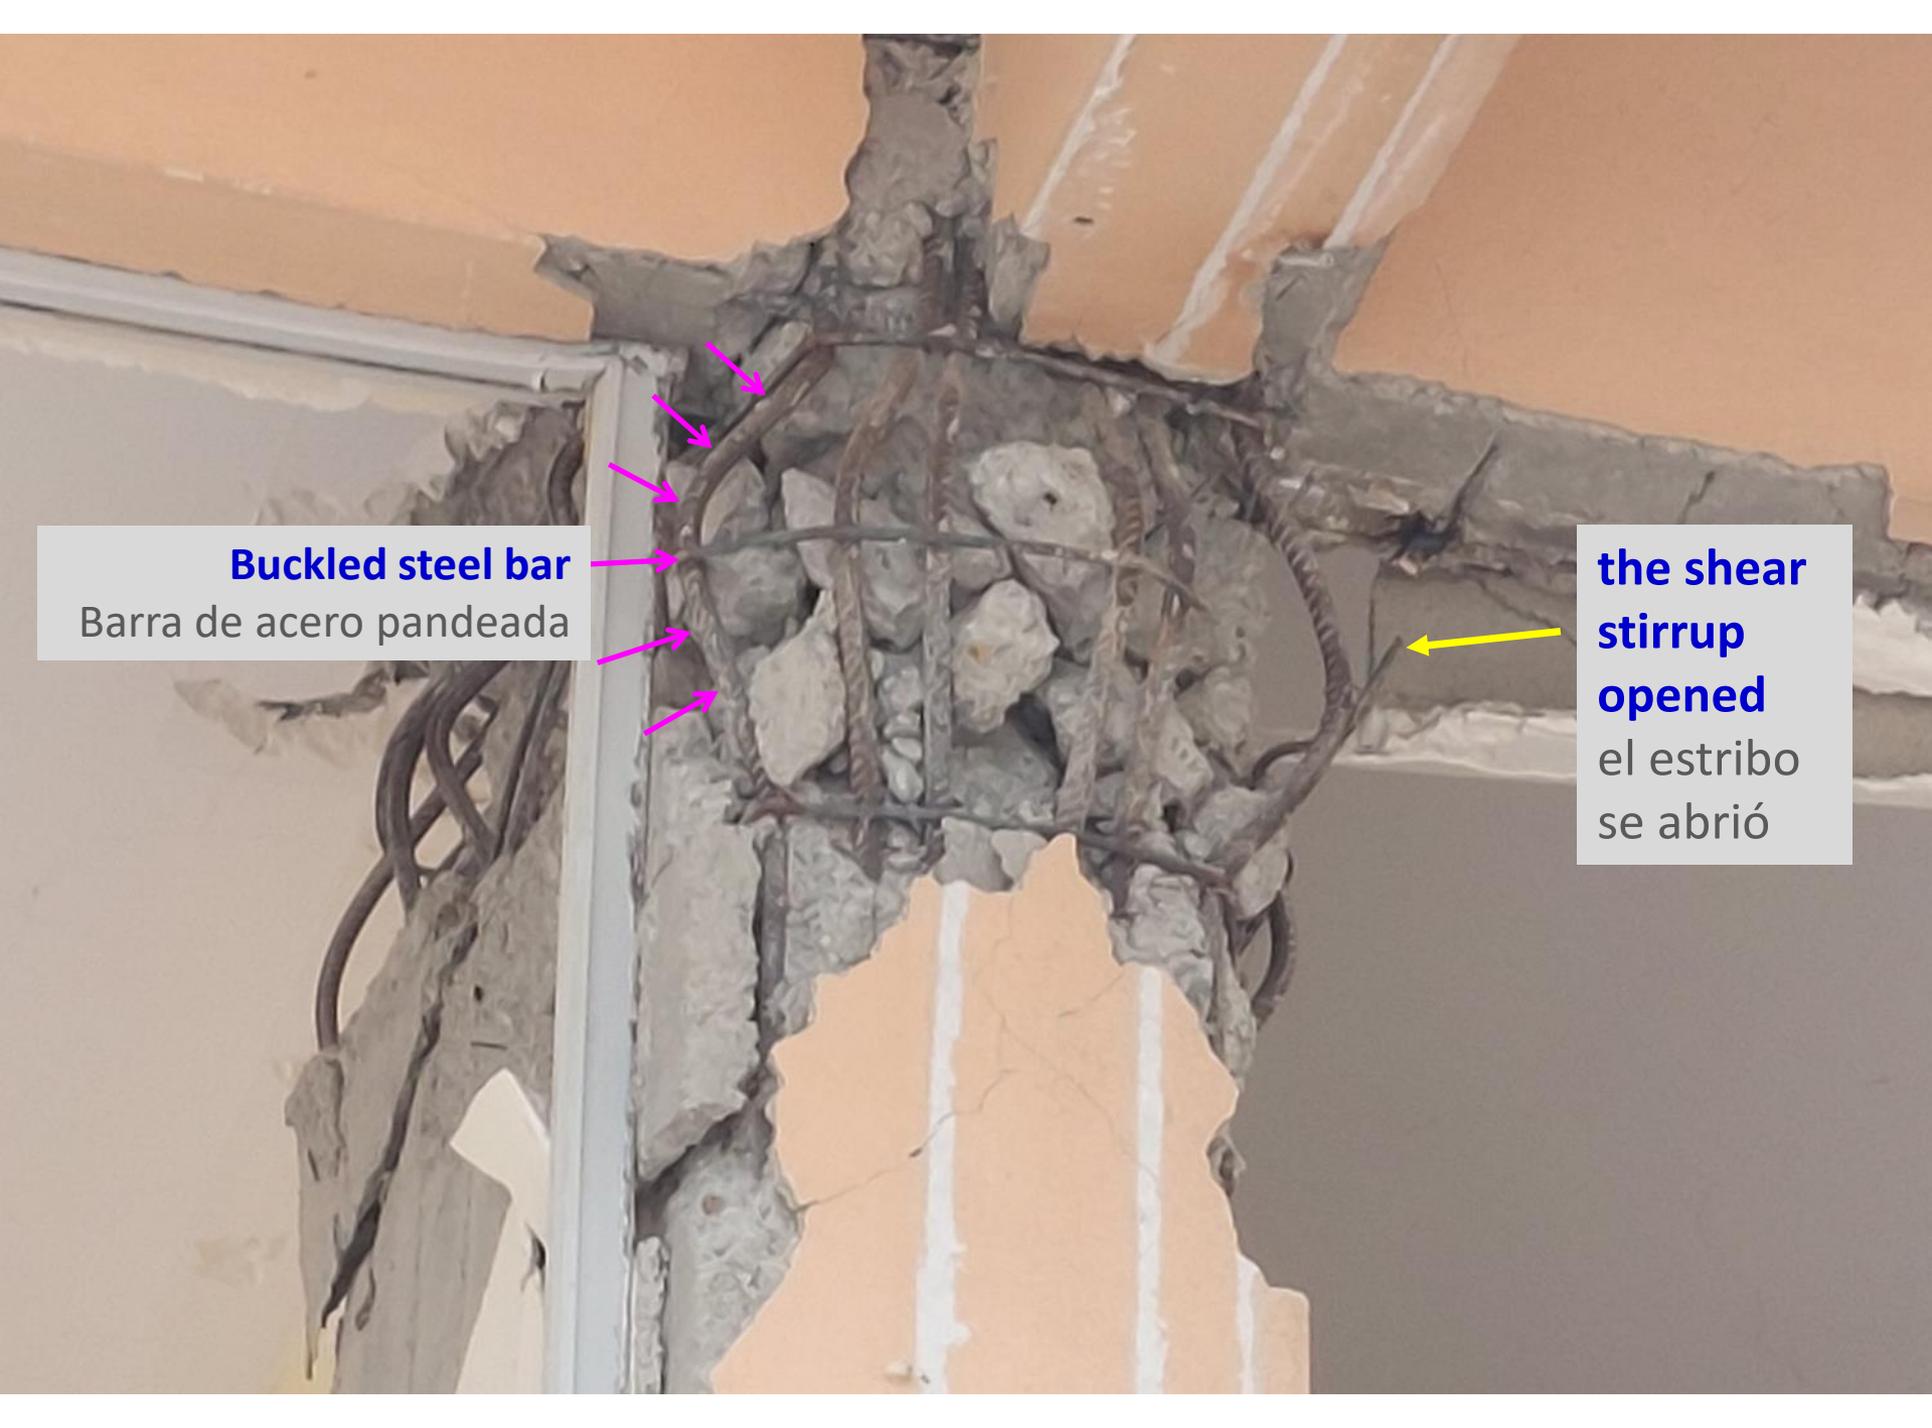
Buckled steel bar

**the shear
stirrup
opened**

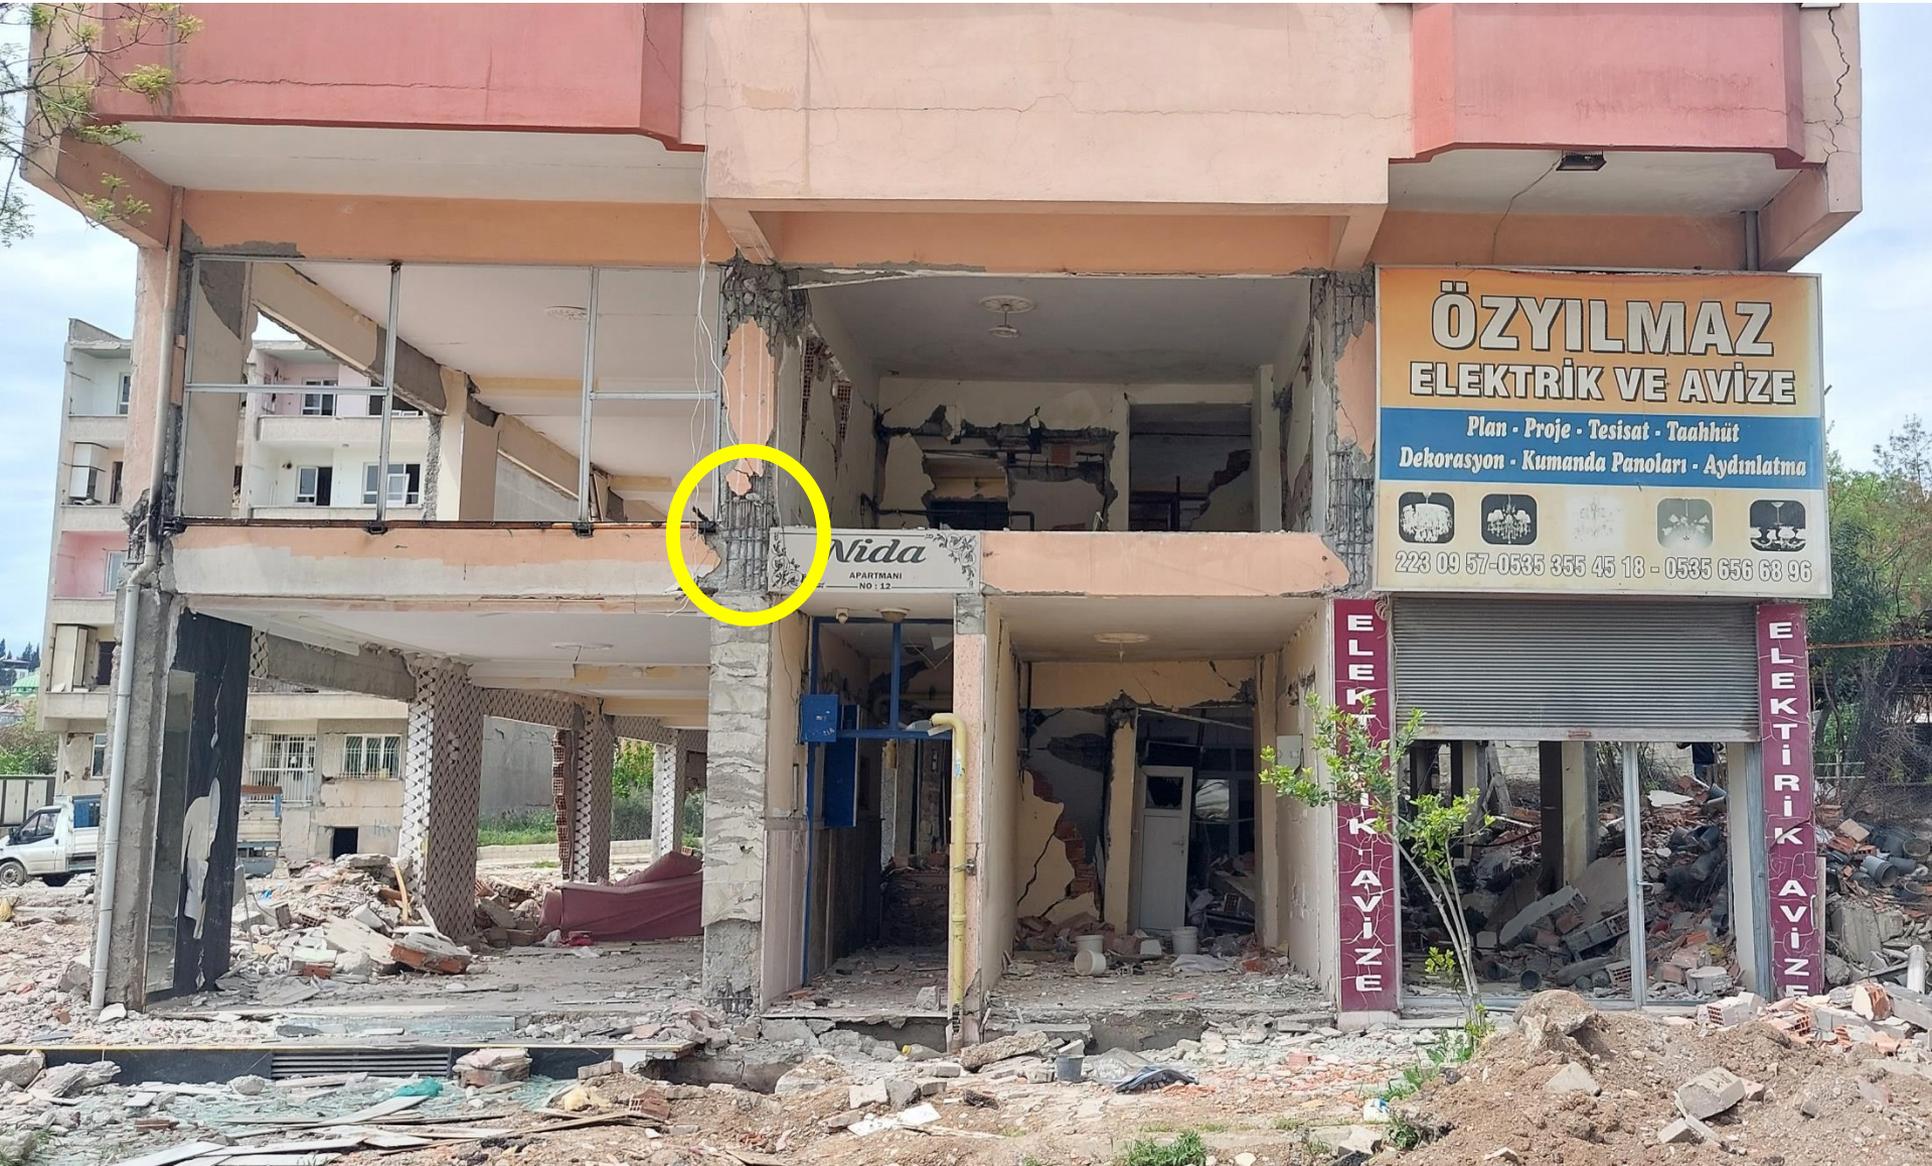
Inadequate shear reinforcement in the joint

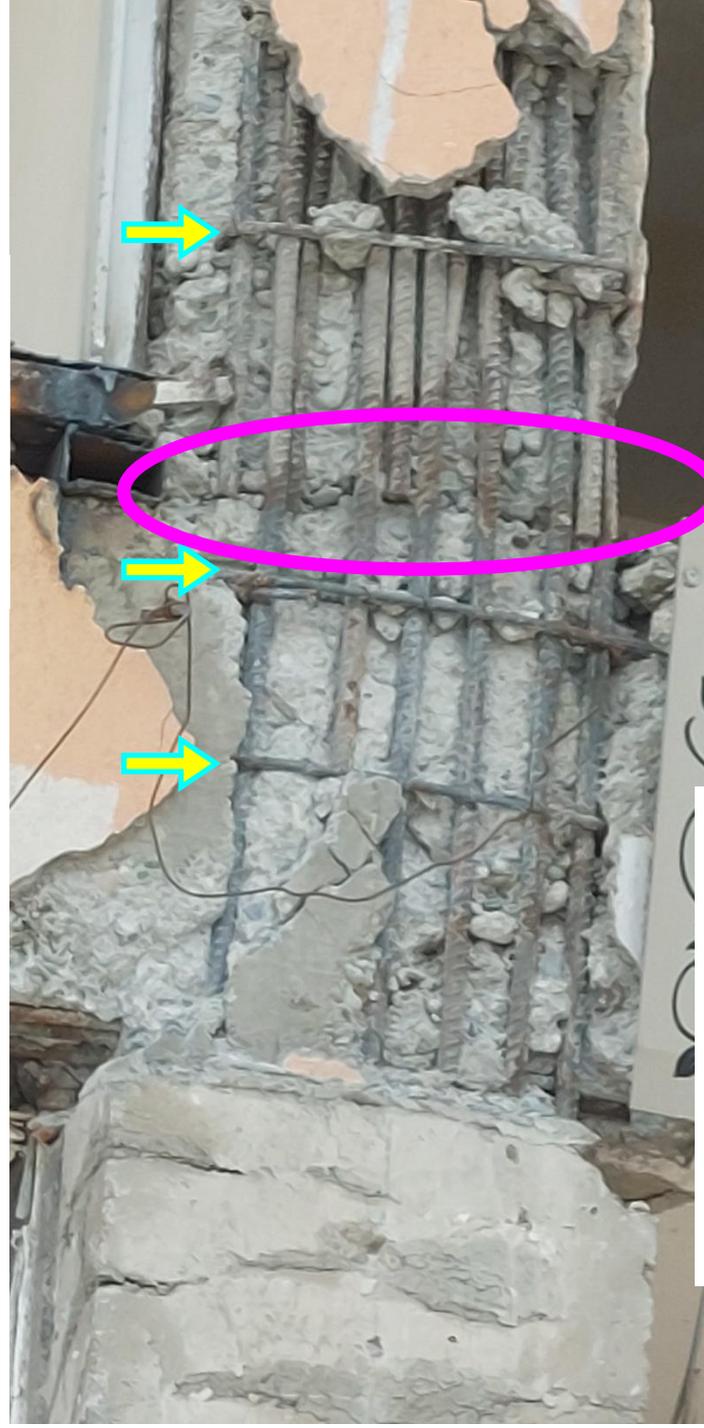
Longitudinal reinforcement is discontinued in the joint

Construction joint in the concrete just above the slab

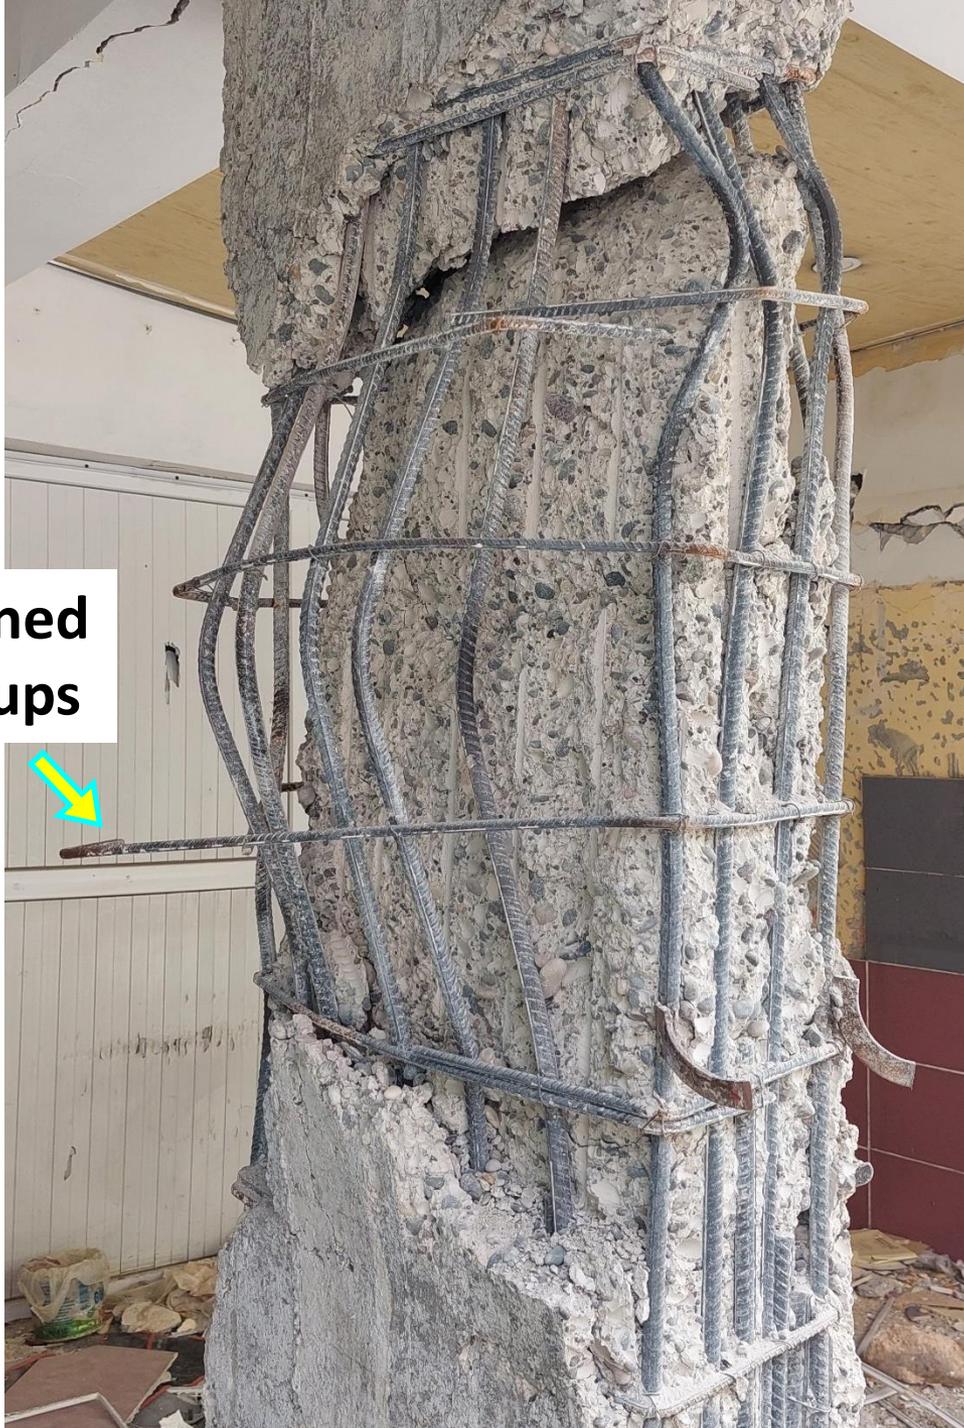
Shear wall failure

- Not close enough stirrups
- Poor concrete quality (large+ rounded aggregates)
- Buckled steel rods

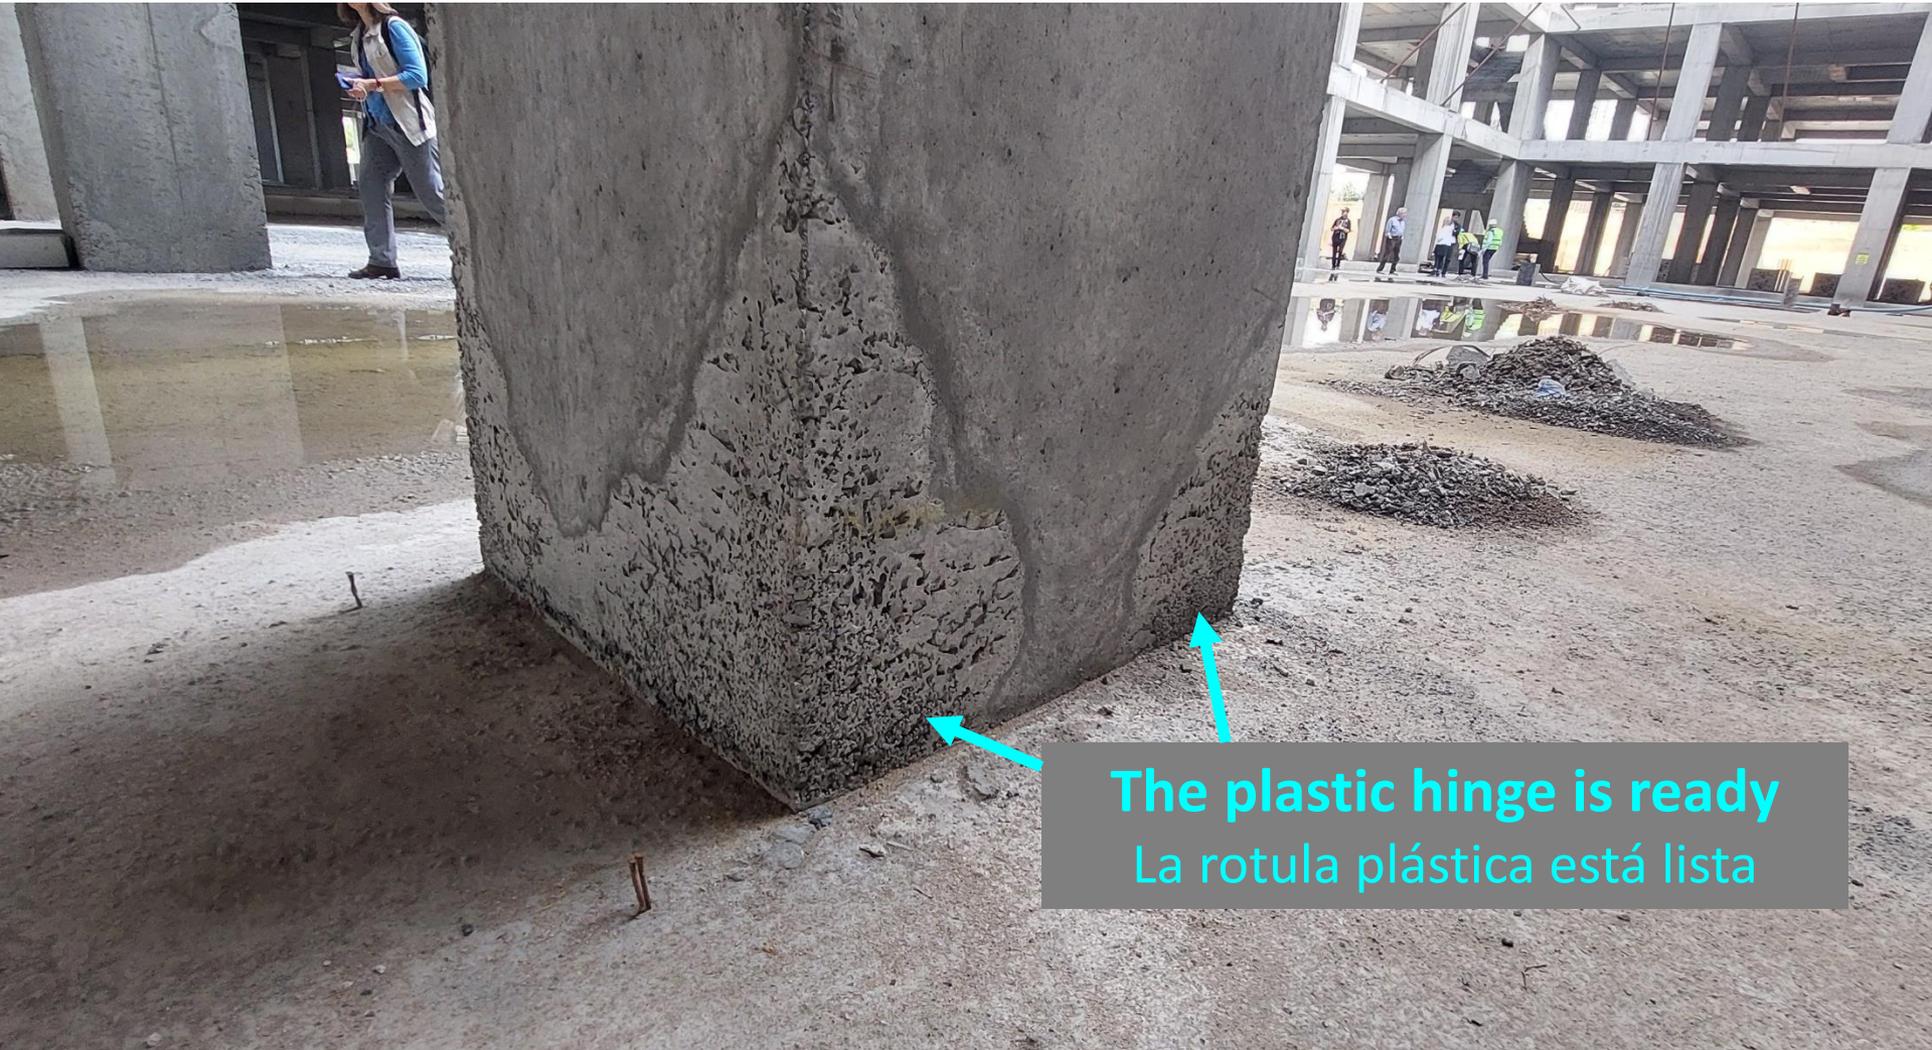
**Concrete NOT
properly compacted**
Concreto NO
compactado
correctamente

At the bottom of a ground floor column

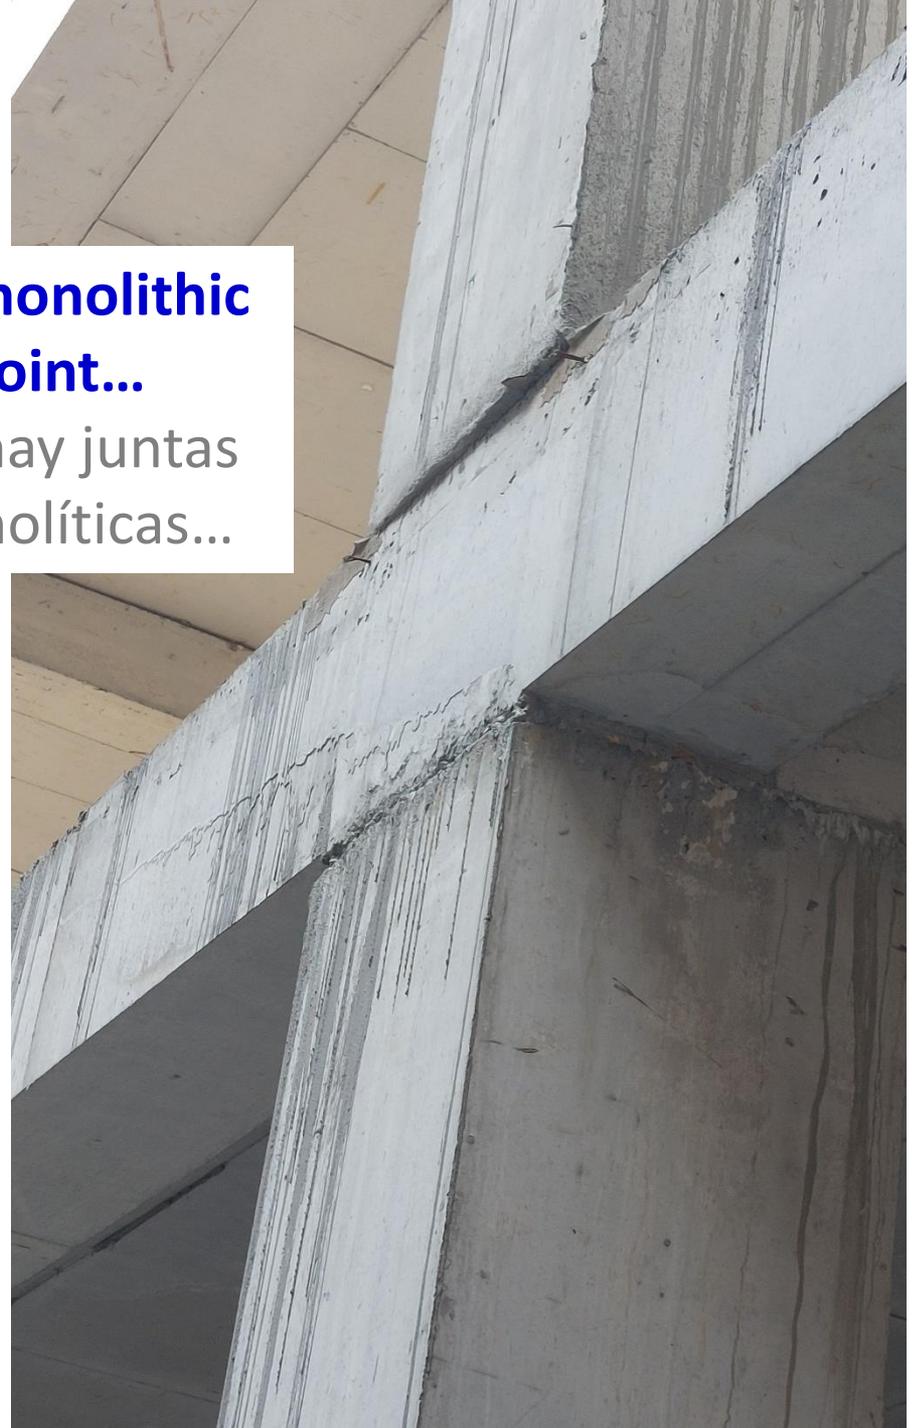
**No monolithic
joint...**

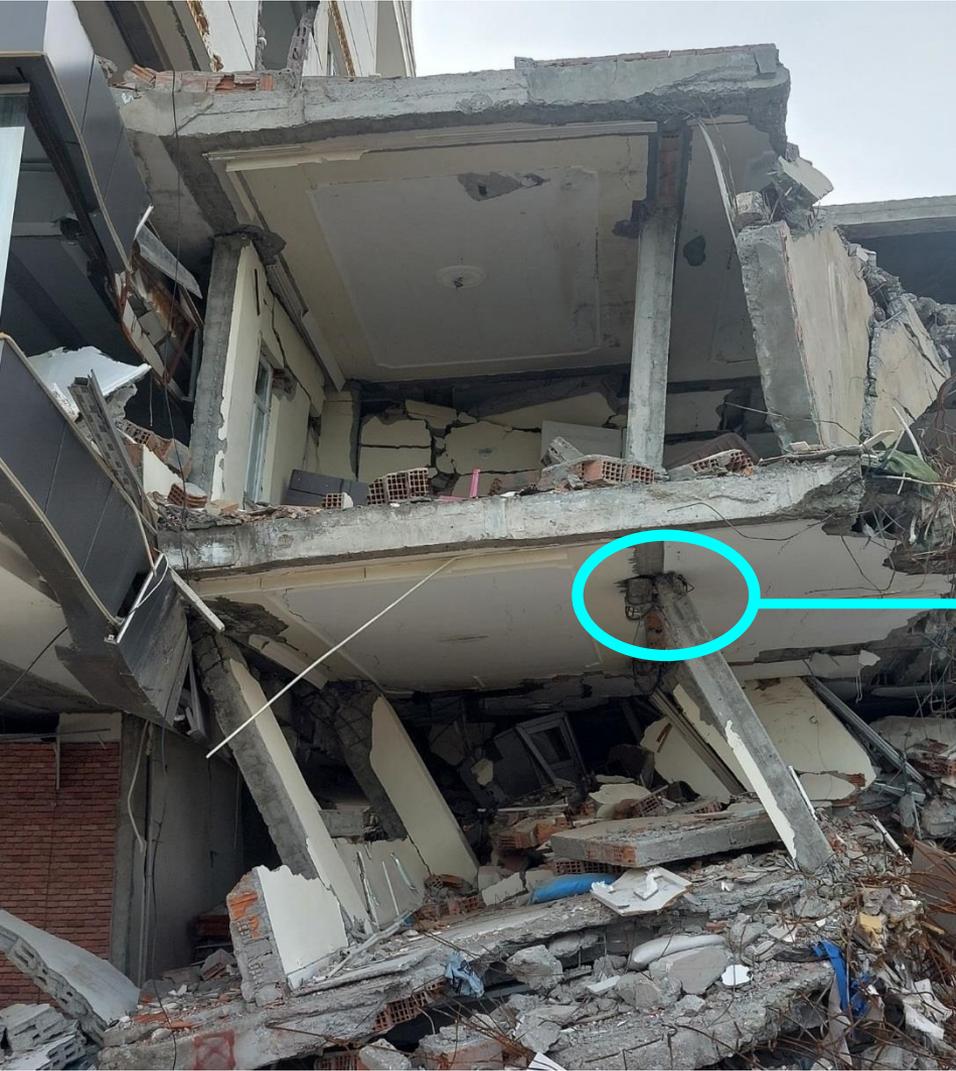
Plastic hinge in a 3-story RC building in Adiyaman

Poorly reinforced joint, no stirrups for shear resistance

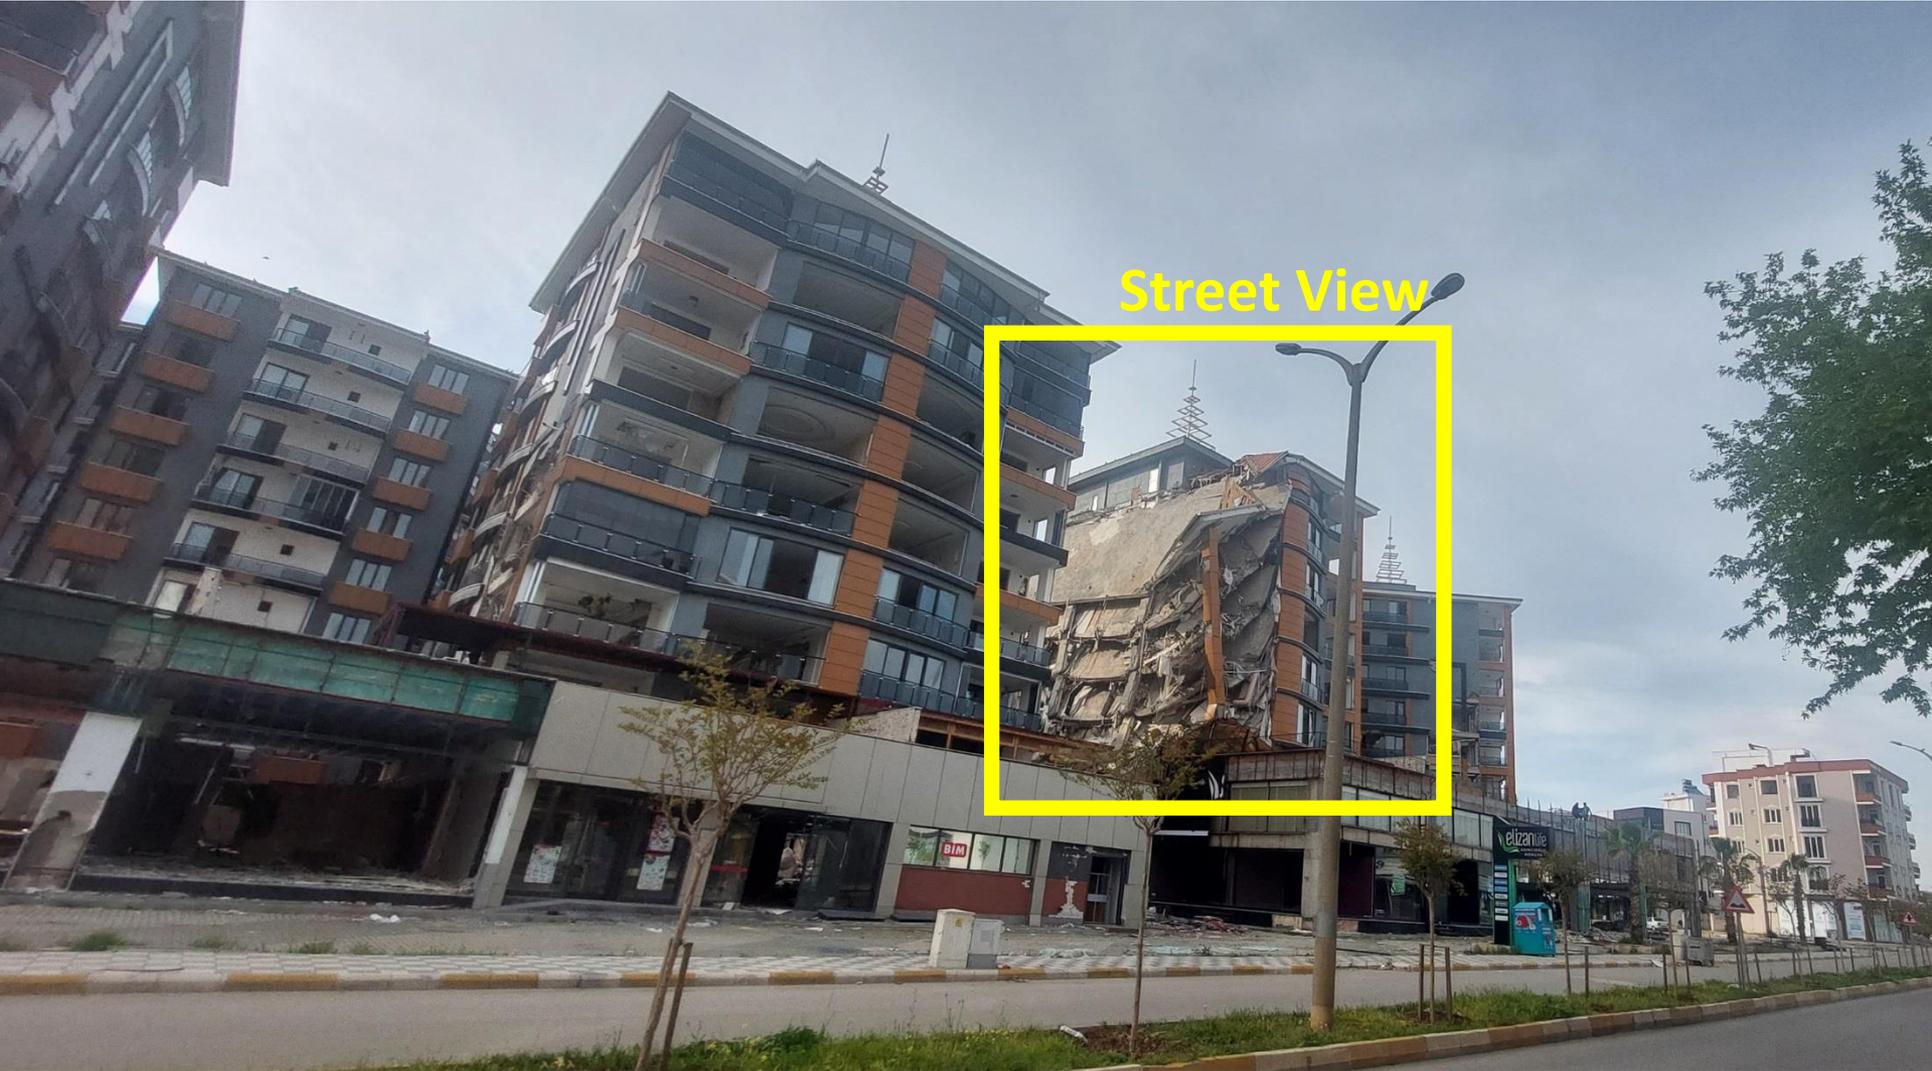
Partial collapse in a 9-story RC building in Adiyaman

No proper joint reinforcement

Result = columns respond independently from the slab

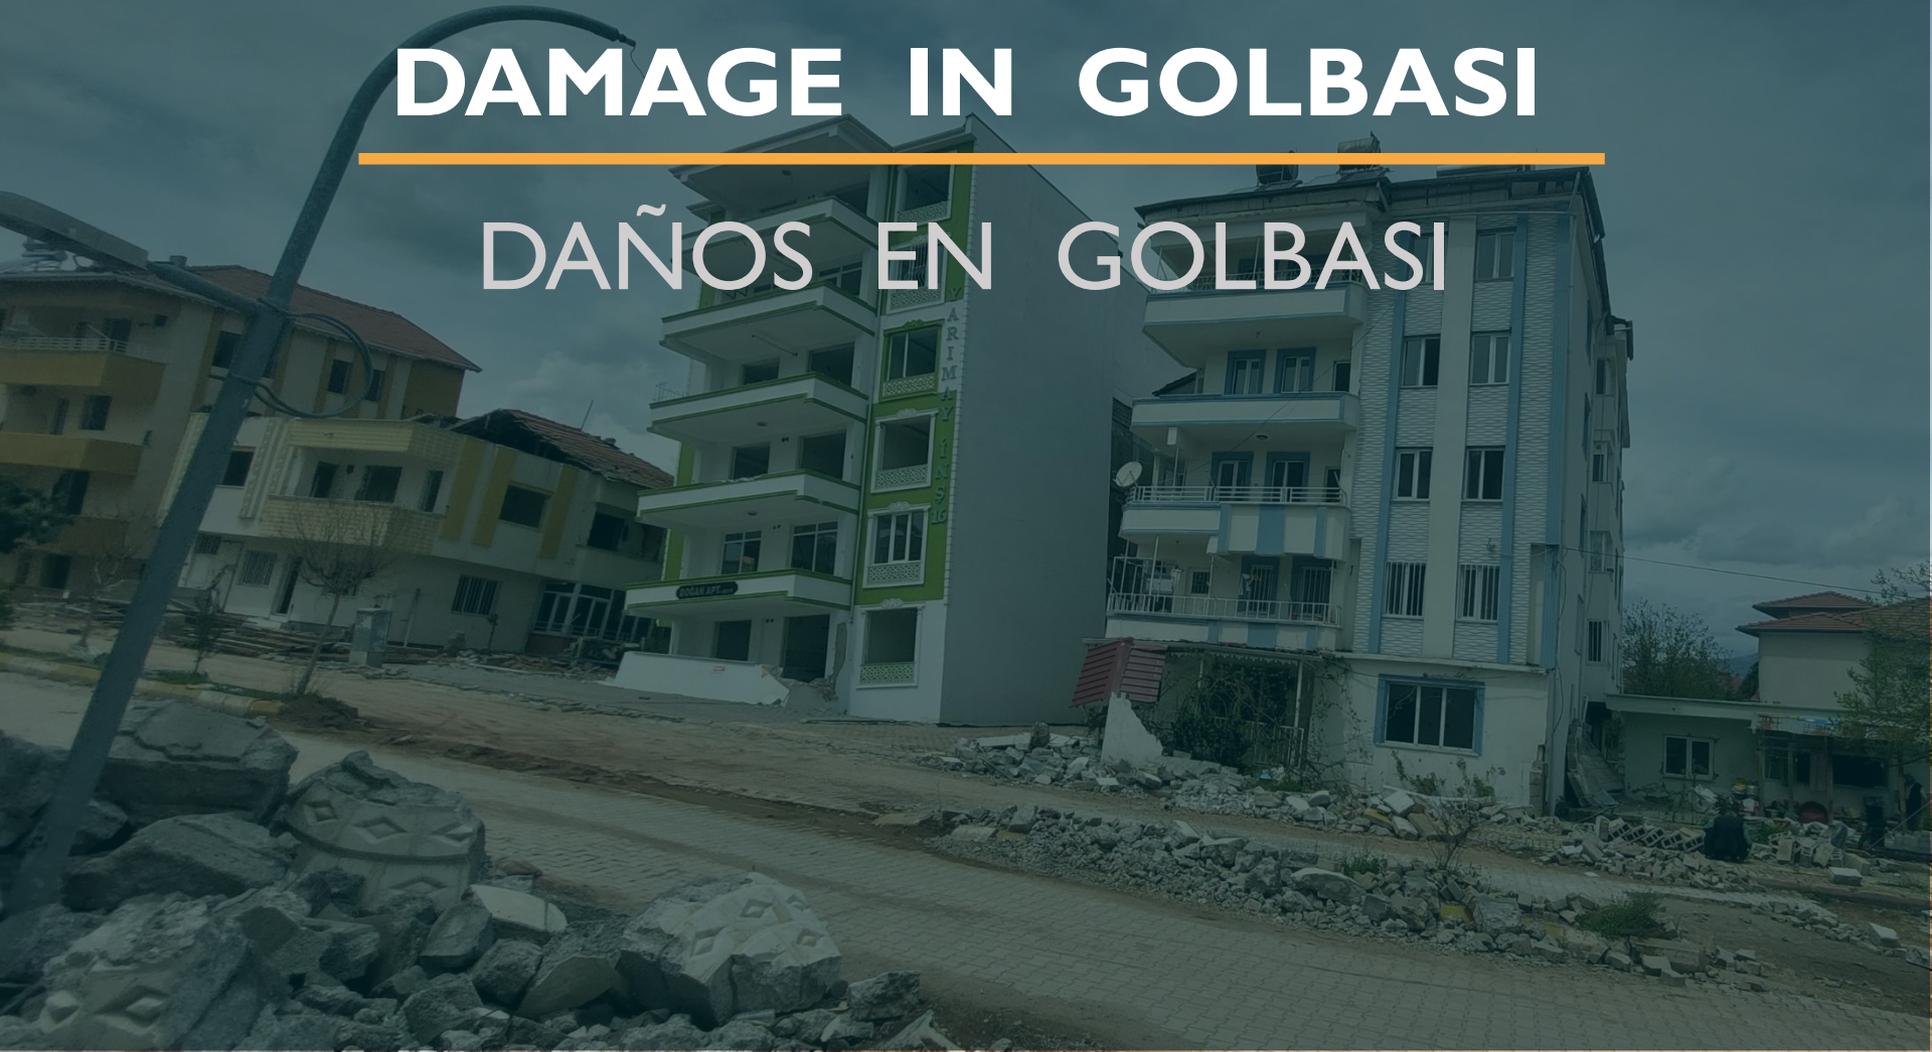
A toppled building in Golbasi, Adiyaman district

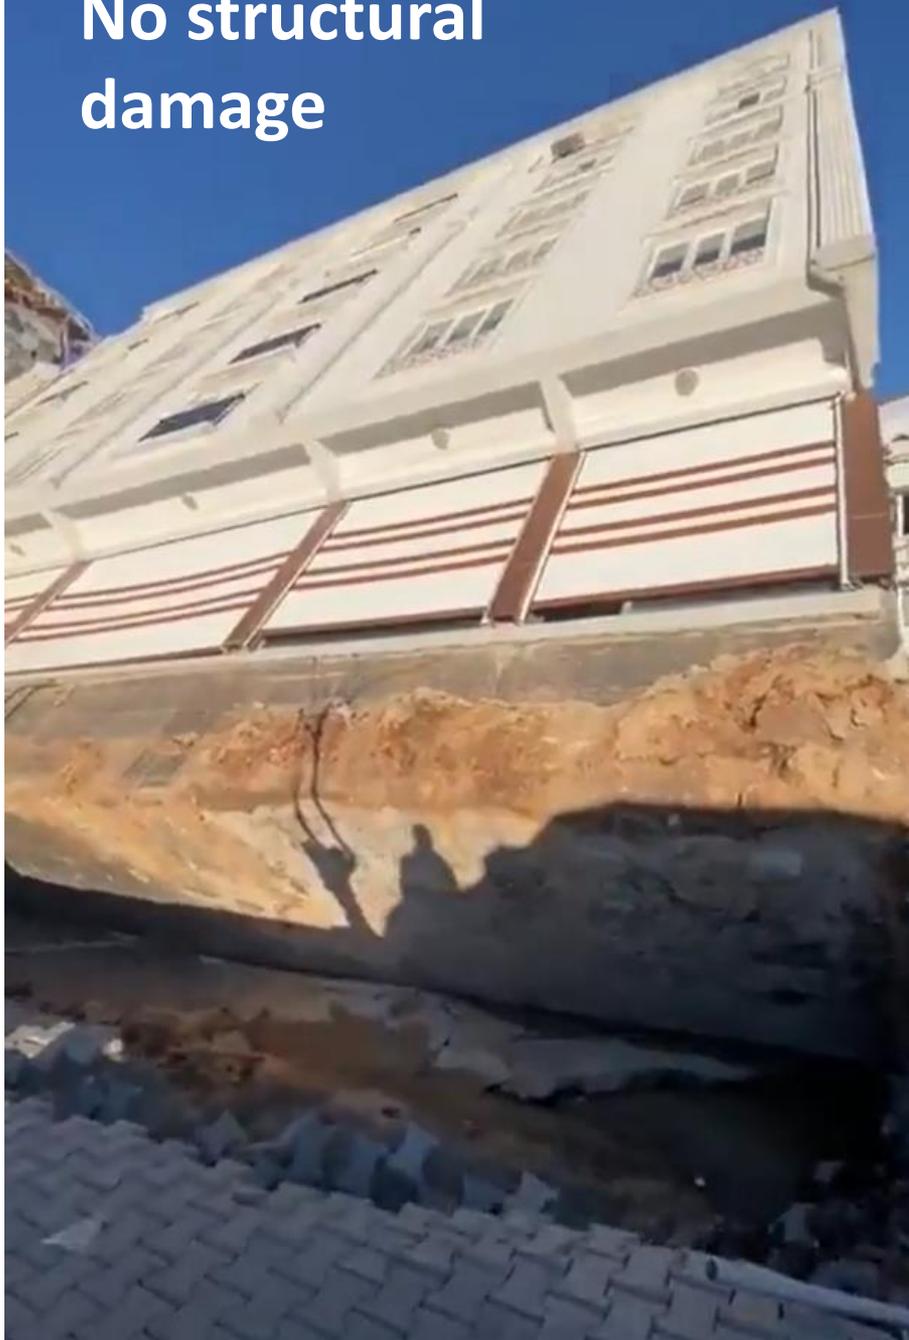
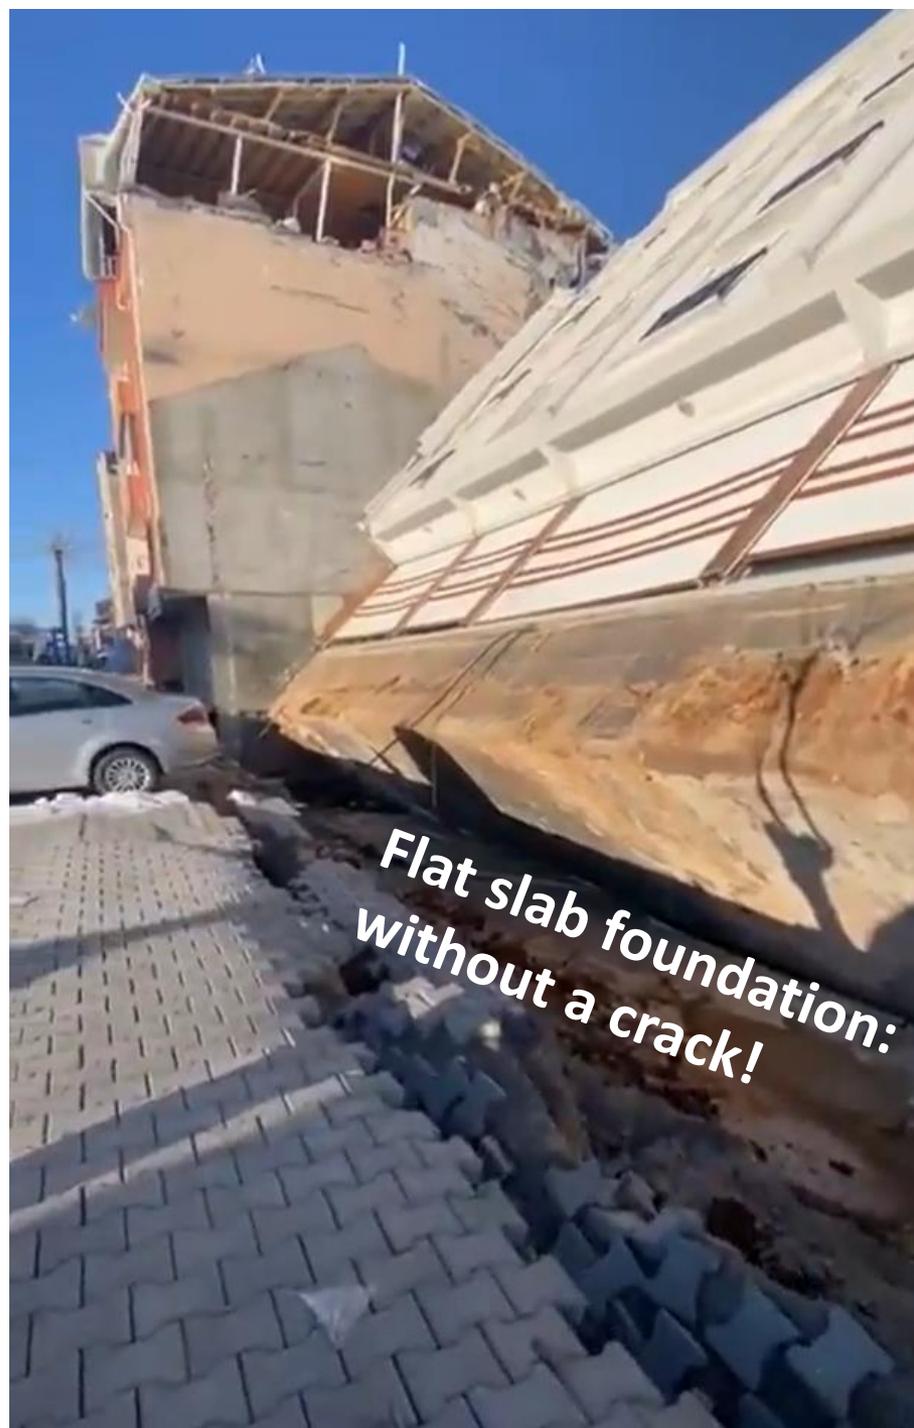
**Flat slab foundation:
without a crack!**

**Rocking of whole
buildings**

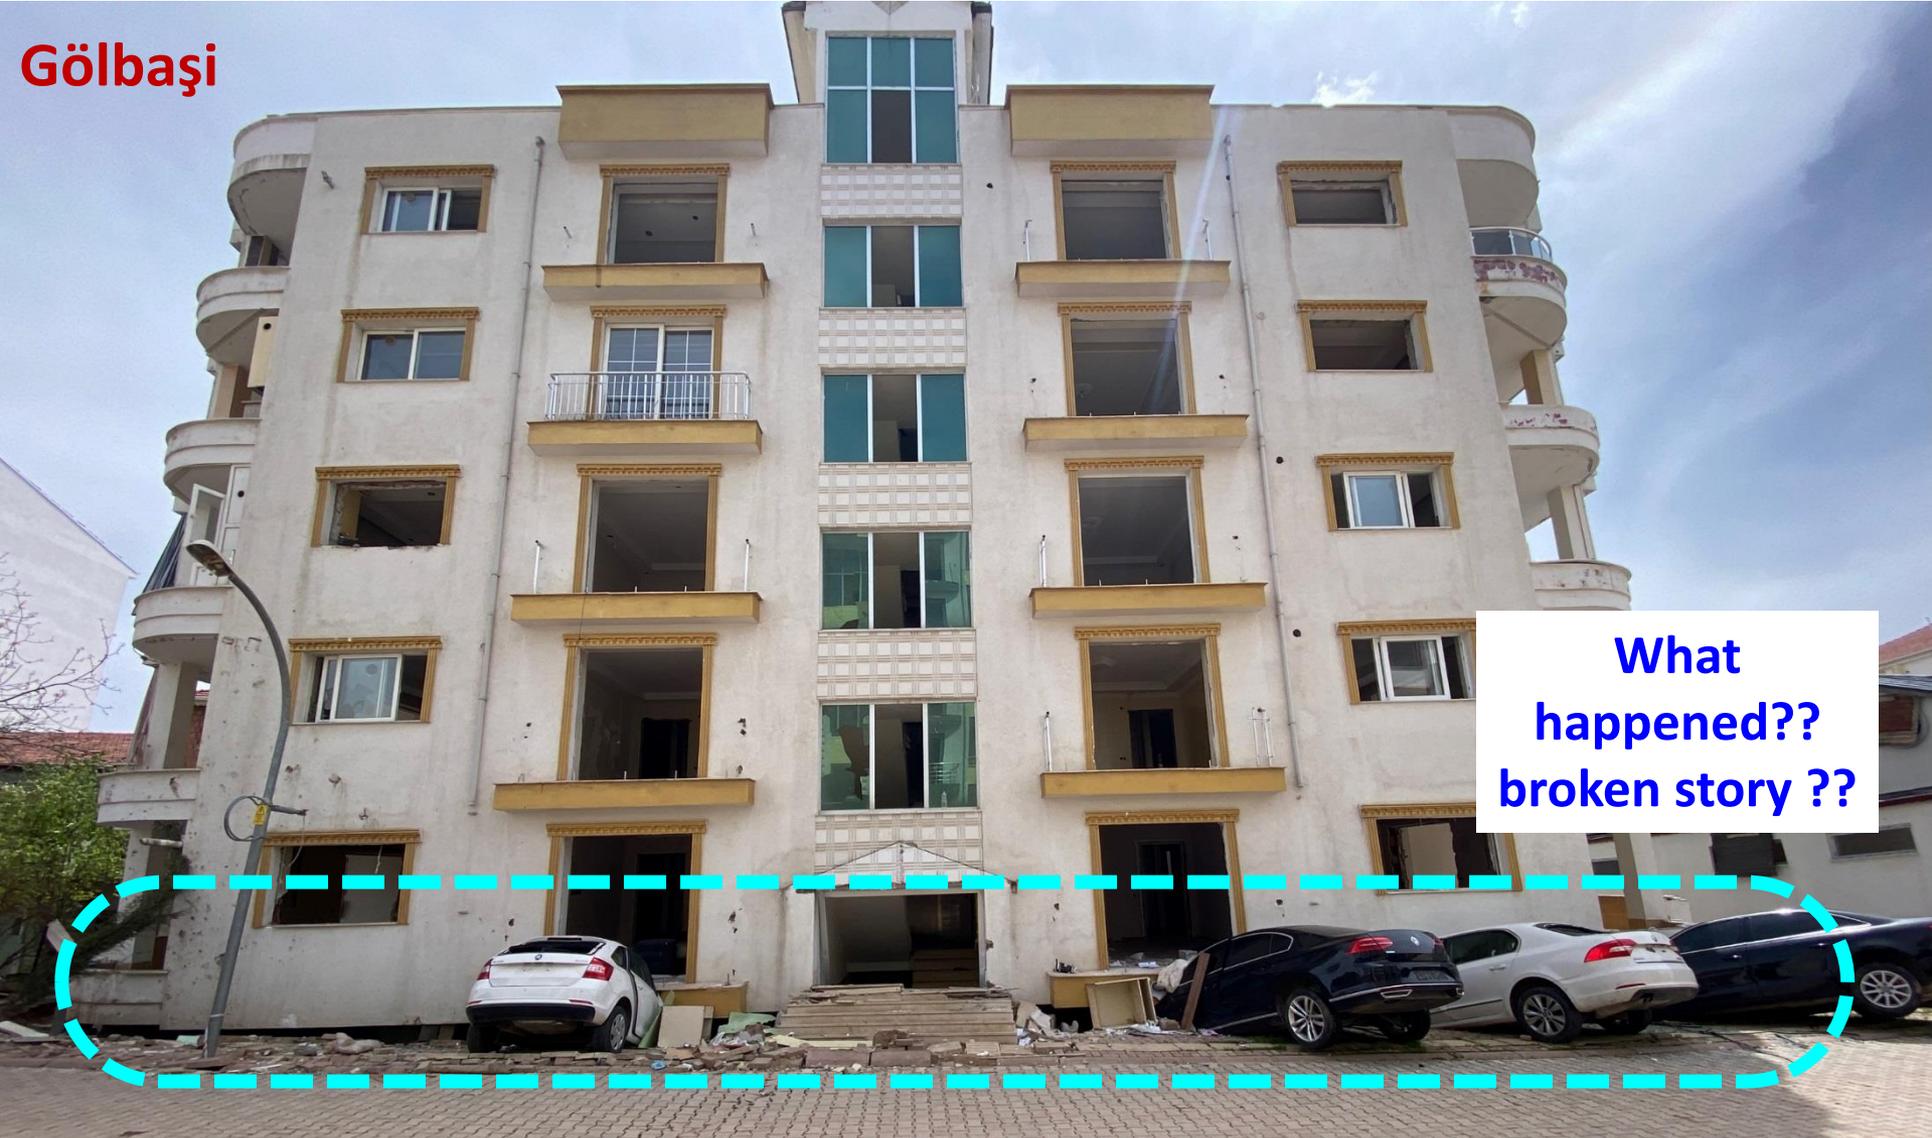
**What
happened??
broken story ??**
