The 2023 Kahramanmaras earthquakes of February 6th in Turkey

Evangelia GARINI and **George GAZETAS**

School of Civil Engineering, Geotechnical Department
National Technical University of Athens, Greece

THE 2023 TURKIYE-SYRIA EARTHQUAKES

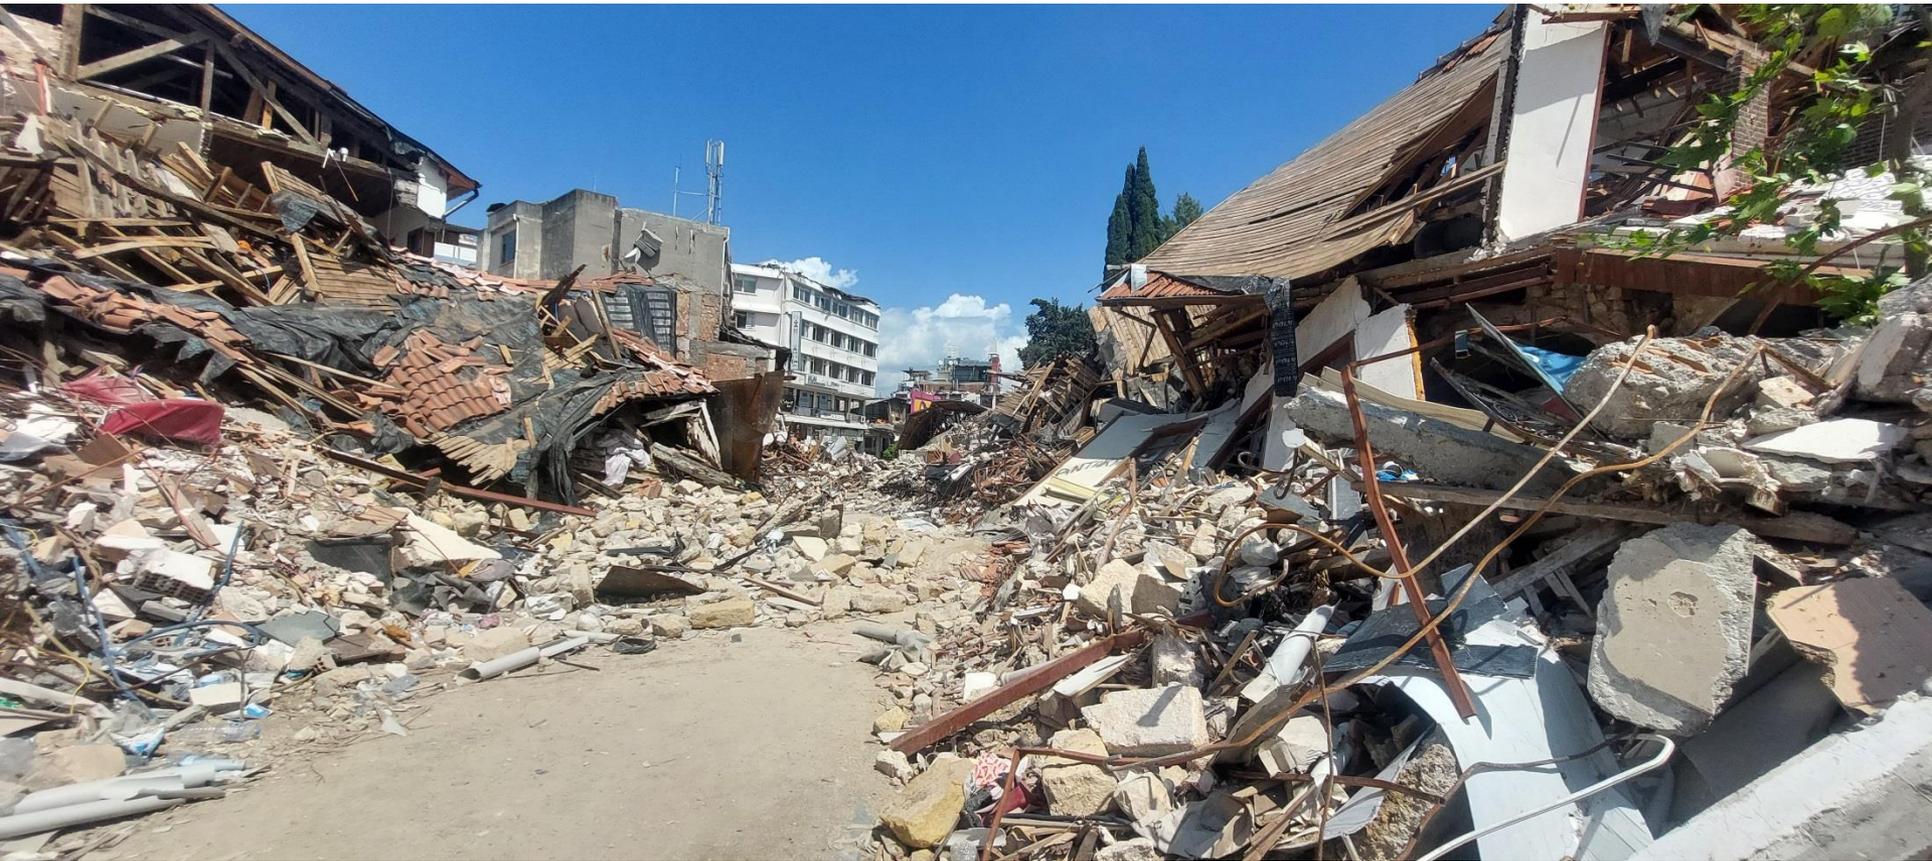
The “modern” part of Antakya is SEVERELY damaged

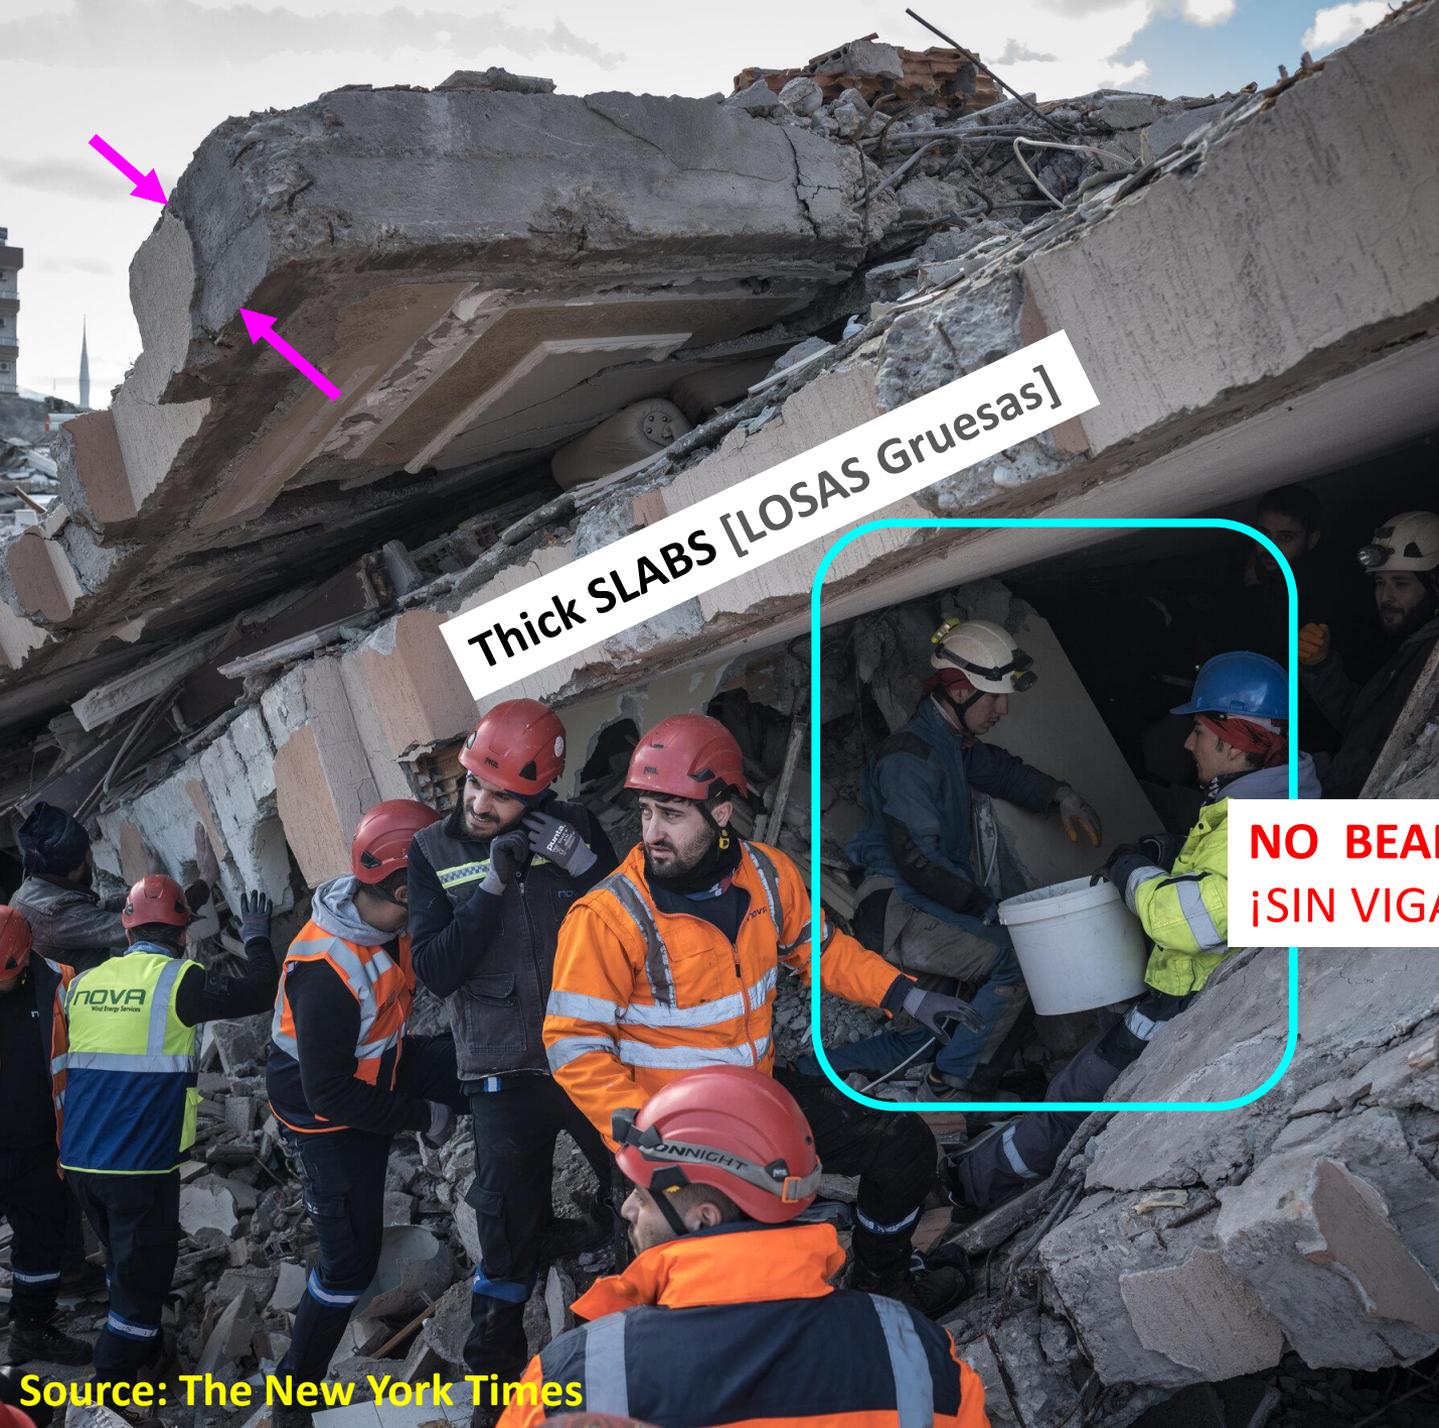
Thick SLABS [LOSAS Gruesas]

**NO BEAMS, POOR JOINTS !
¡SIN VIGAS, JUNTAS POBRES!**

A hotel recently constructed: lost the ground floor

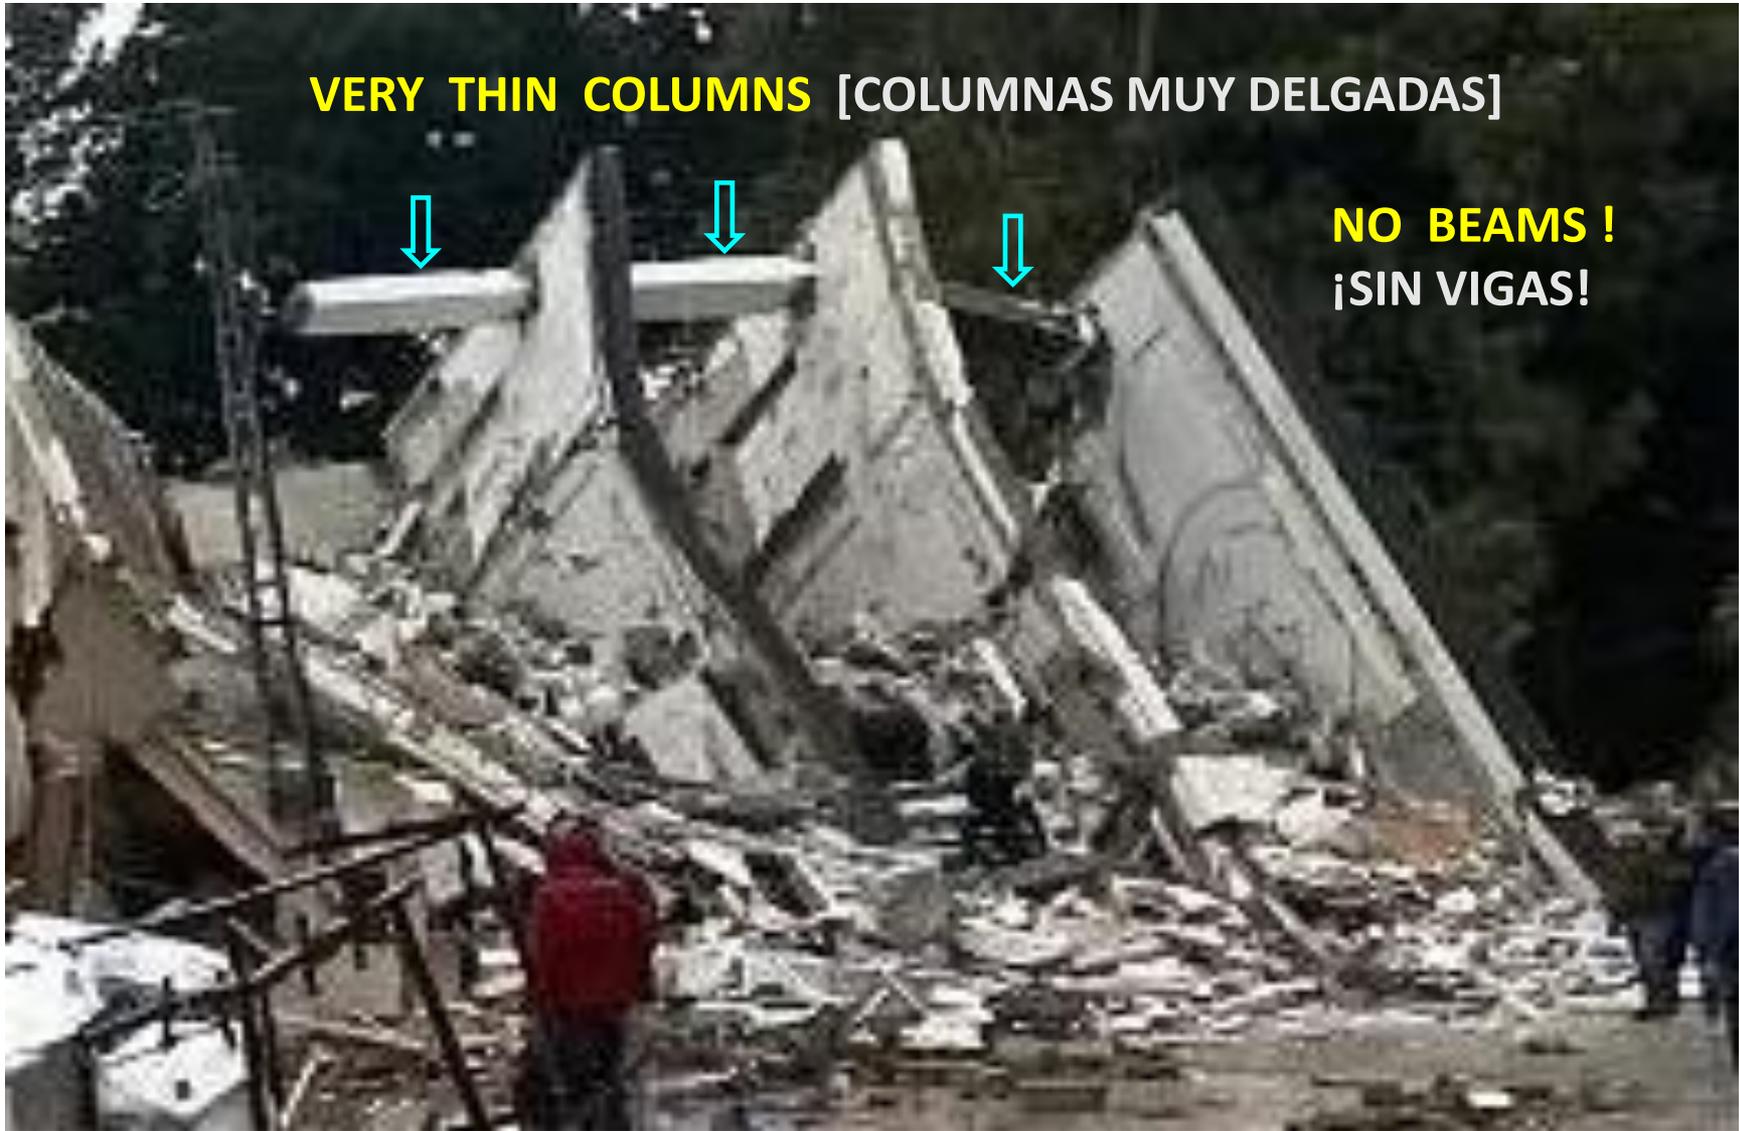
Numerous building without any beam, with small size columns (inappropriate even for 1-story buildings in a region of moderate seismicity).

a thin column with **only 10 stirrups**
for shear reinforcement in its
height...of course **totally collapsed**

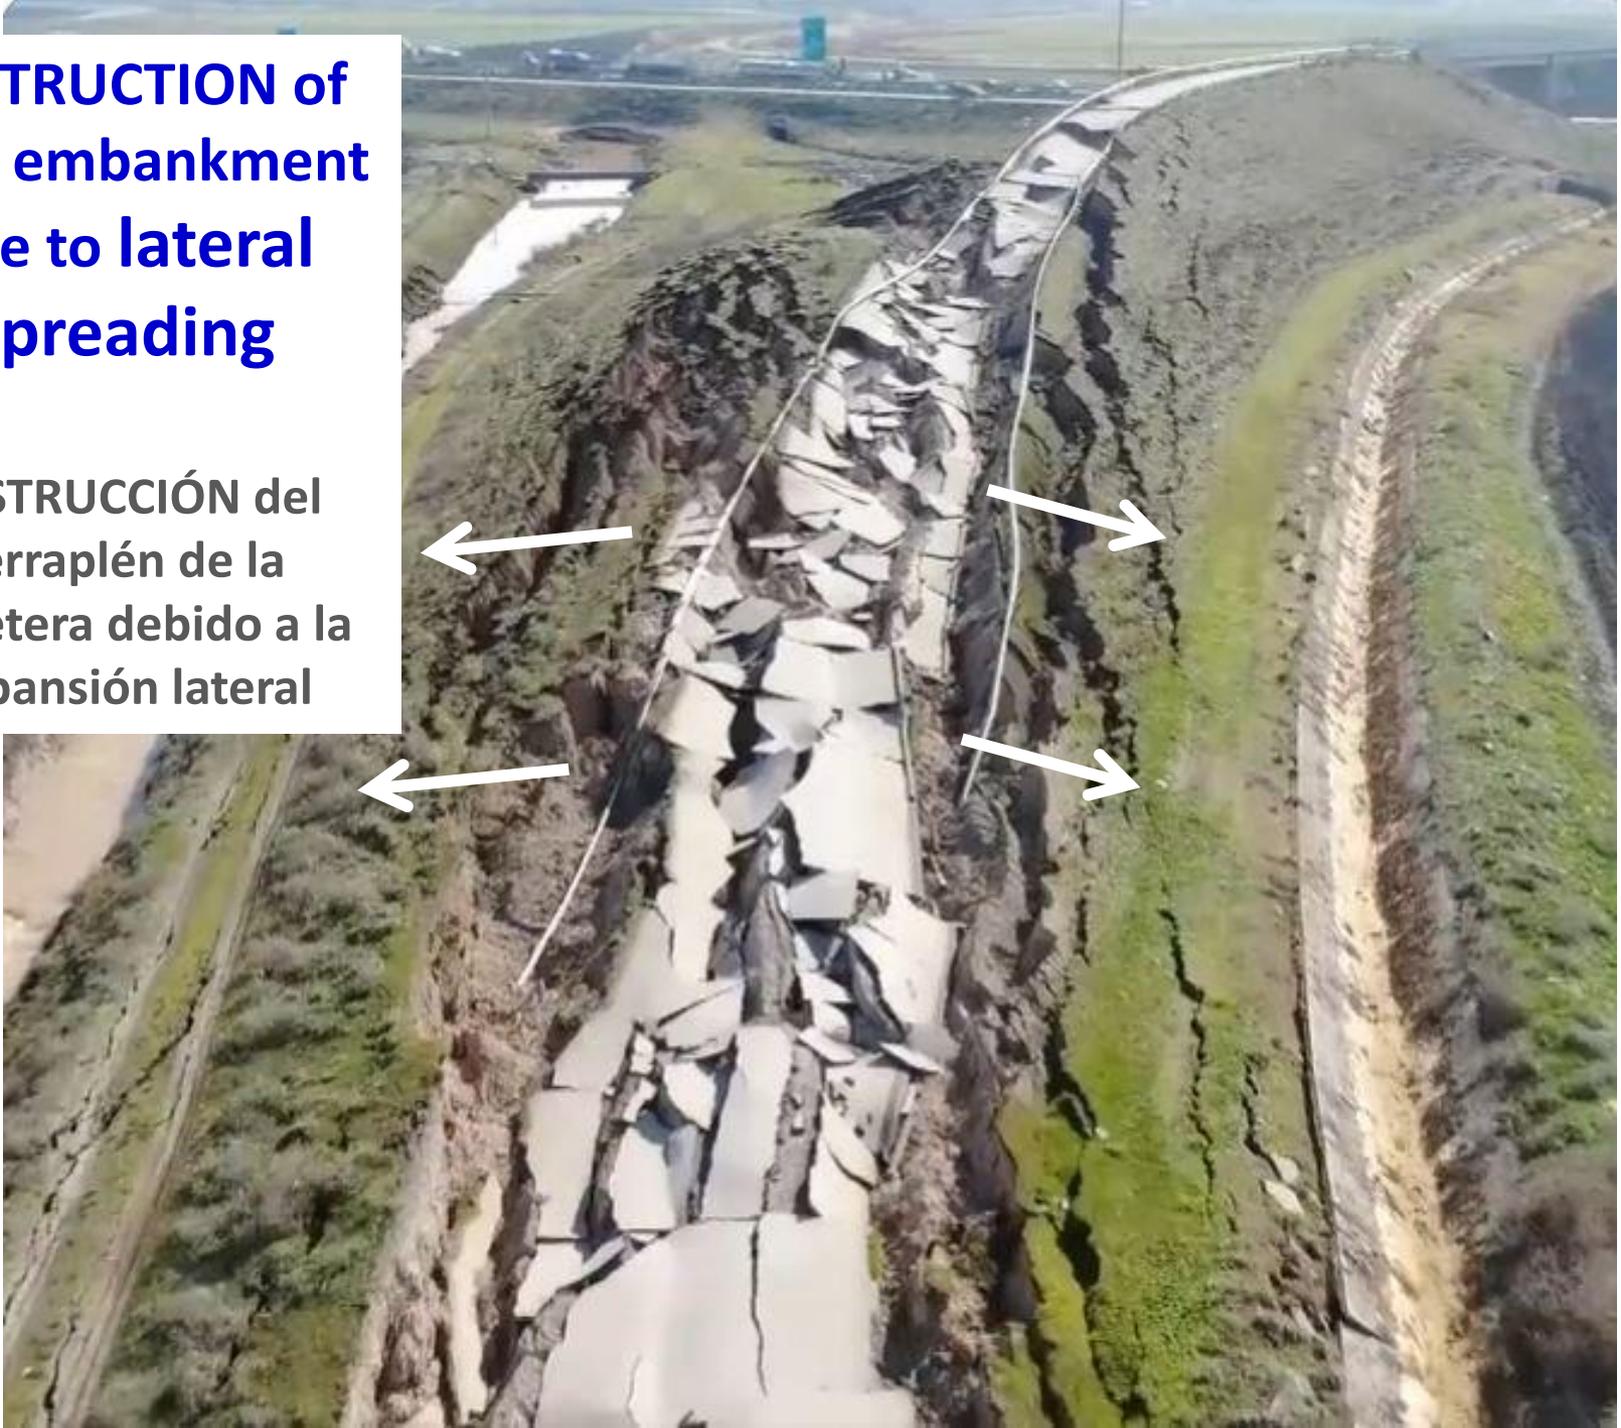
**DESTRUCTION of
road embankment
due to lateral
spreading**

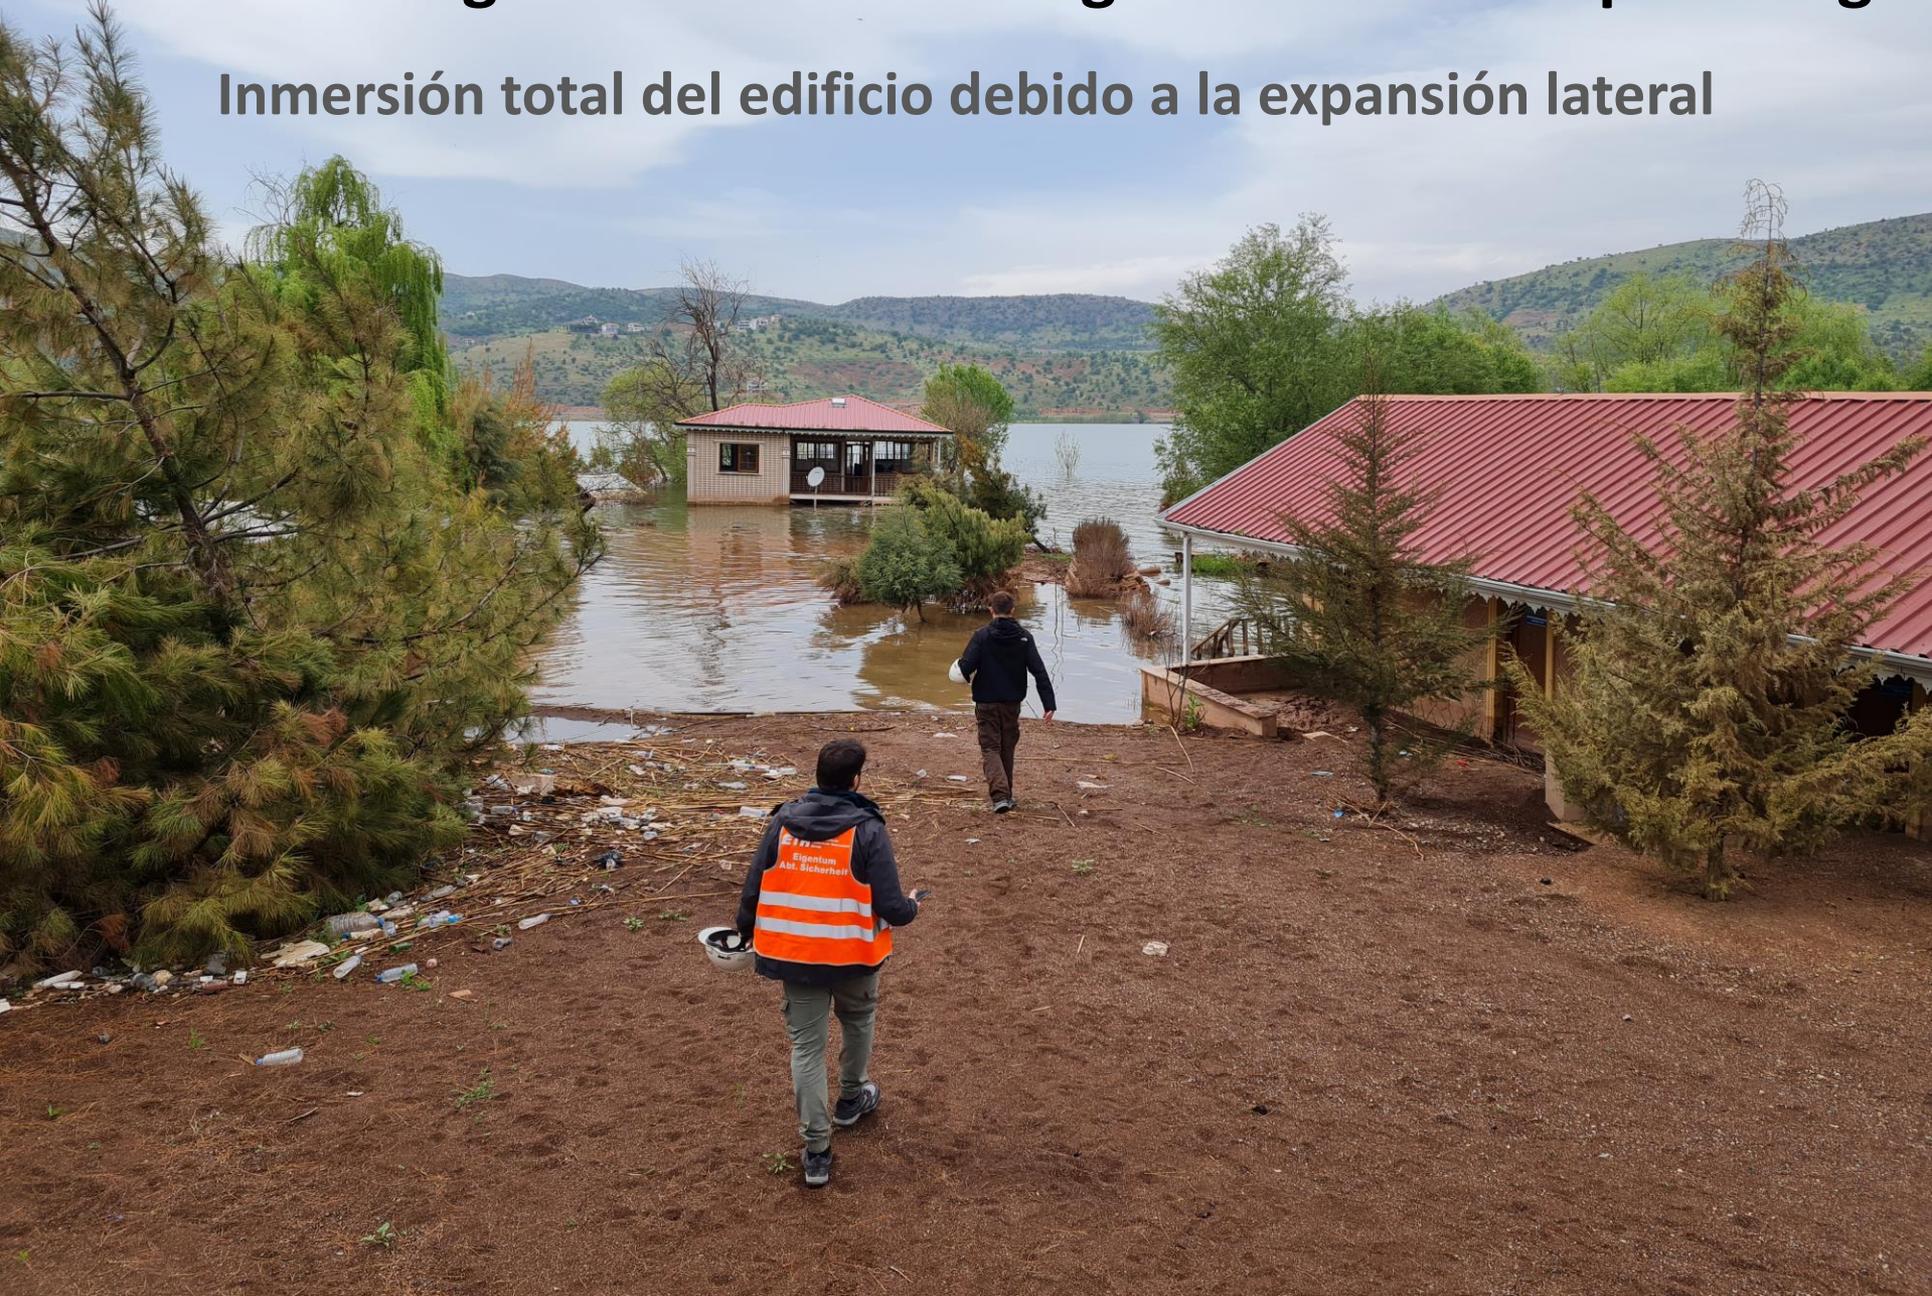
Total submergence of the building due to lateral spreading

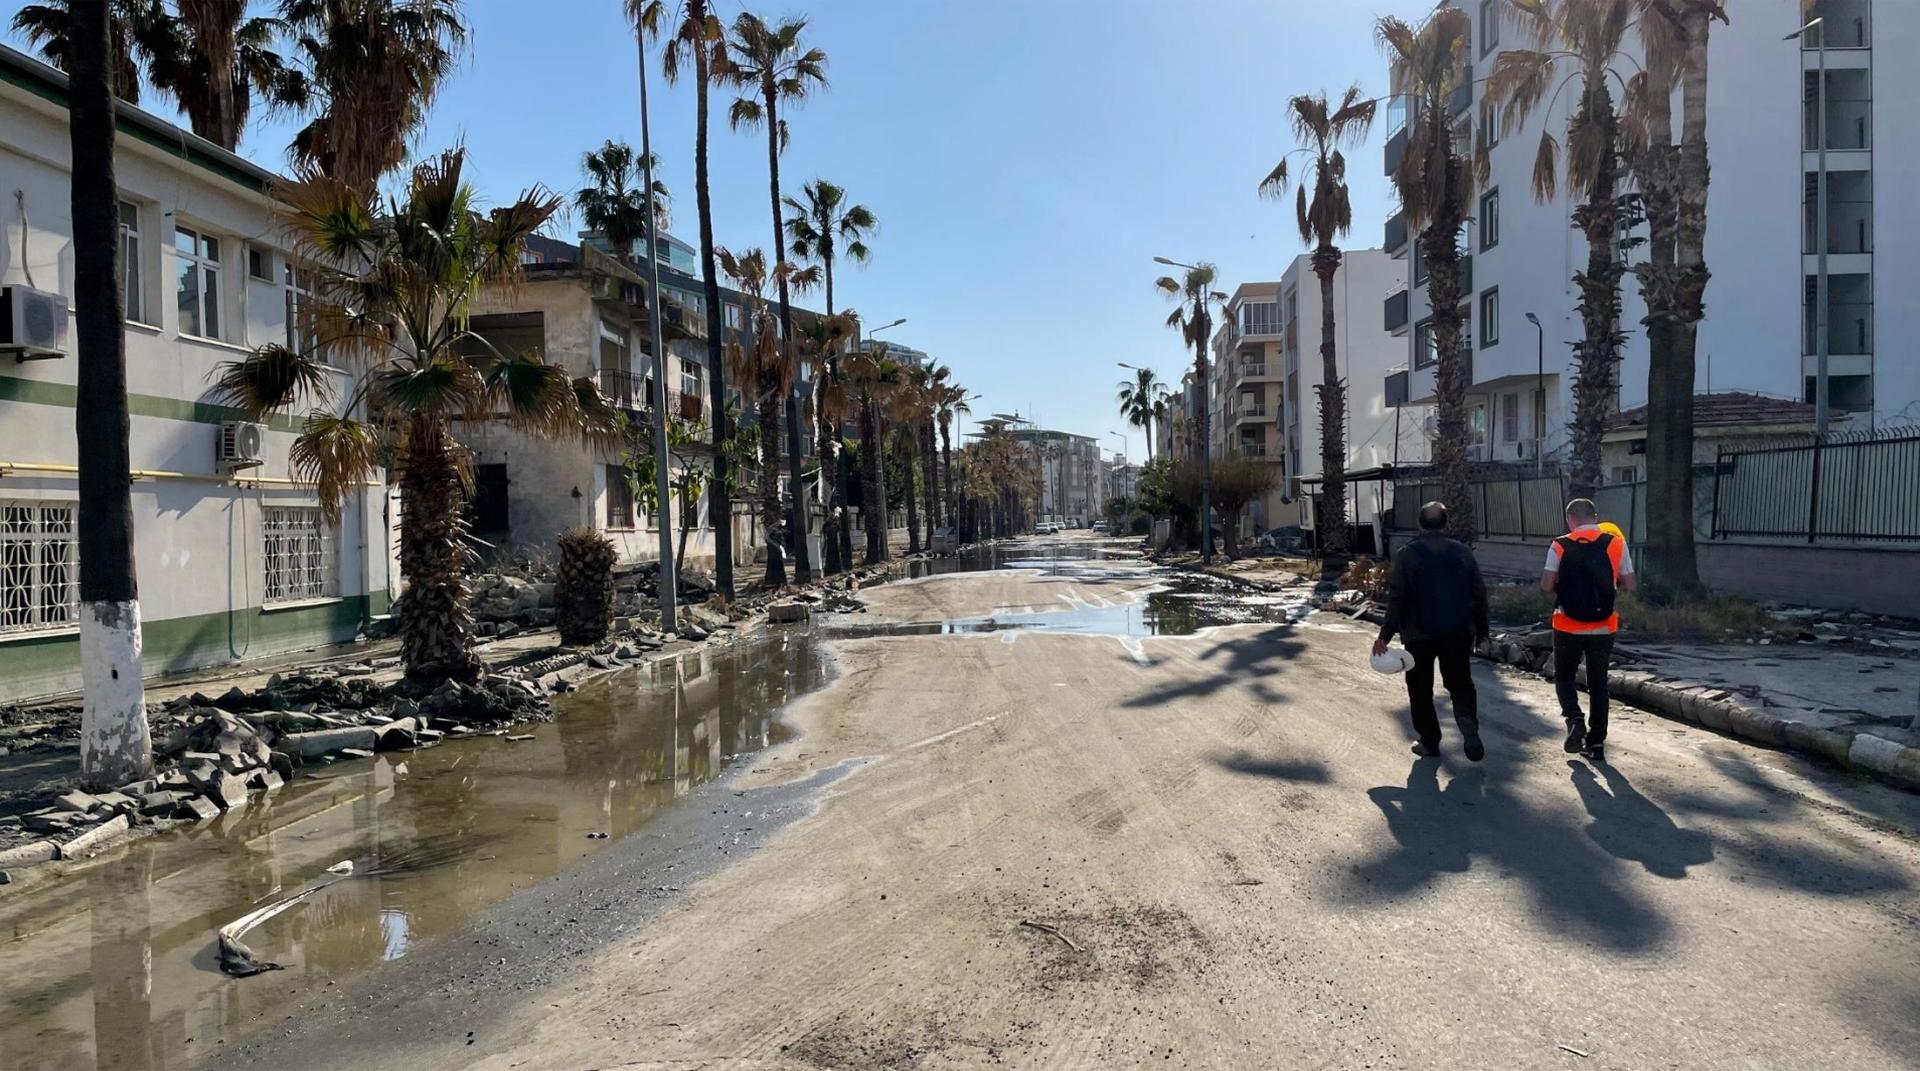
Subsidence in the coastal neighborhoods of Iskenderun

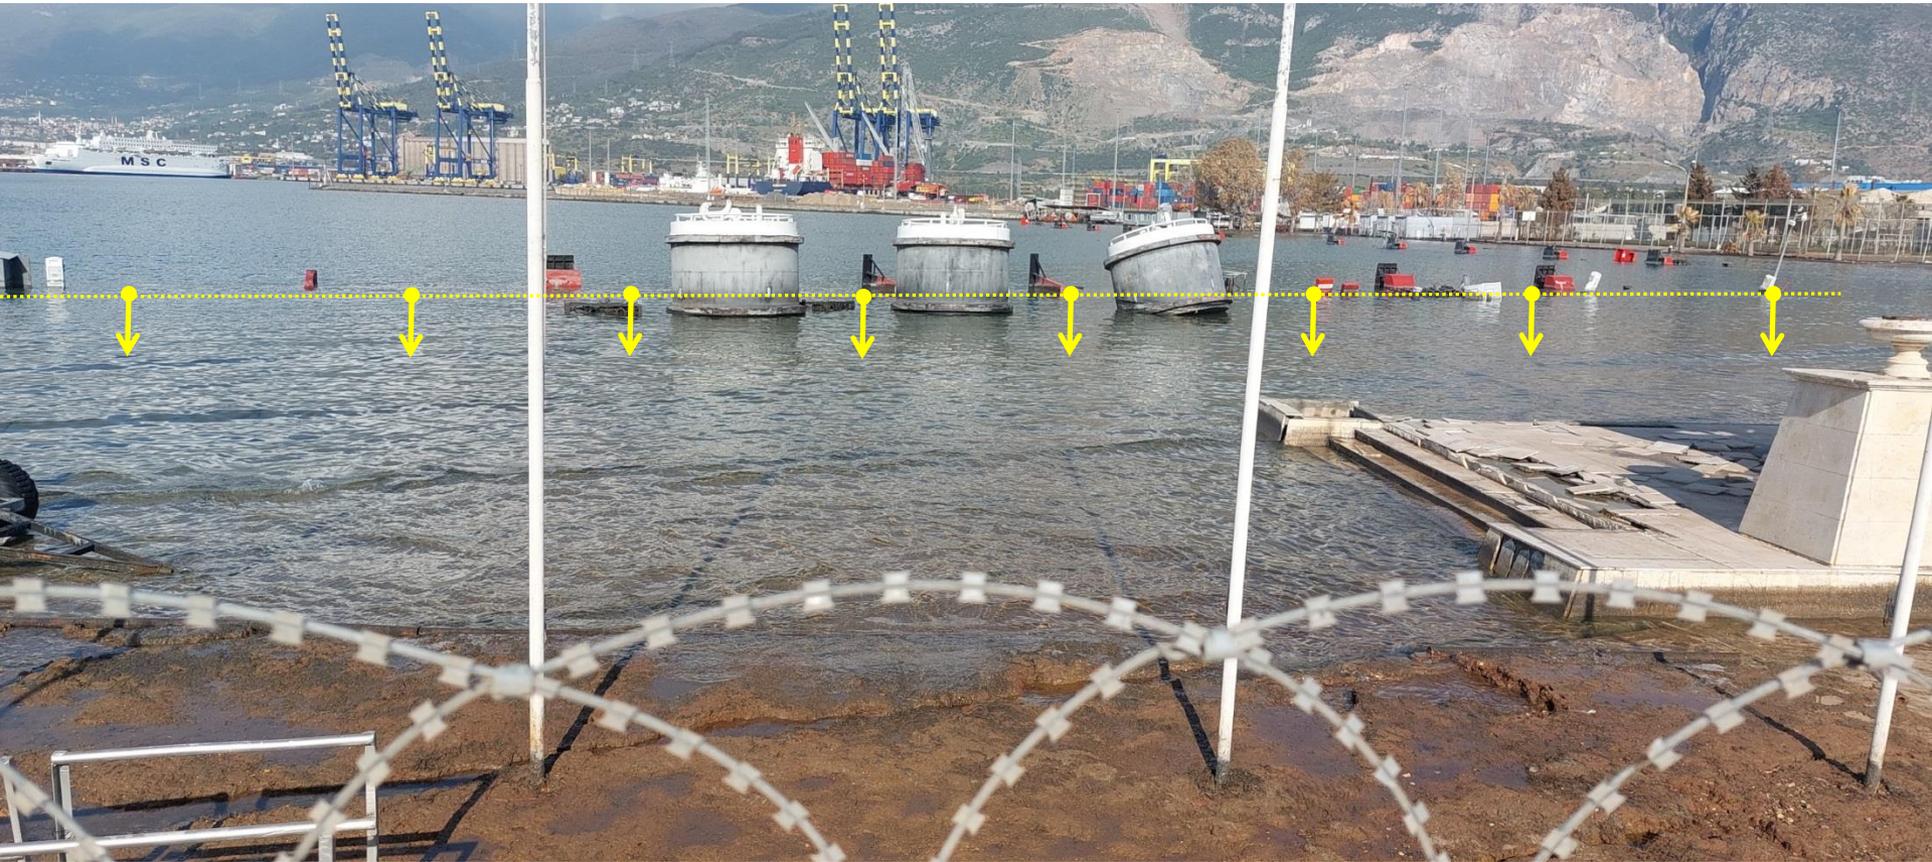
Submergence of a military Port in Iskenderun
