The 2023 Kahramanmaras earthquakes of February 6th in Turkey

Evangelia GARINI and **George GAZETAS**

School of Civil Engineering, Geotechnical Department
National Technical University of Athens, Greece

THE 2023 TURKIYE-SYRIA EARTHQUAKES

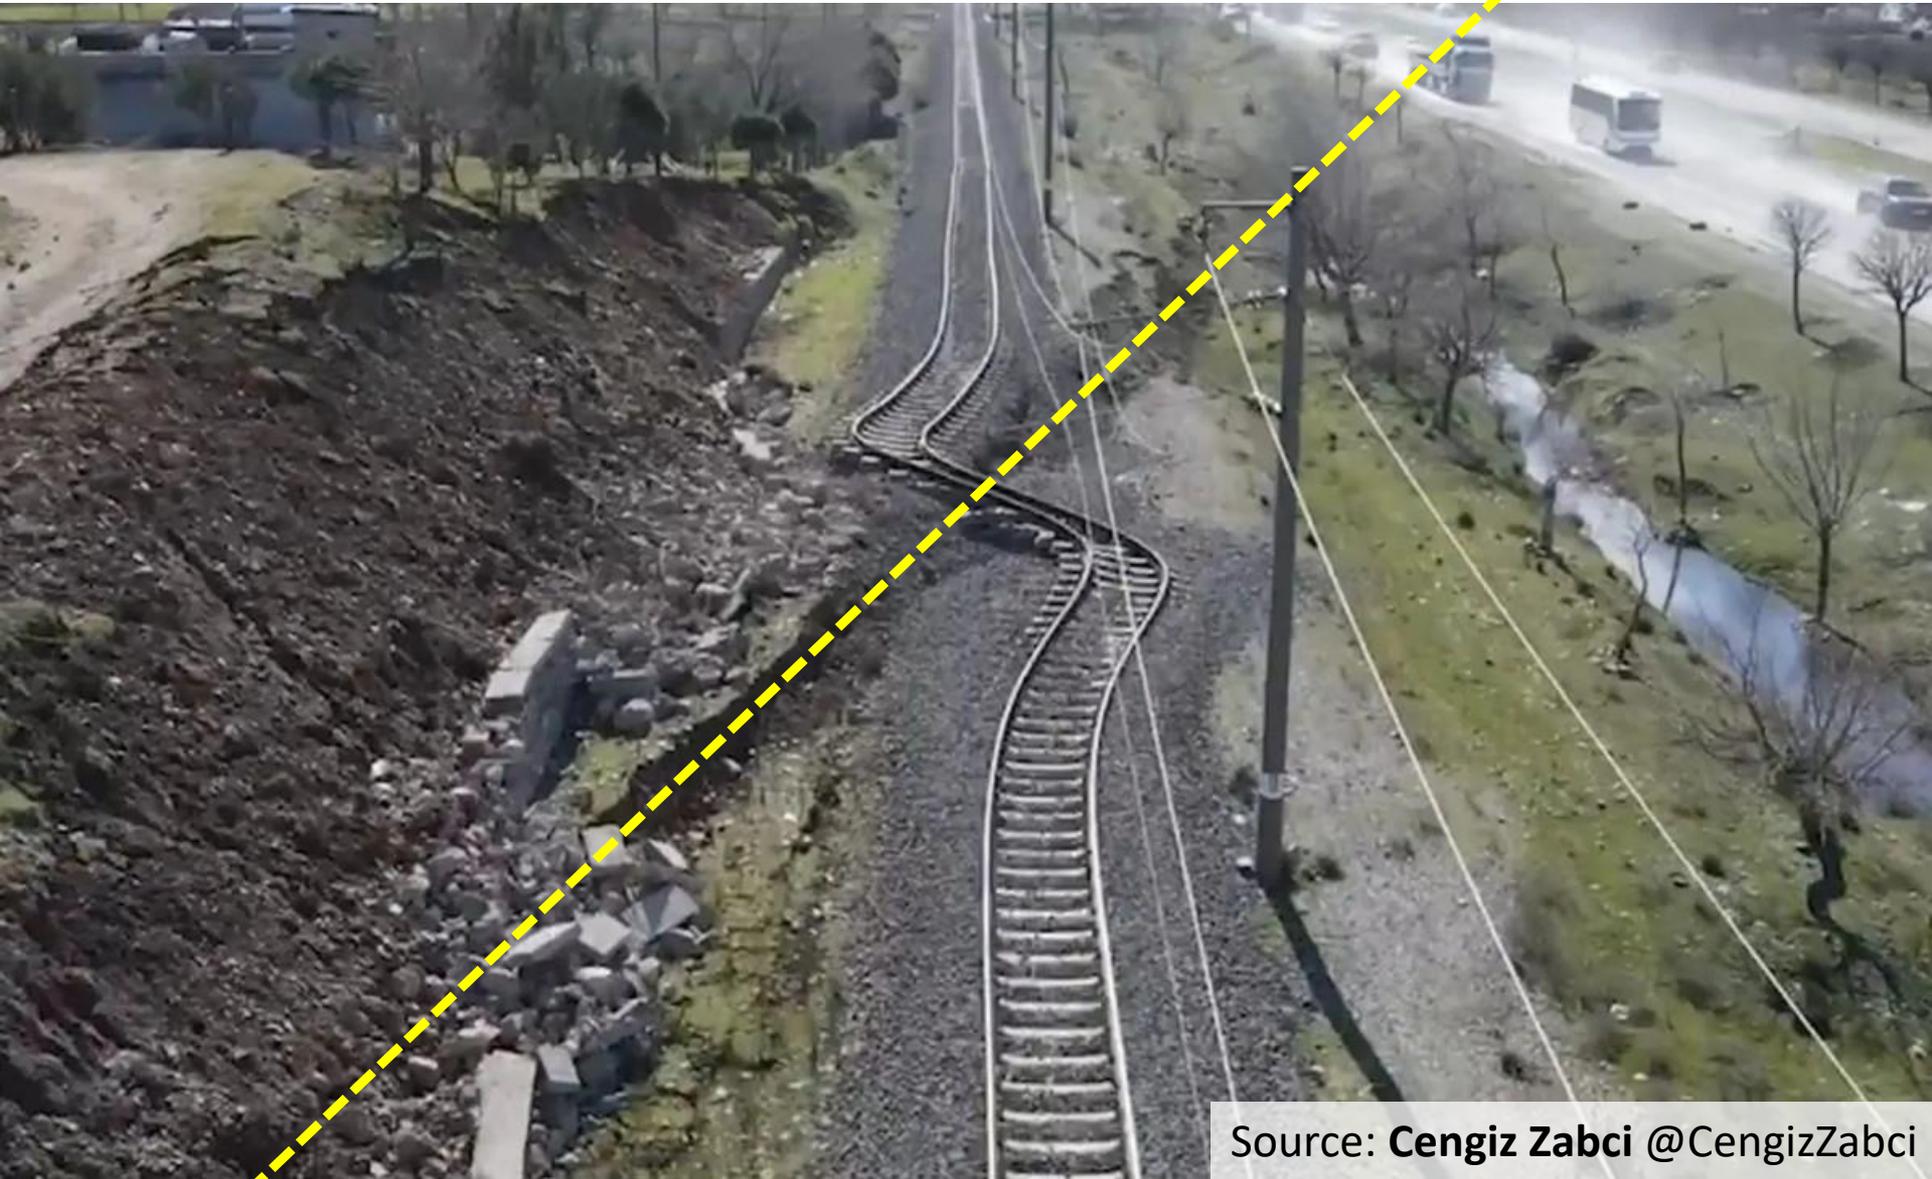
The strike-slip fault emerging at acute angle to the rails causes them to buckle.

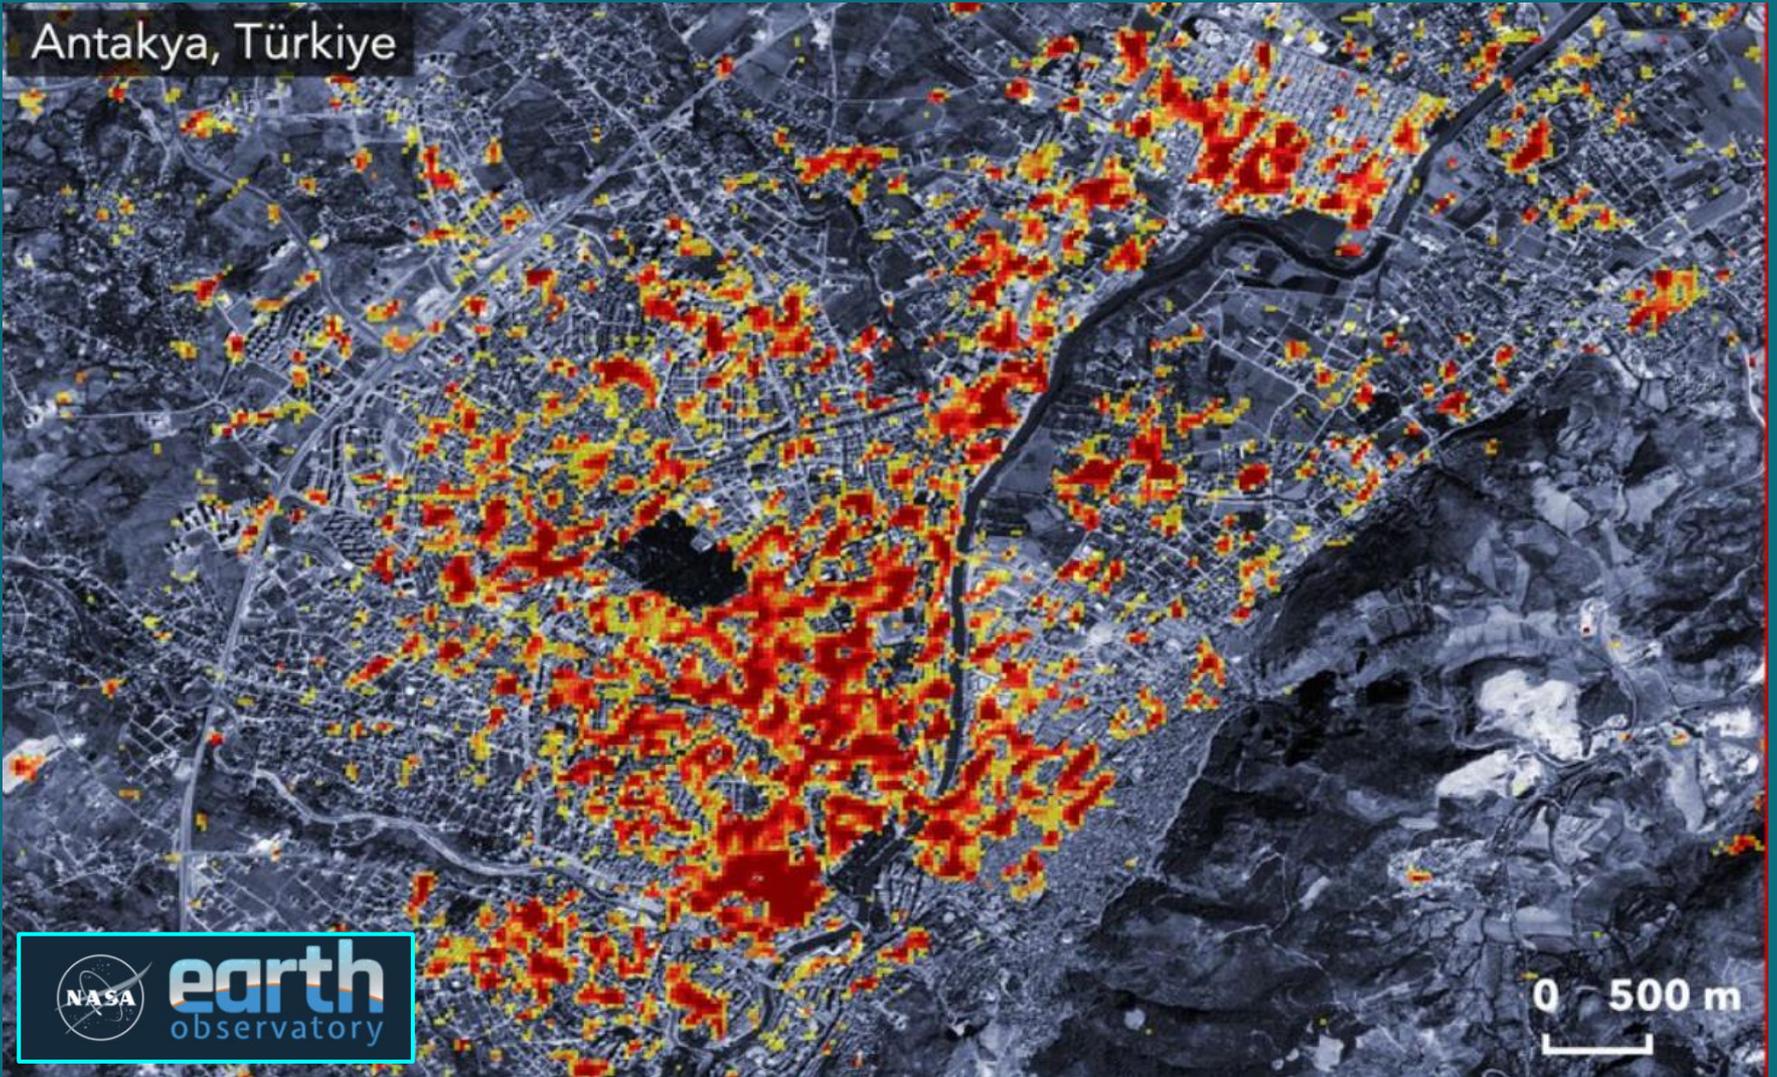
Antakya, Türkiye

Damage distribution
through satellite
observations

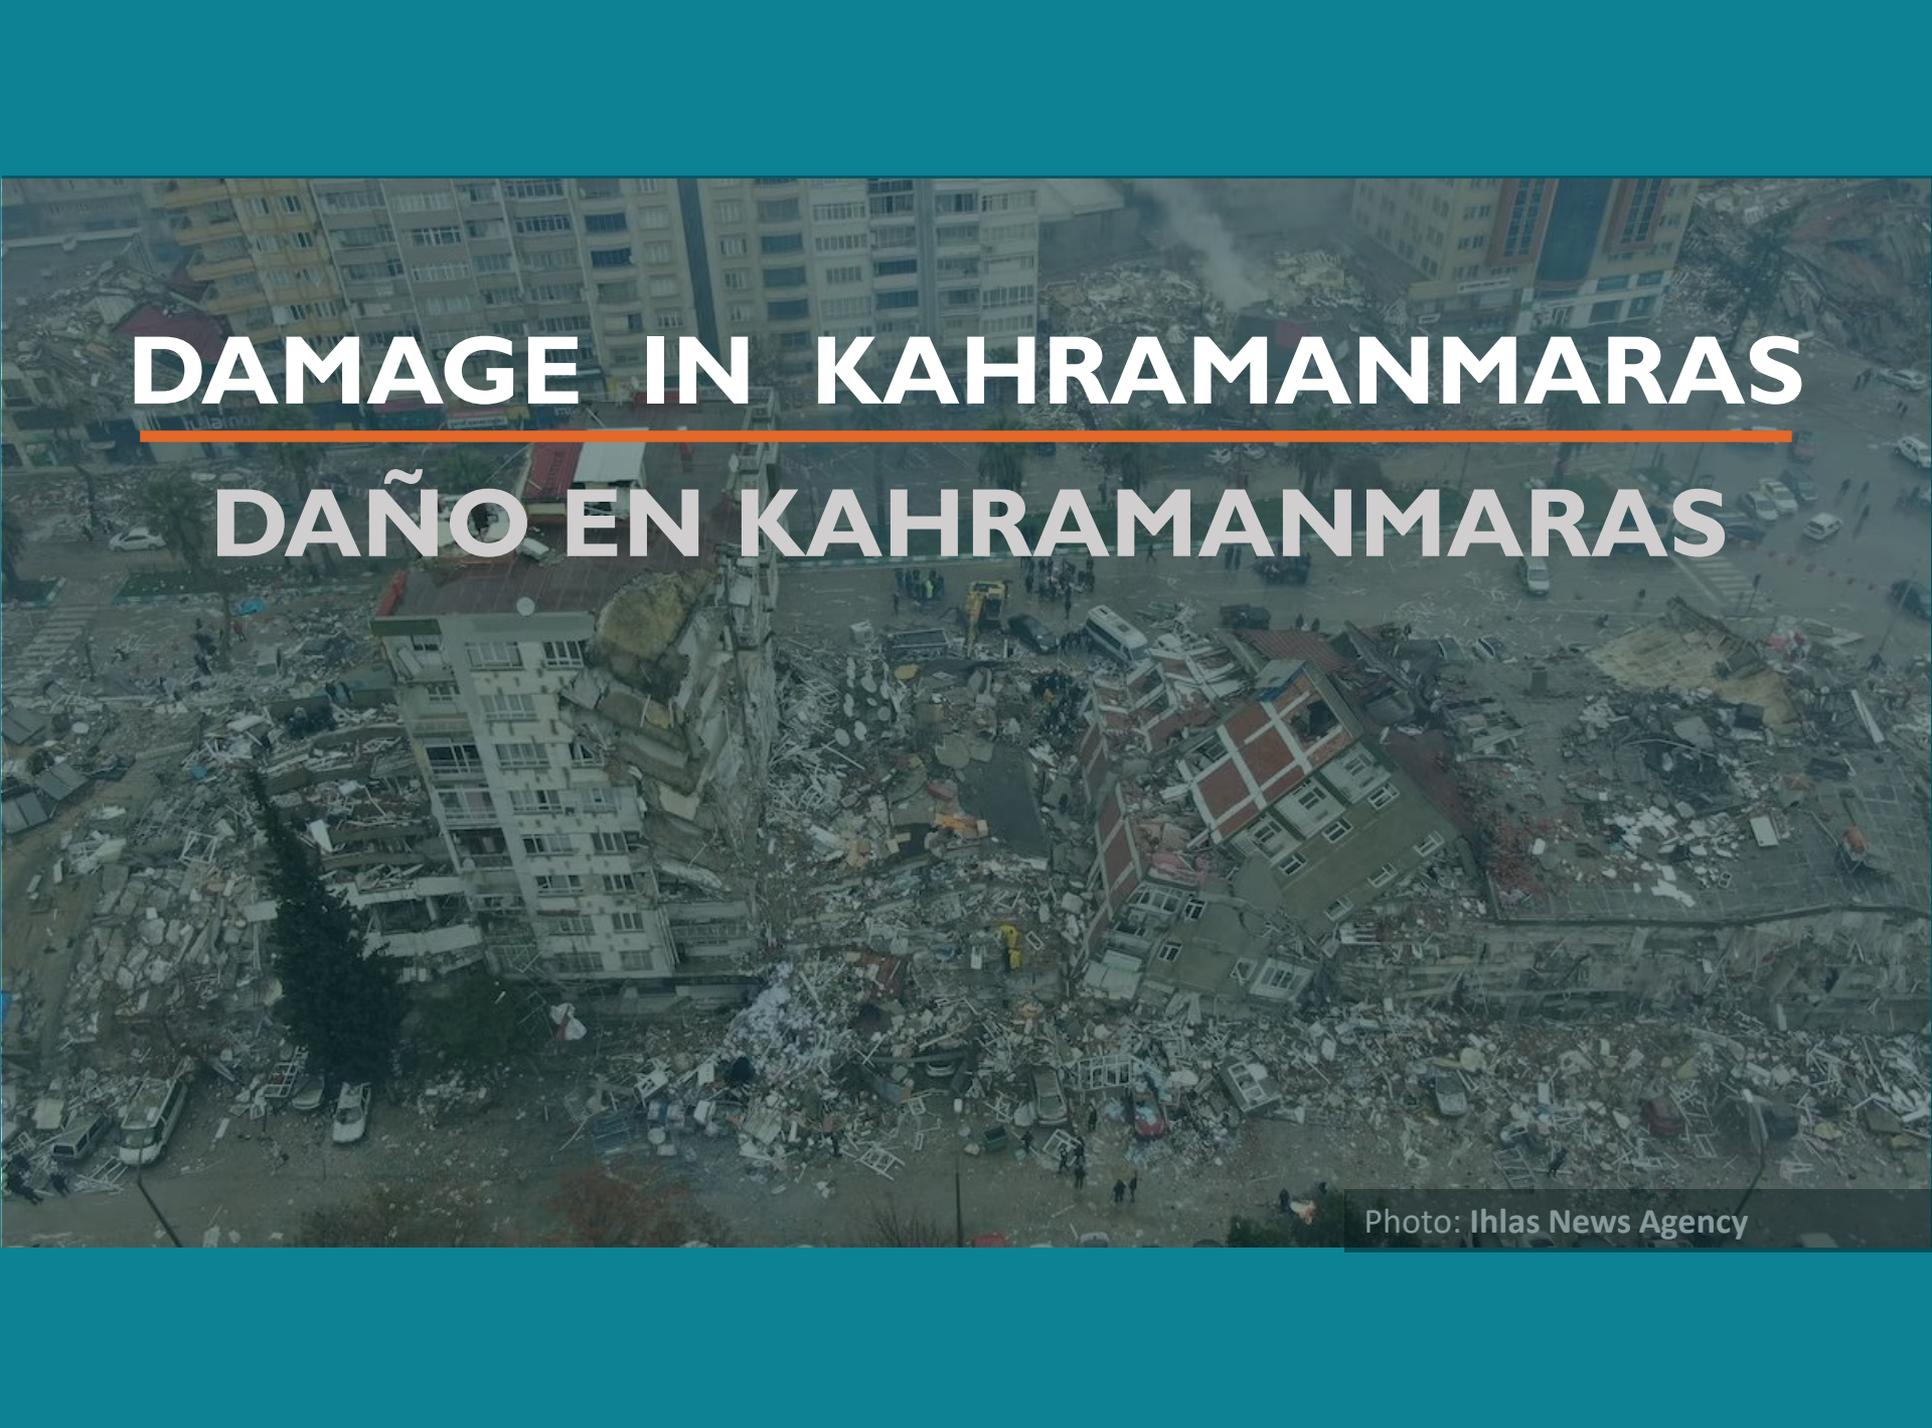
DAMAGE IN KAHRAMANMARAS

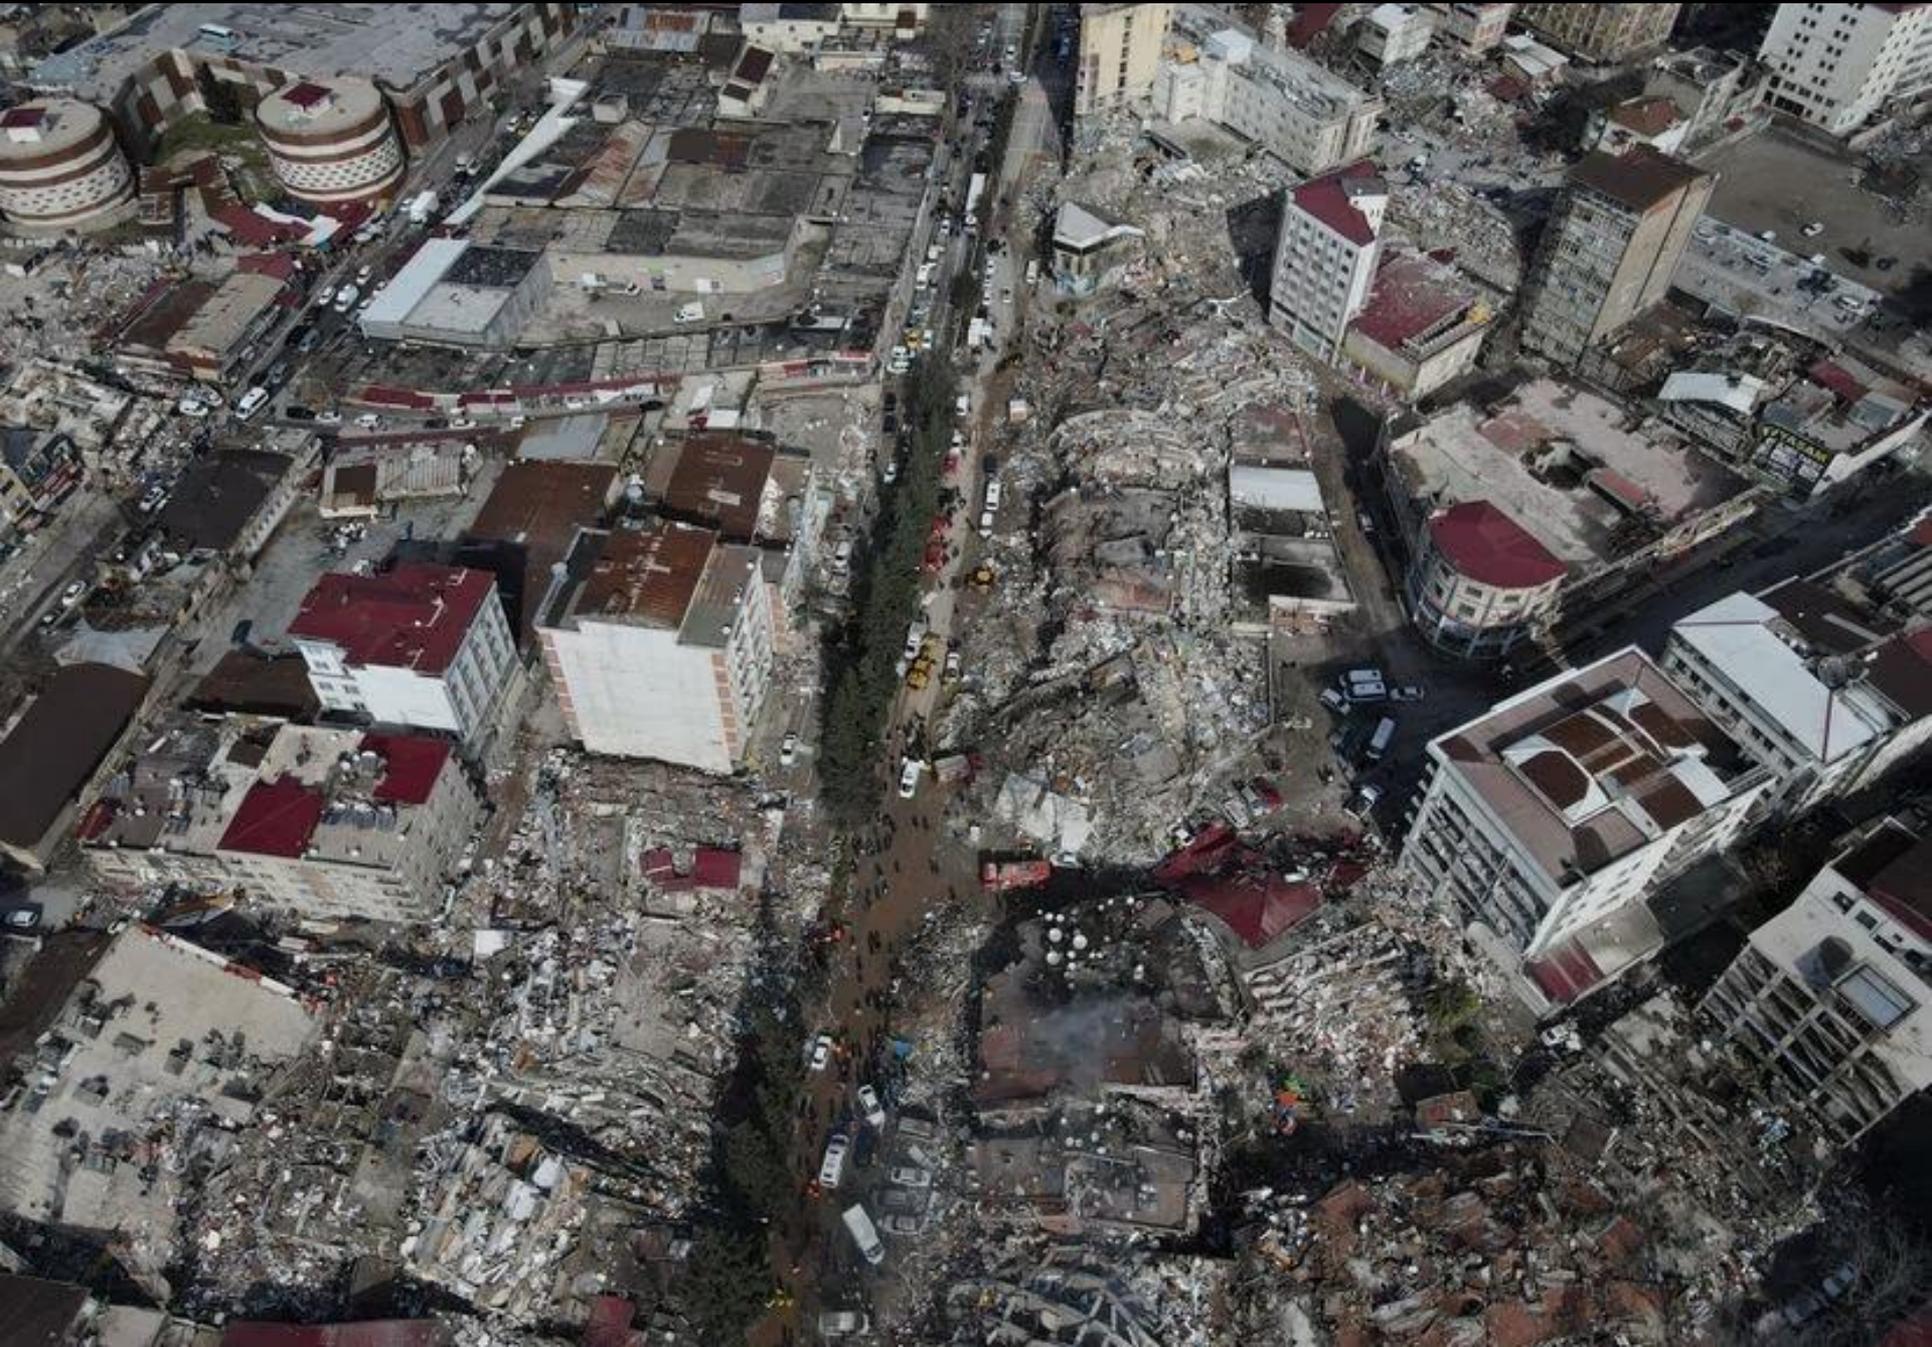
General view in Kahramanmaras neighborhoods

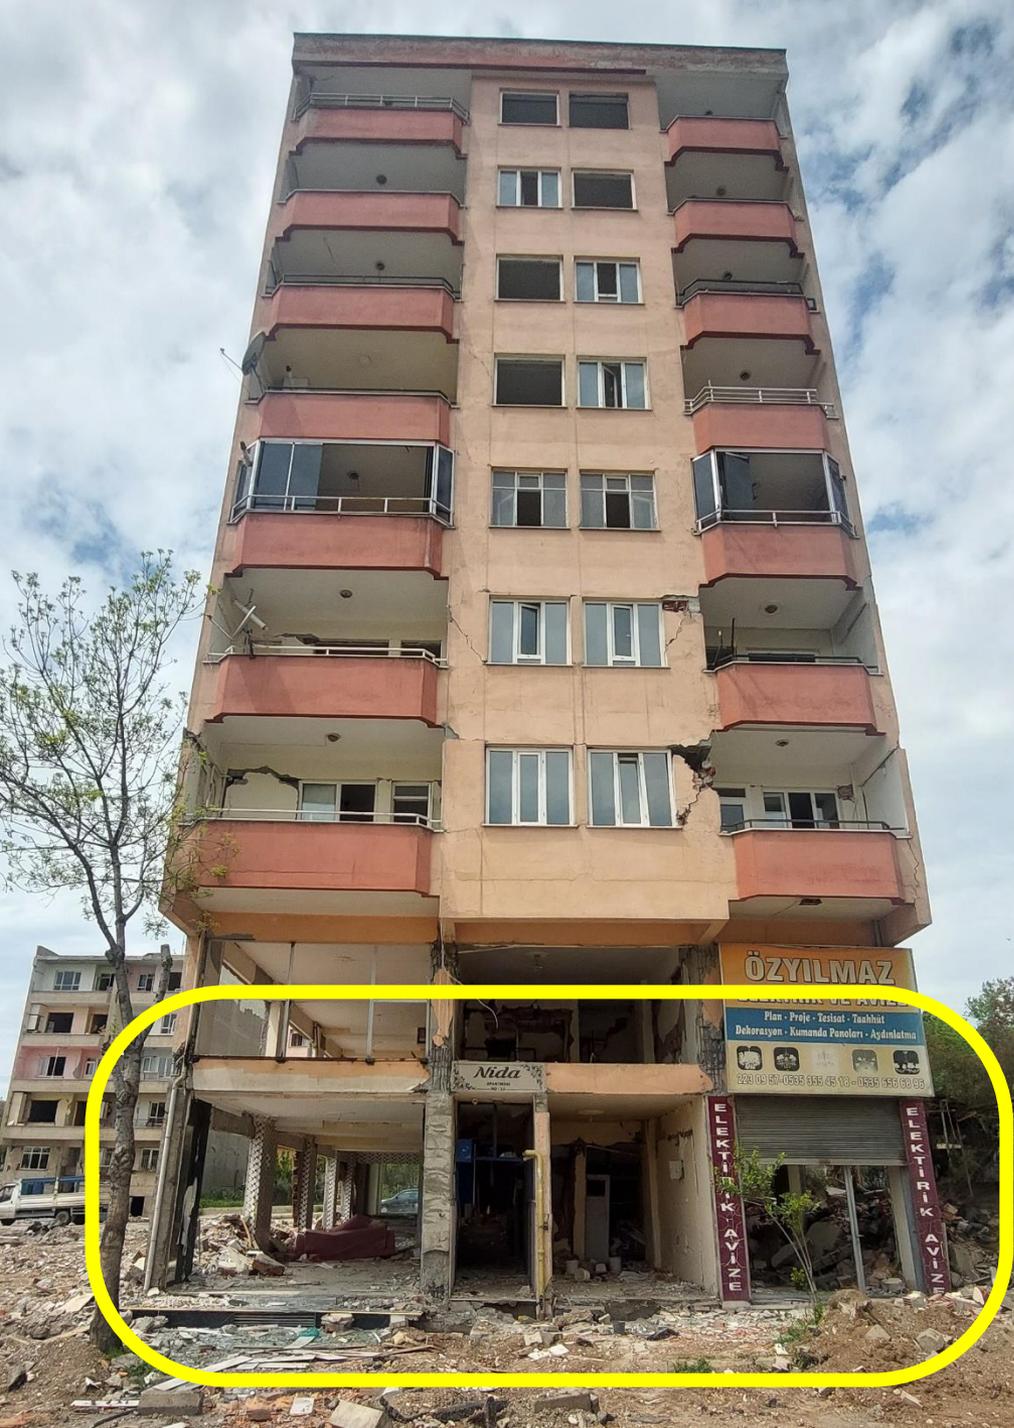
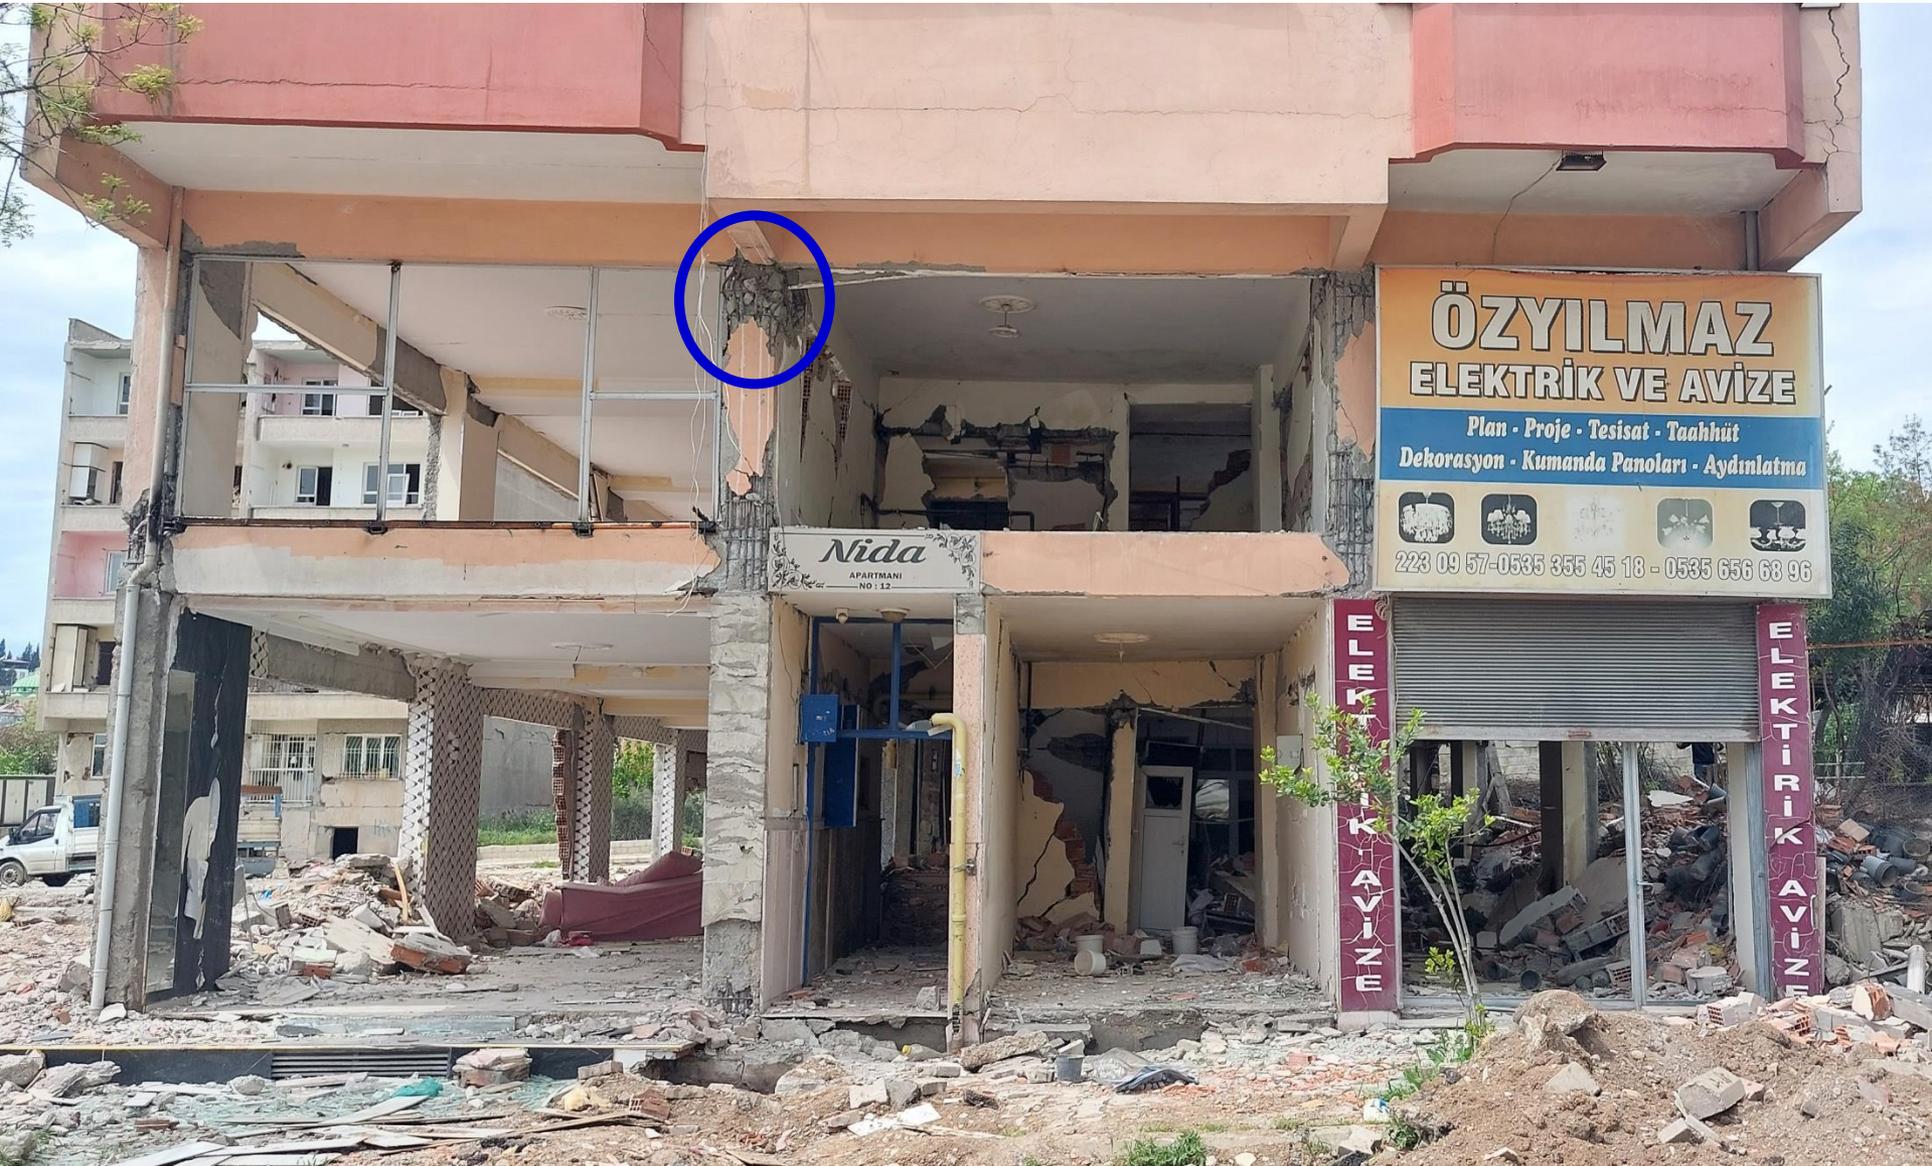
Kahramanmaras

9-story RC building
edificio RC de 9 pisos

Structural damage
concentrated on the
ground and 1st floors

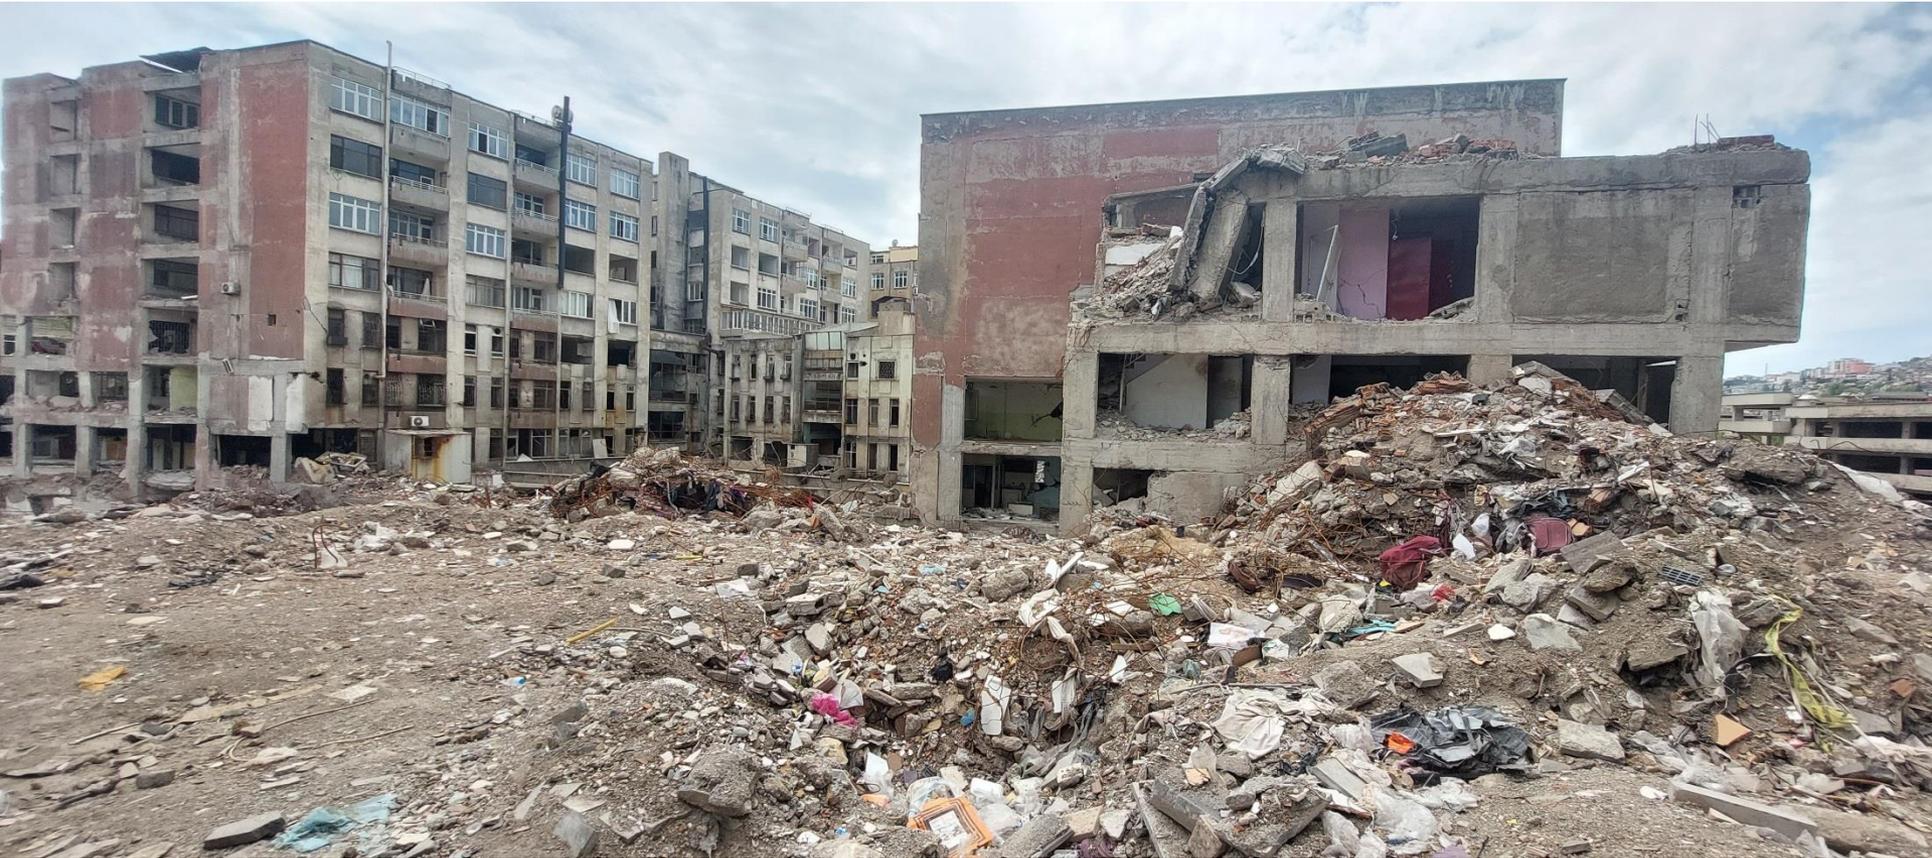
General view in Kahramanmaras neighborhoods

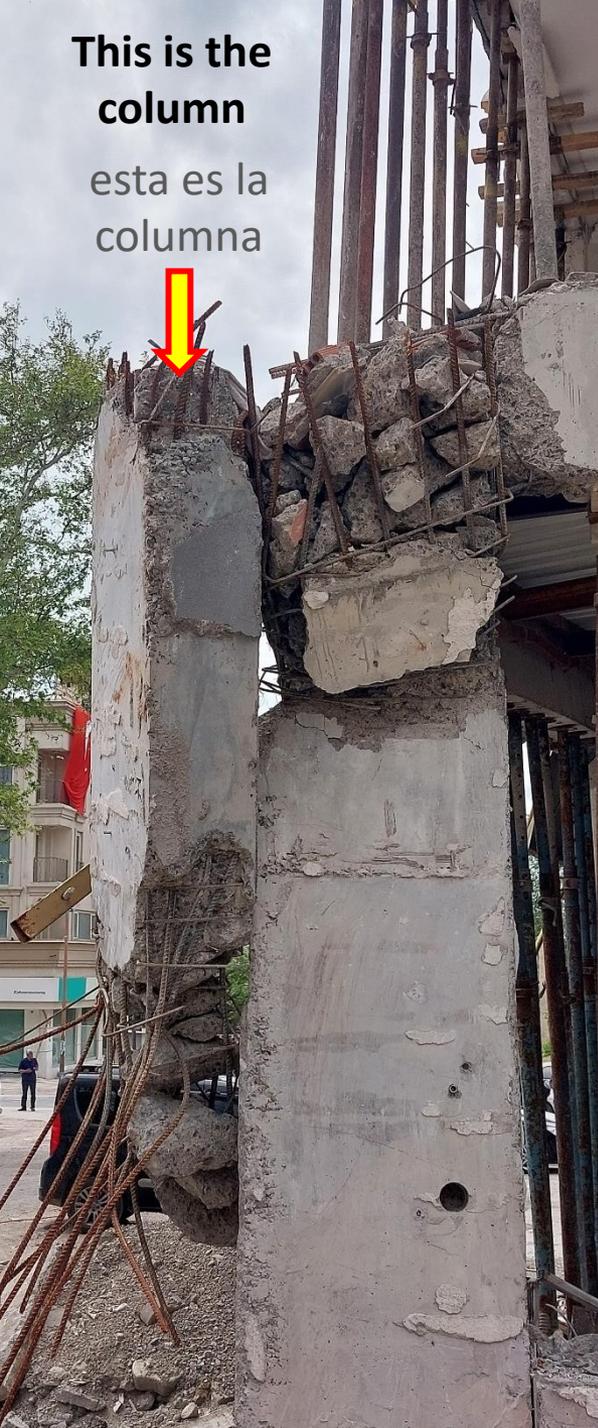
Longitudinal reinforcement is discontinued at the joint
El refuerzo longitudinal se interrumpe en la junta

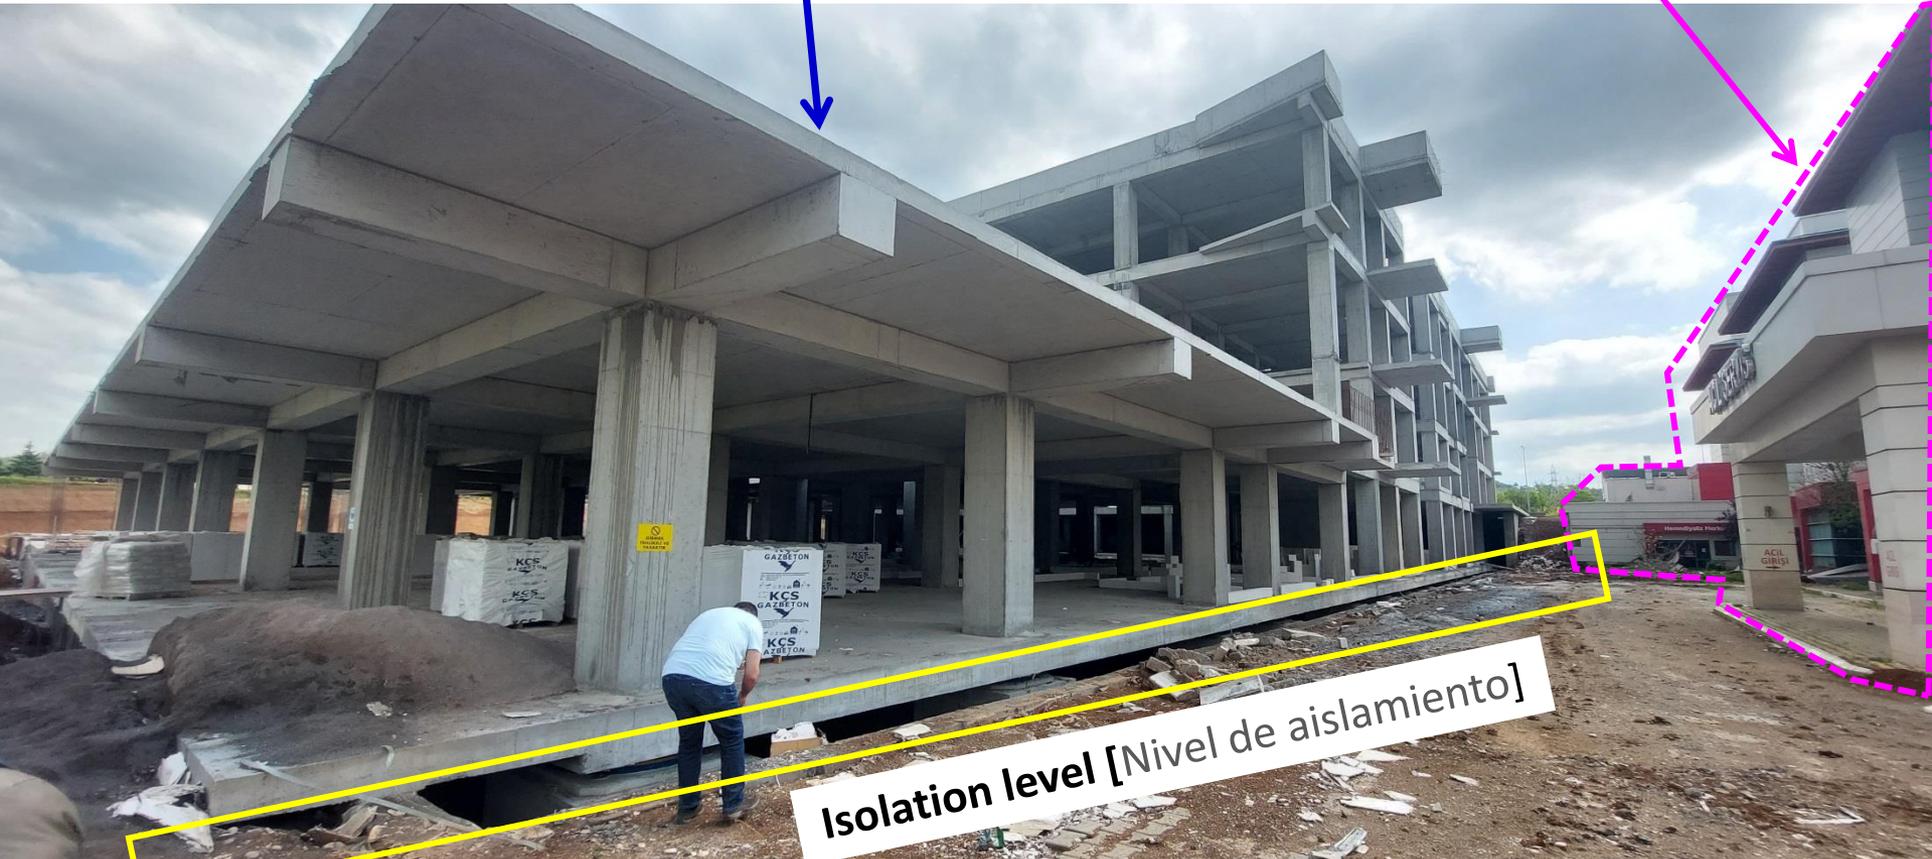
A new base-isolated hospital
outside Kahramanmaras

the new under-construction wing
la nueva ala en construcción

the older hospital wing
el ala del hospital más antigua

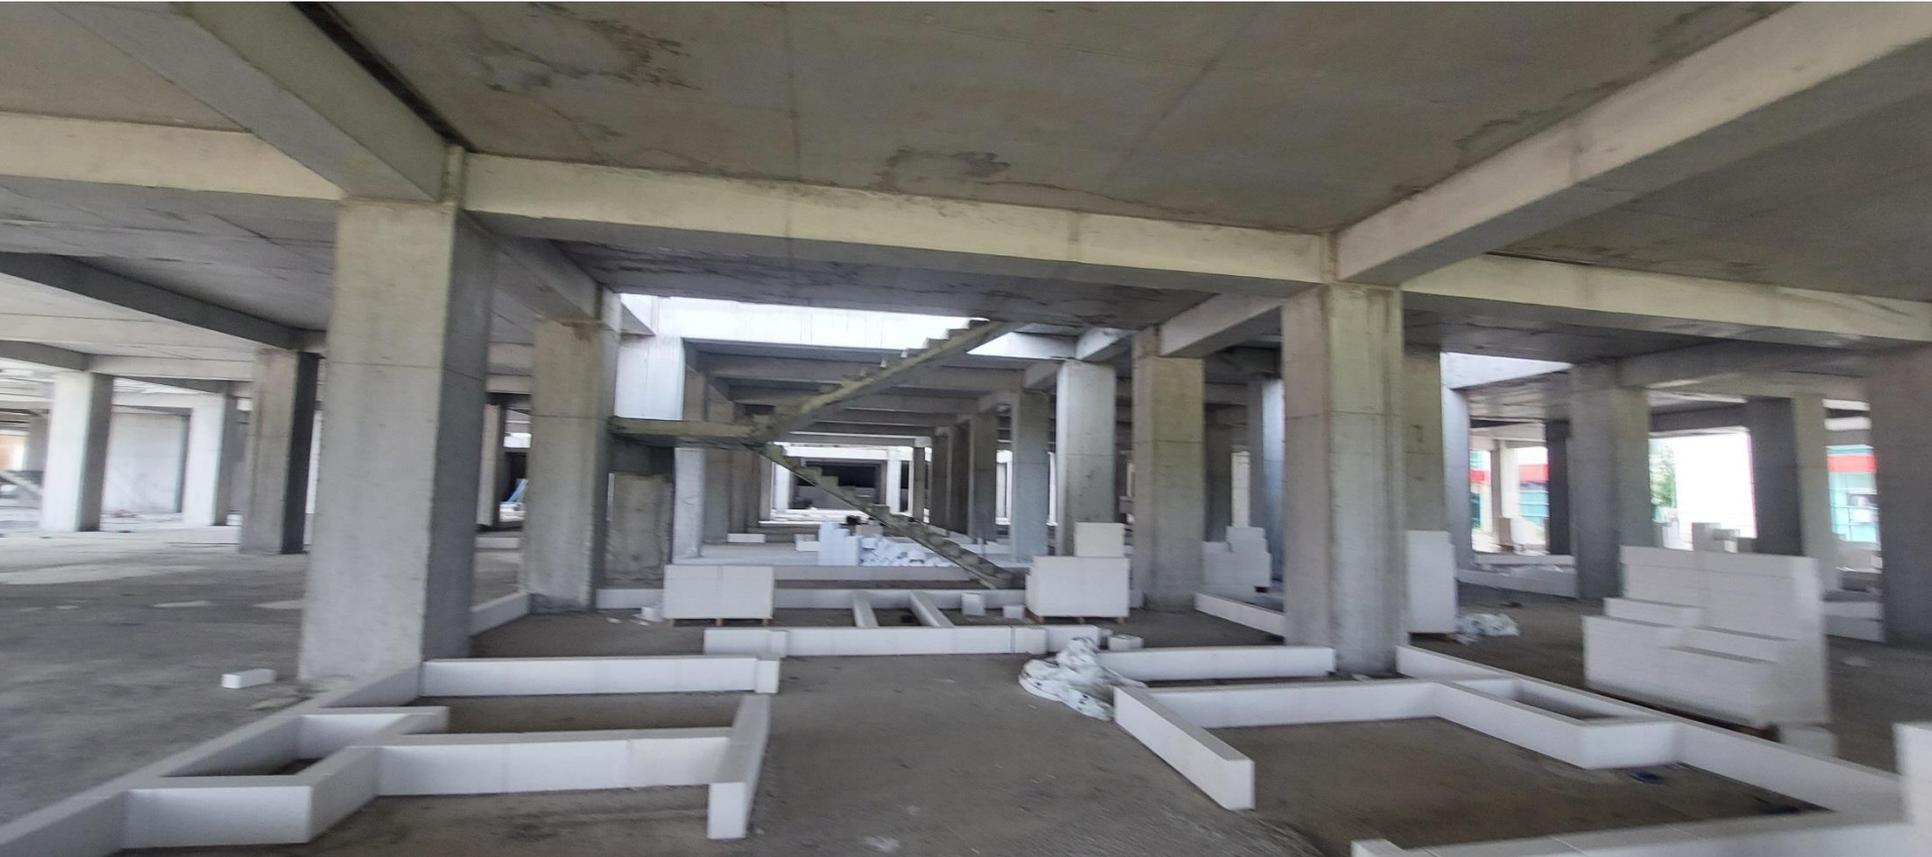
The **FRICION** pendulum system Isolators

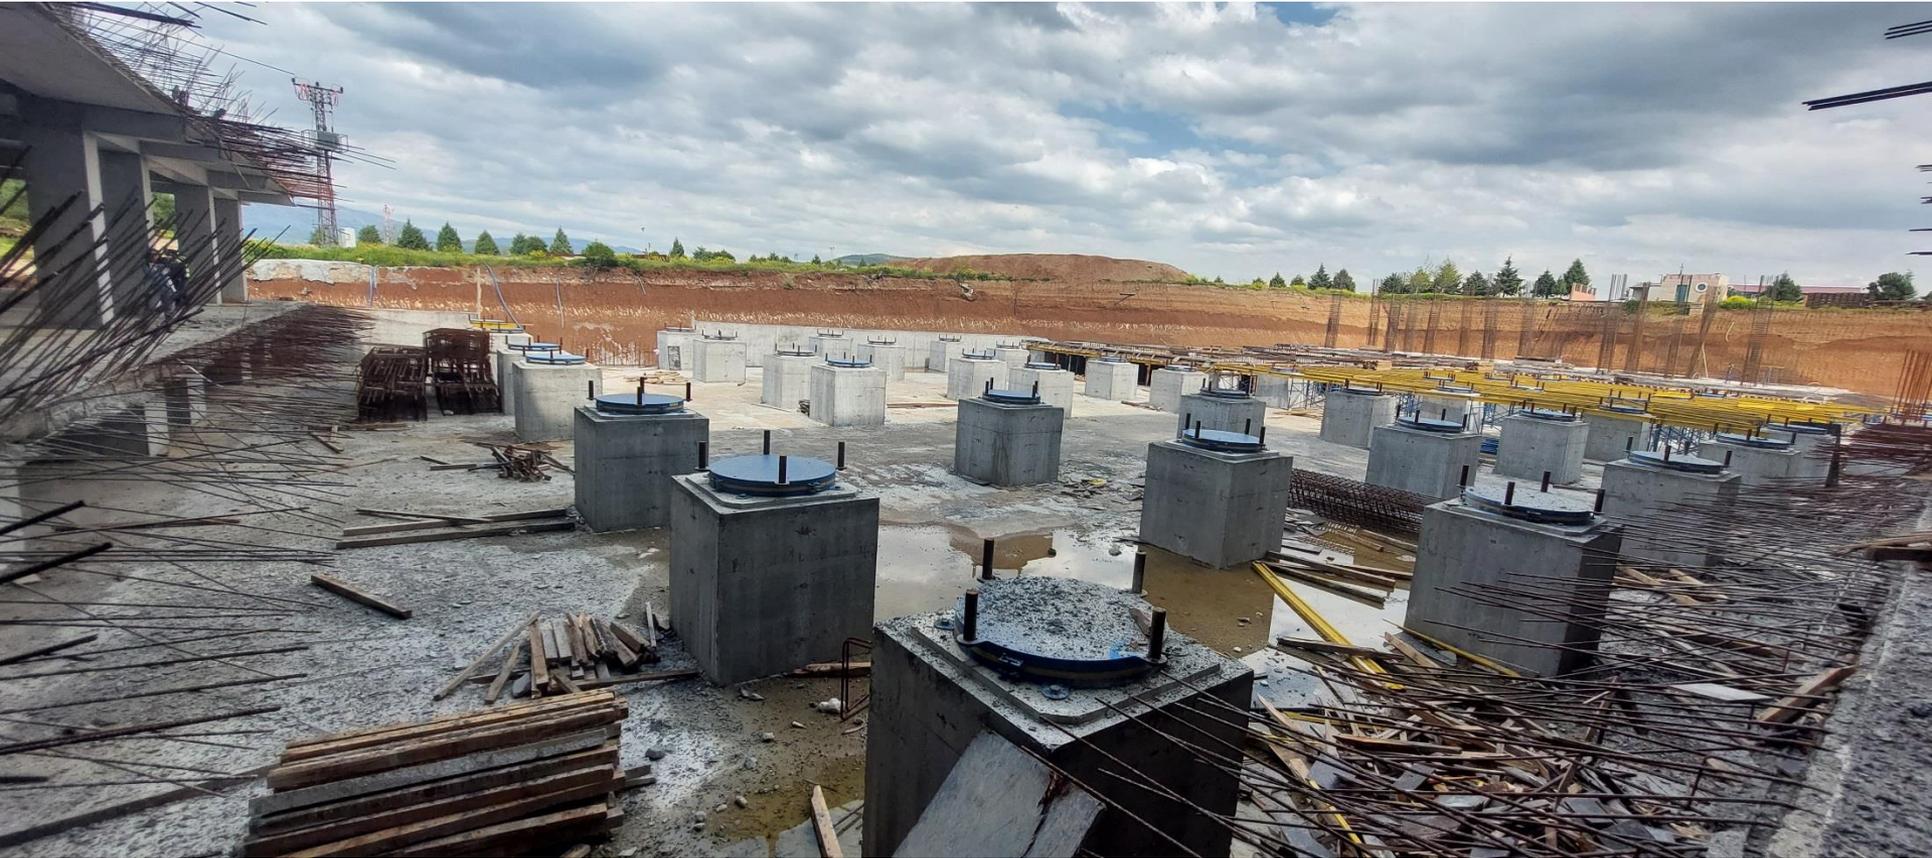
Everything looks fine ...

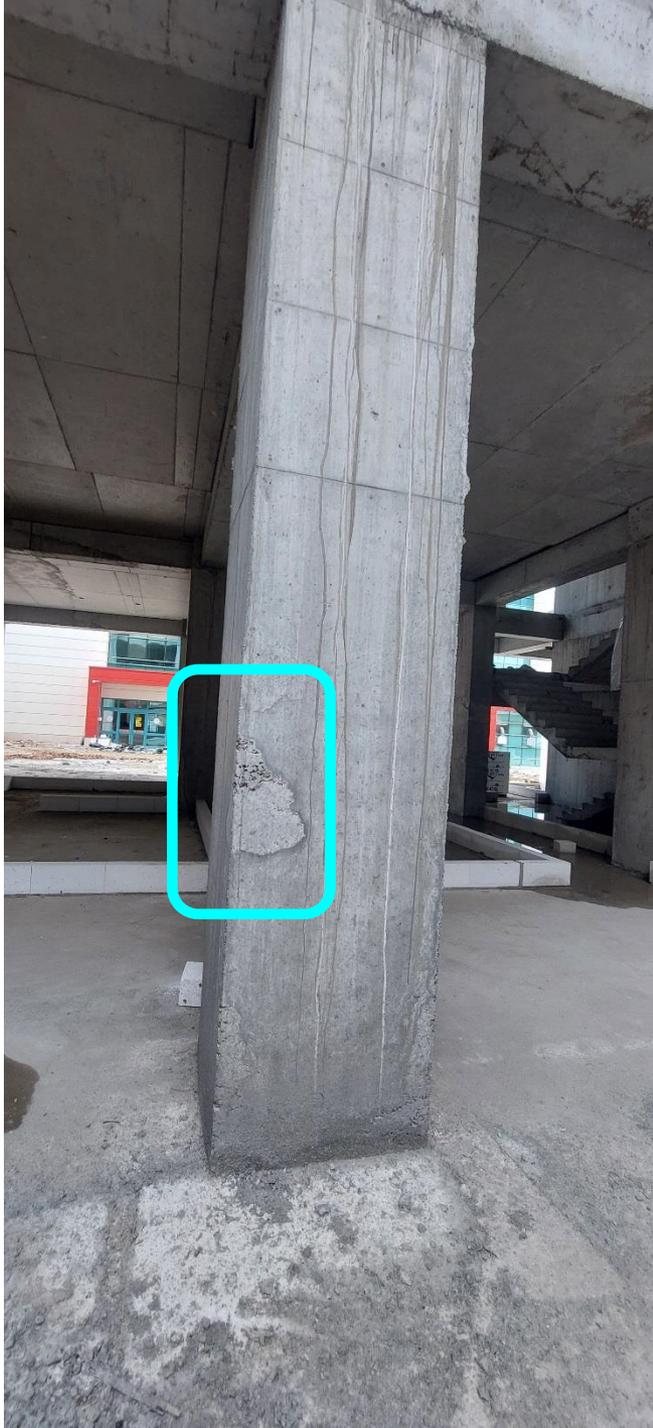
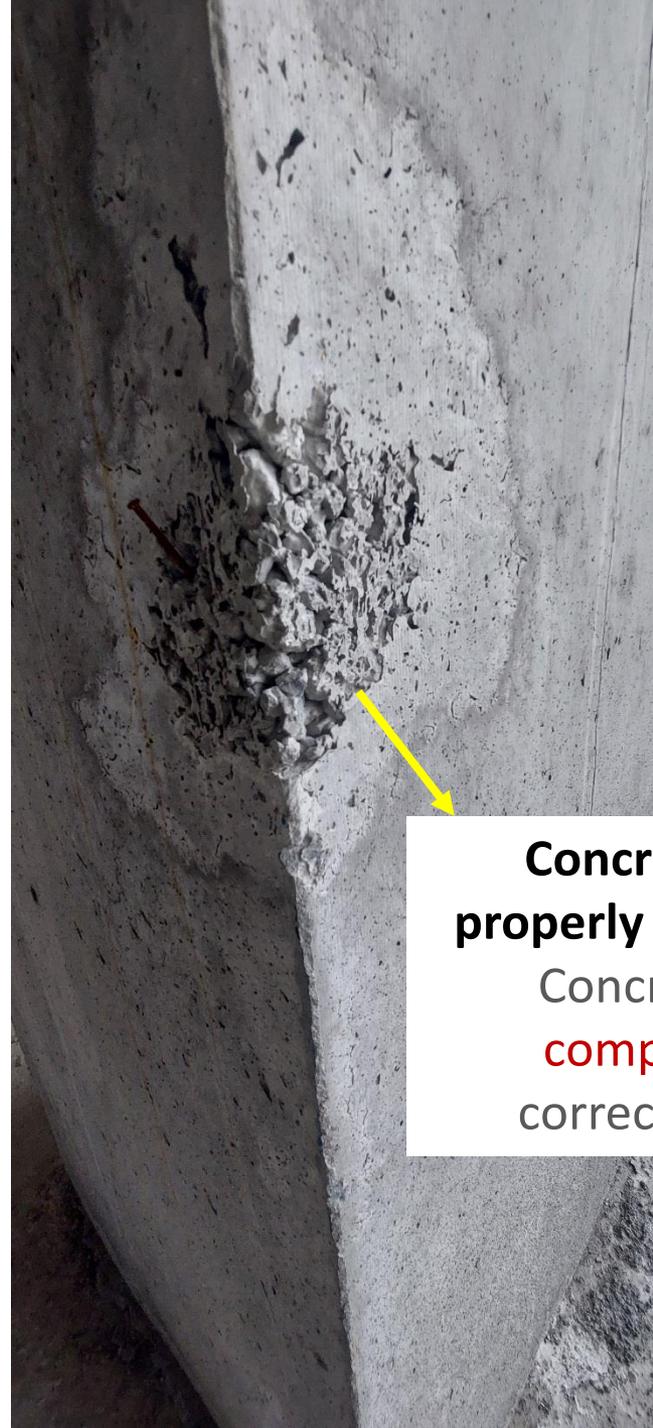
**Concrete NOT
properly compacted**
Concreto NO
compactado
correctamente

At the bottom of a ground floor column
