The 2023 Kahramanmaras earthquakes of February 6th in Turkey

Evangelia GARINI and **George GAZETAS**

School of Civil Engineering, Geotechnical Department
National Technical University of Athens, Greece

THE 2023 TURKIYE-SYRIA EARTHQUAKES

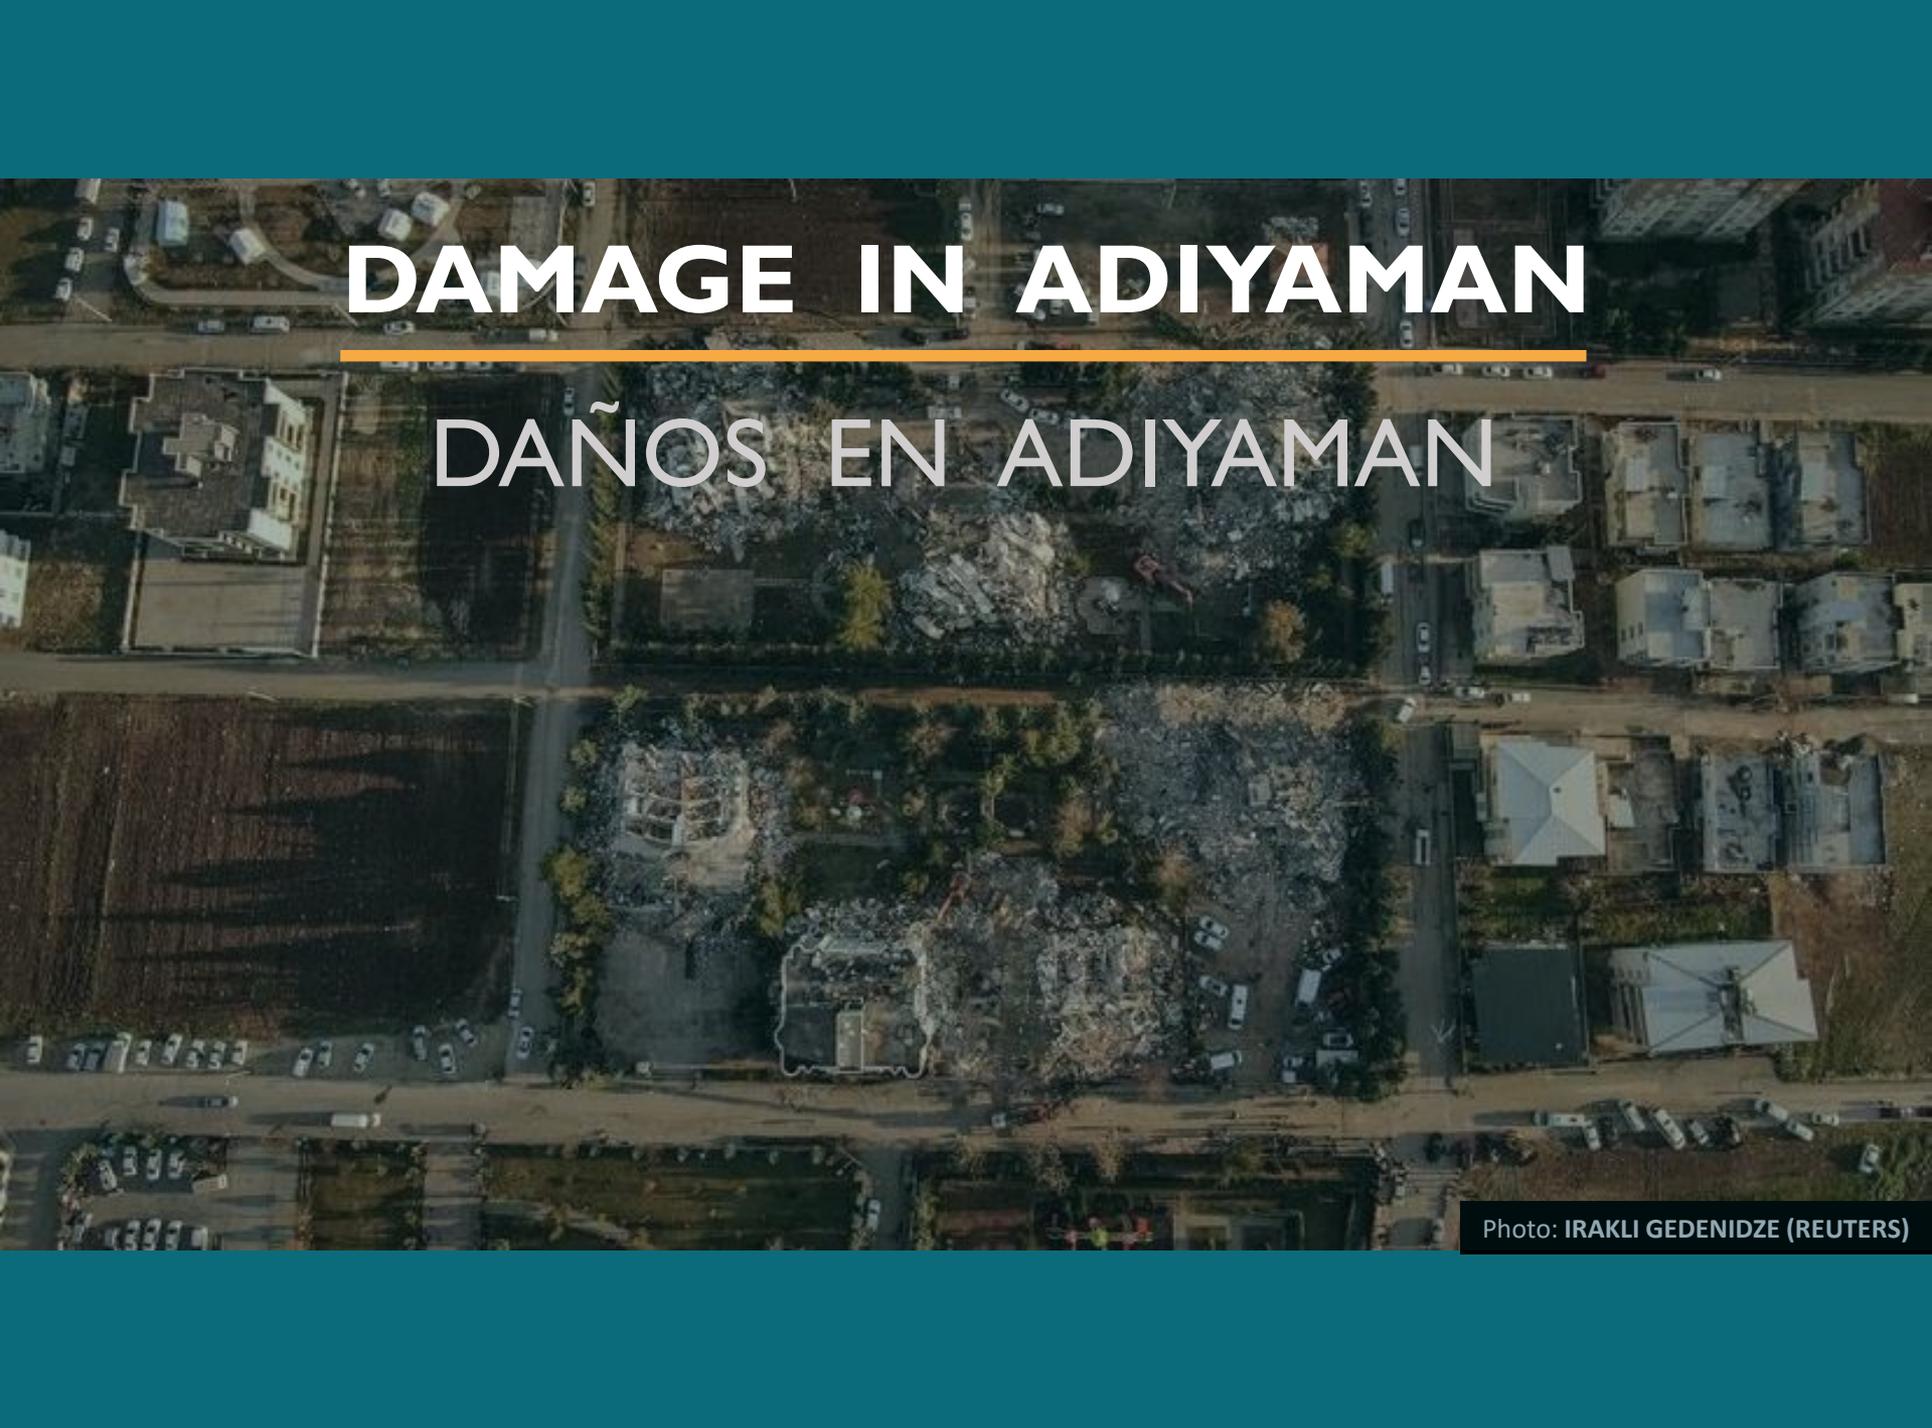
DAMAGE IN ADIYAMAN

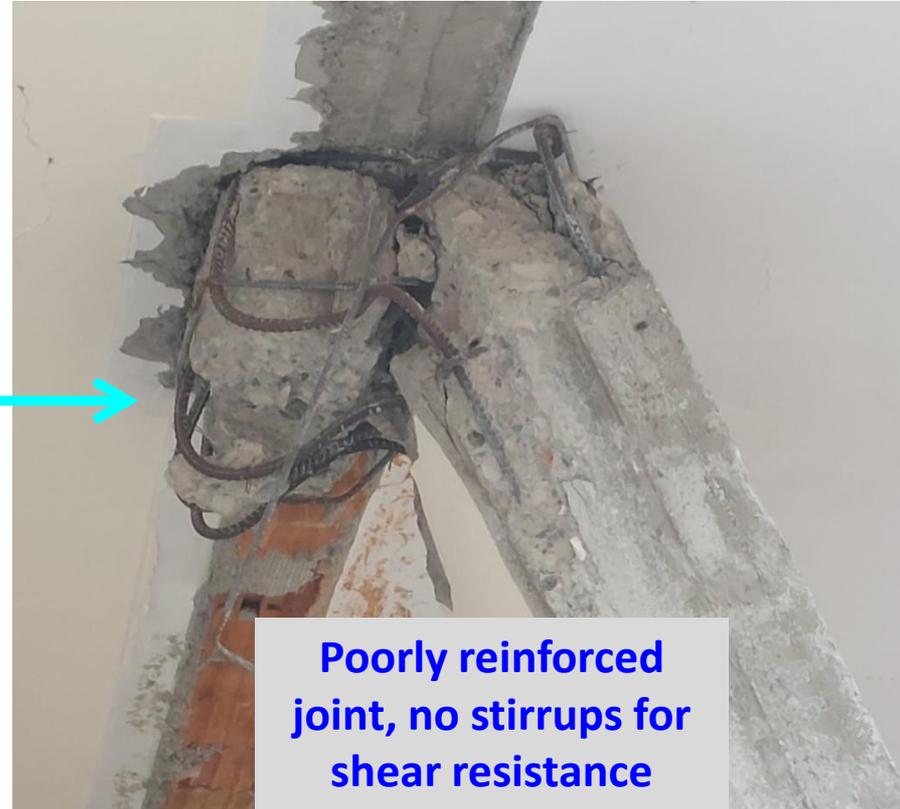
Poorly reinforced joint, no stirrups for shear resistance

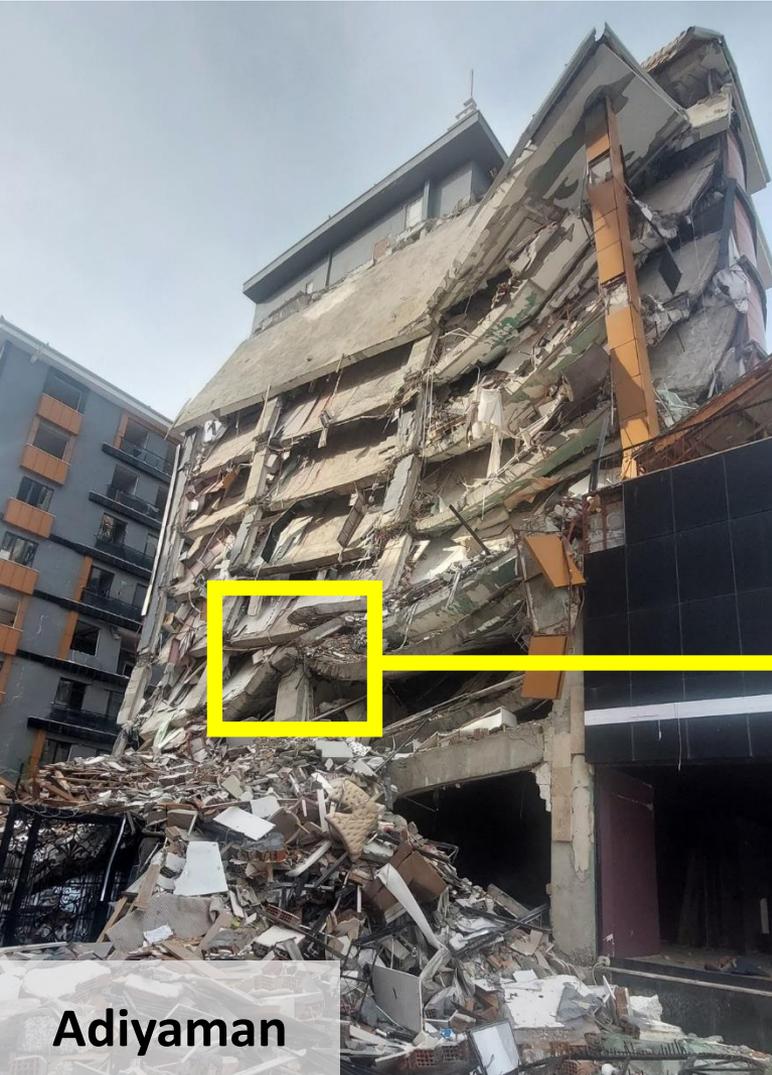
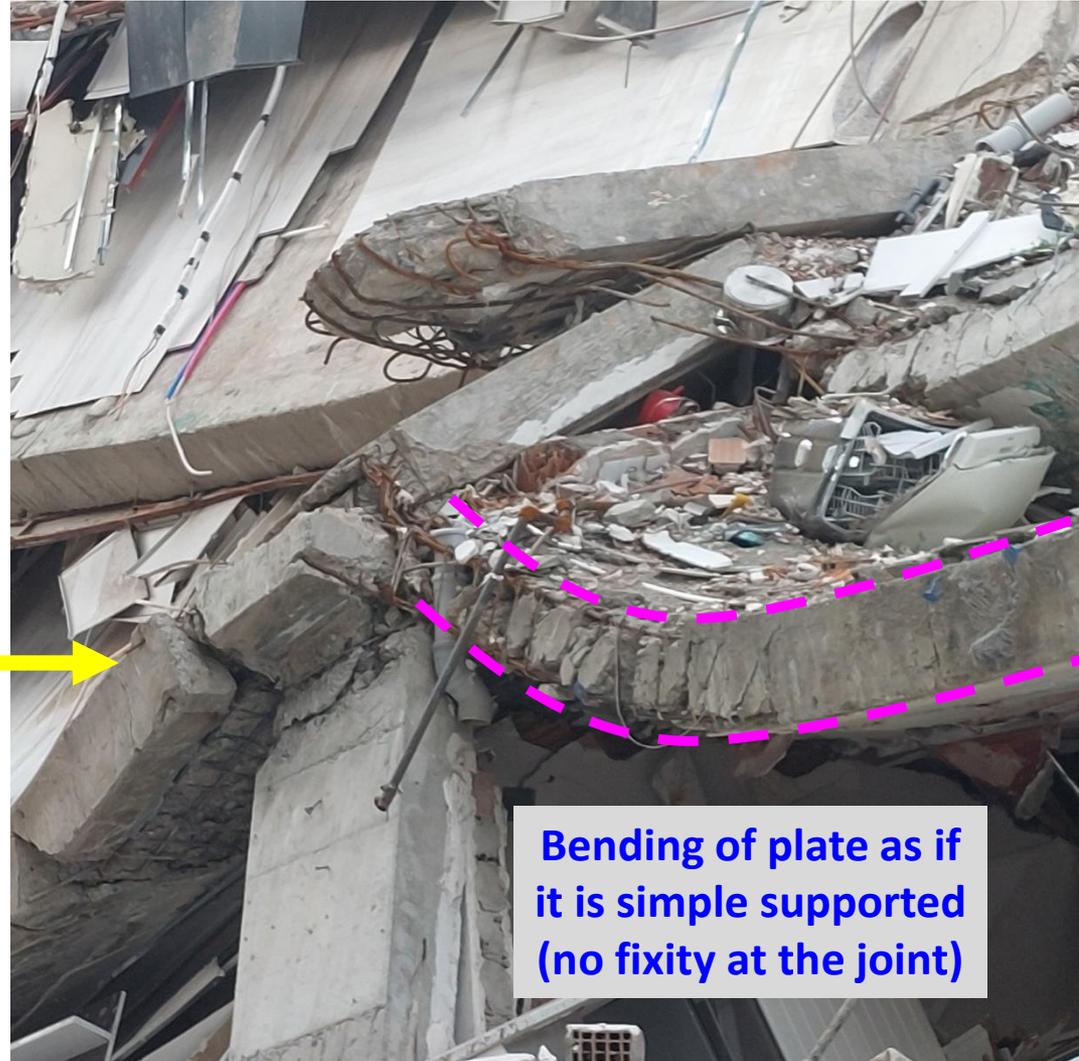
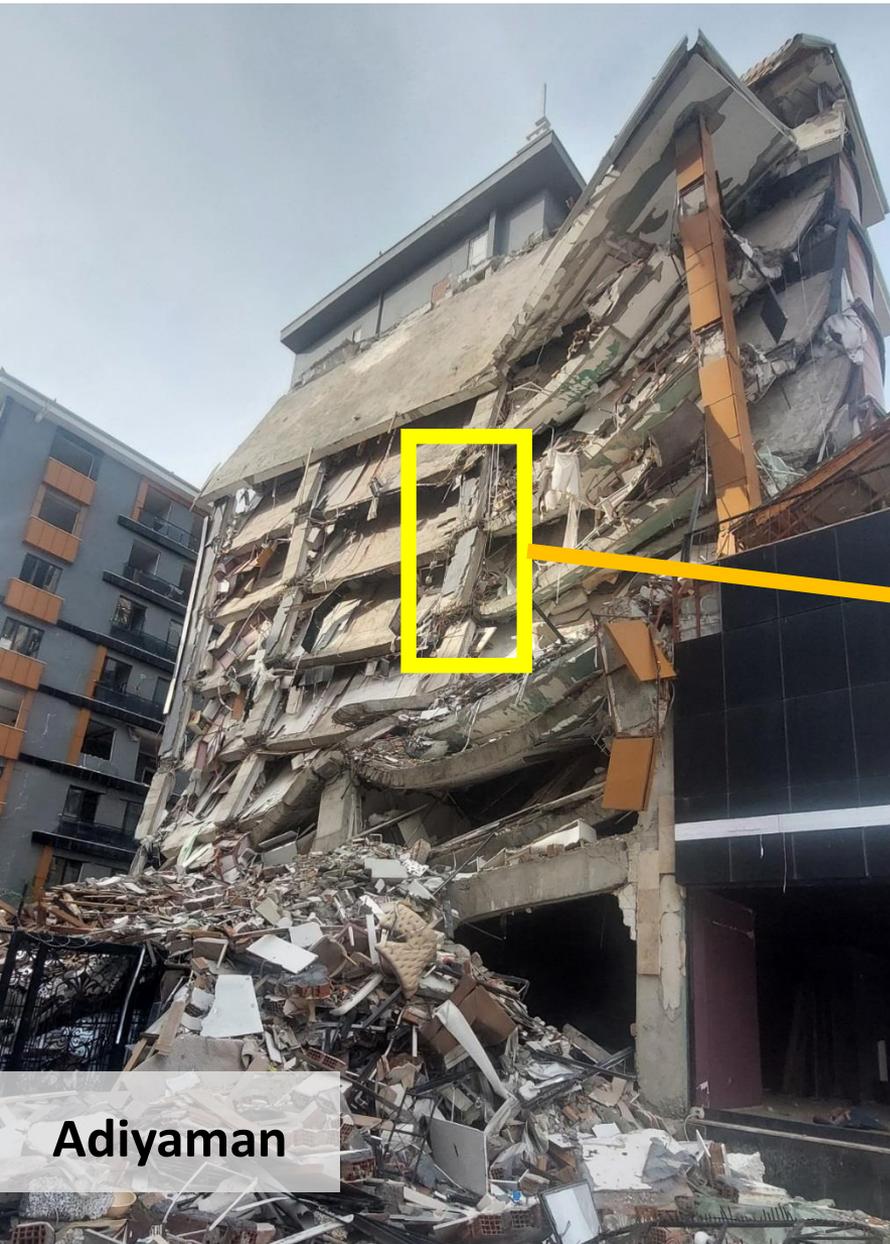
Partial collapse in a 9-story RC building in Adiyaman

This is a column...

No proper joint reinforcement

Result = columns respond independently from the slab

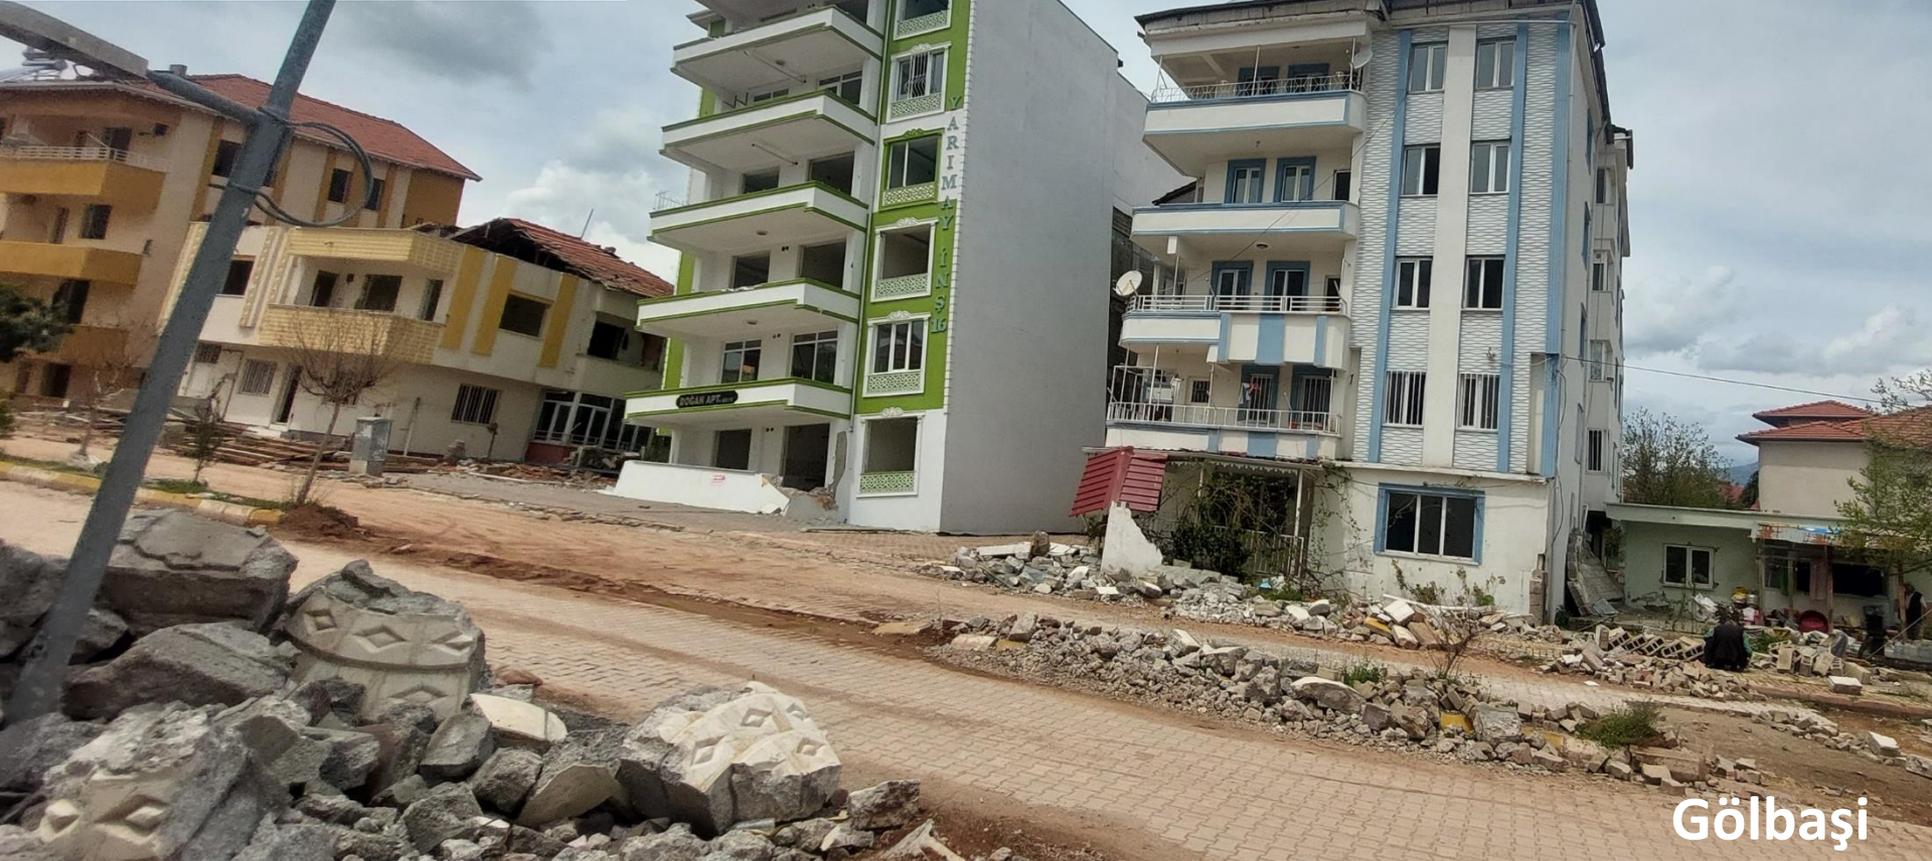
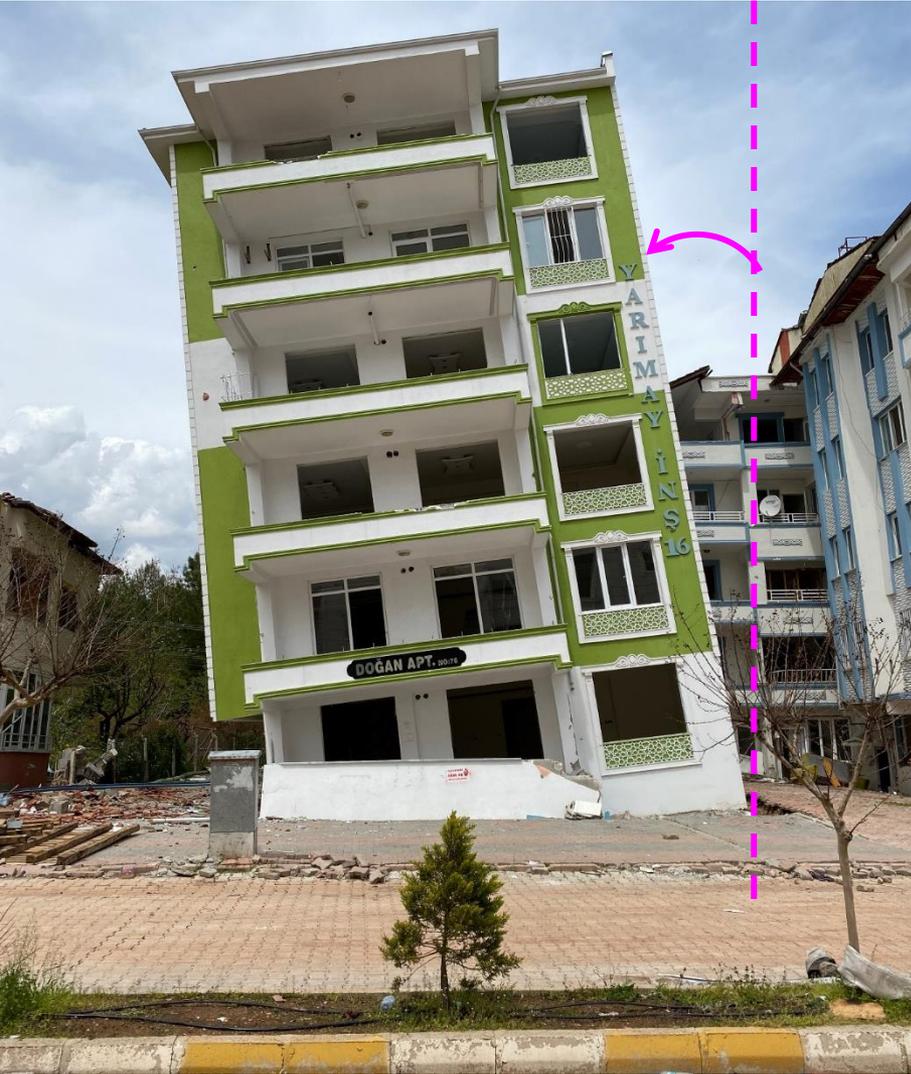
Gölbaşı

**Flat slab foundation:
without a crack!**

**Rocking of whole
buildings**

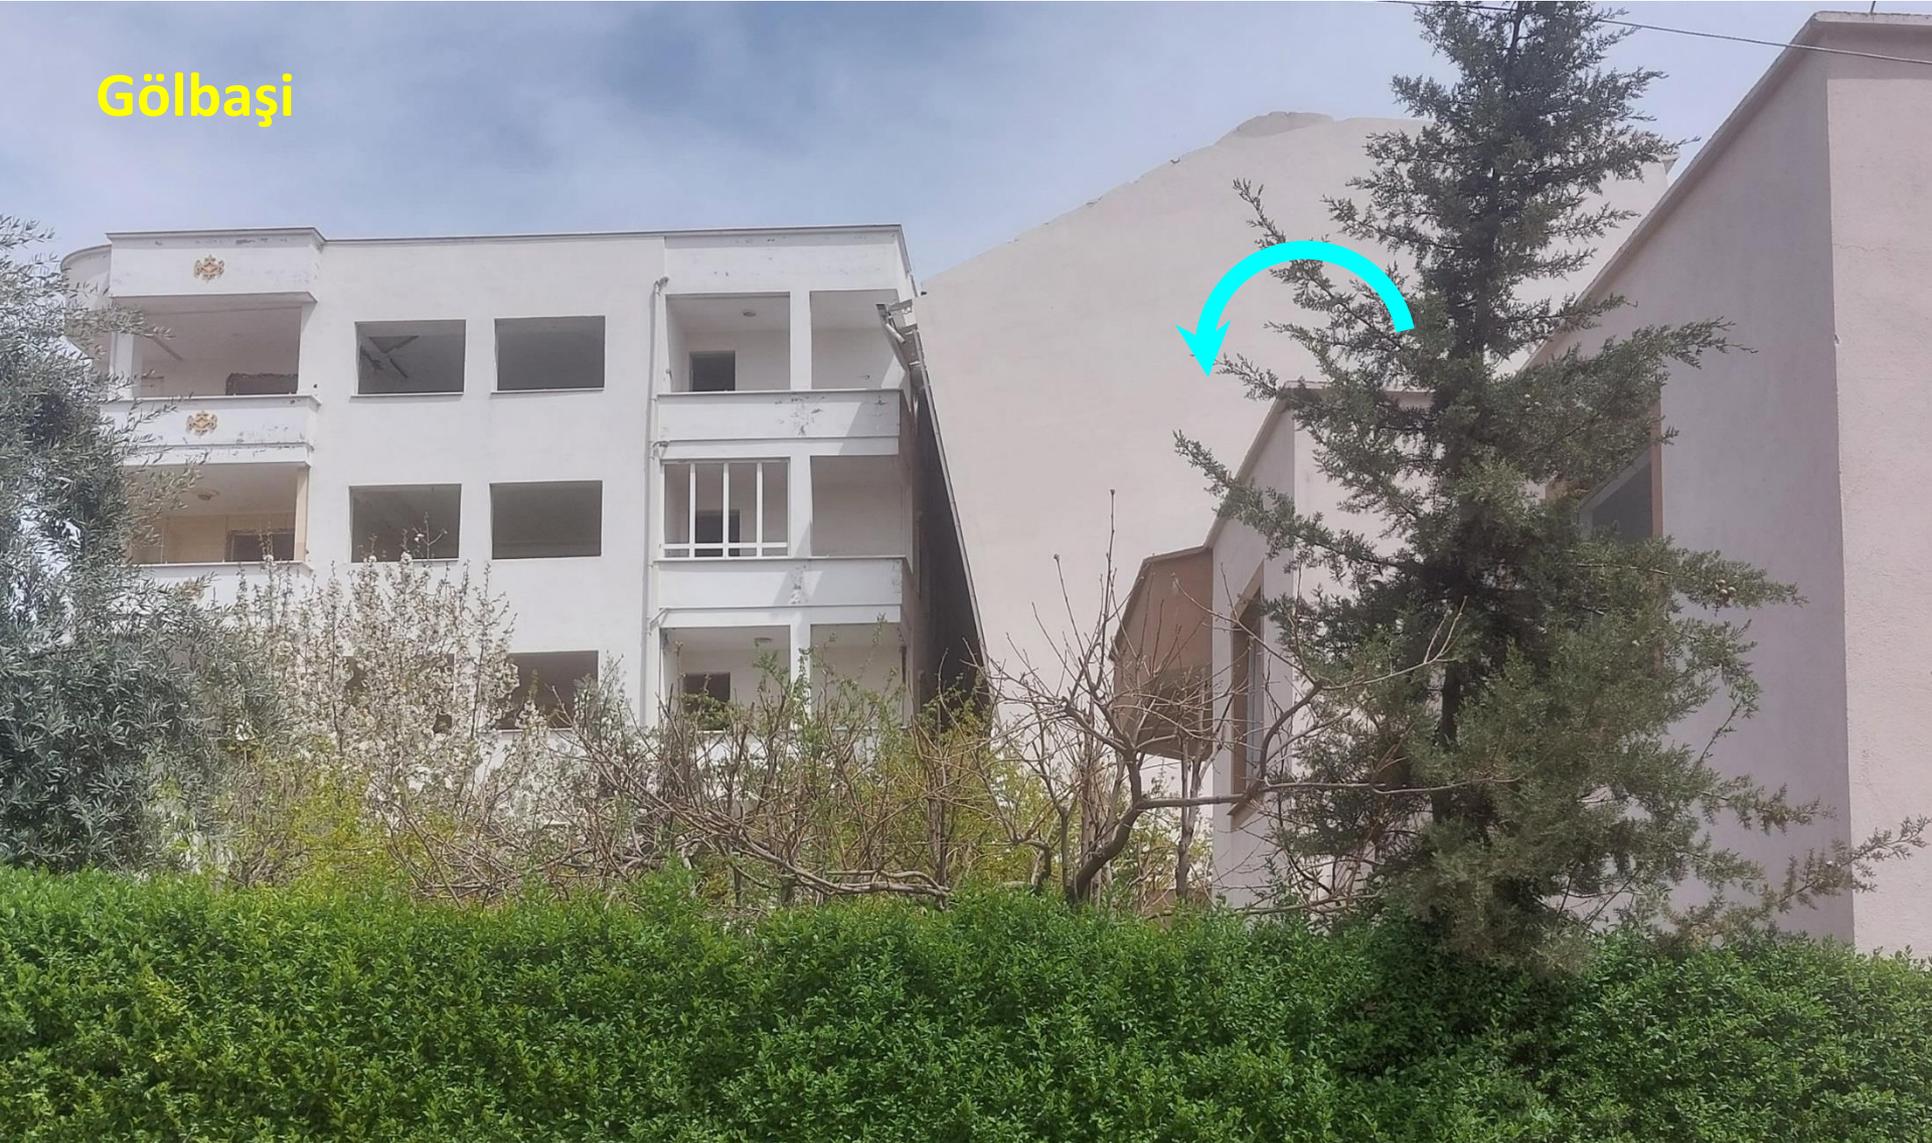
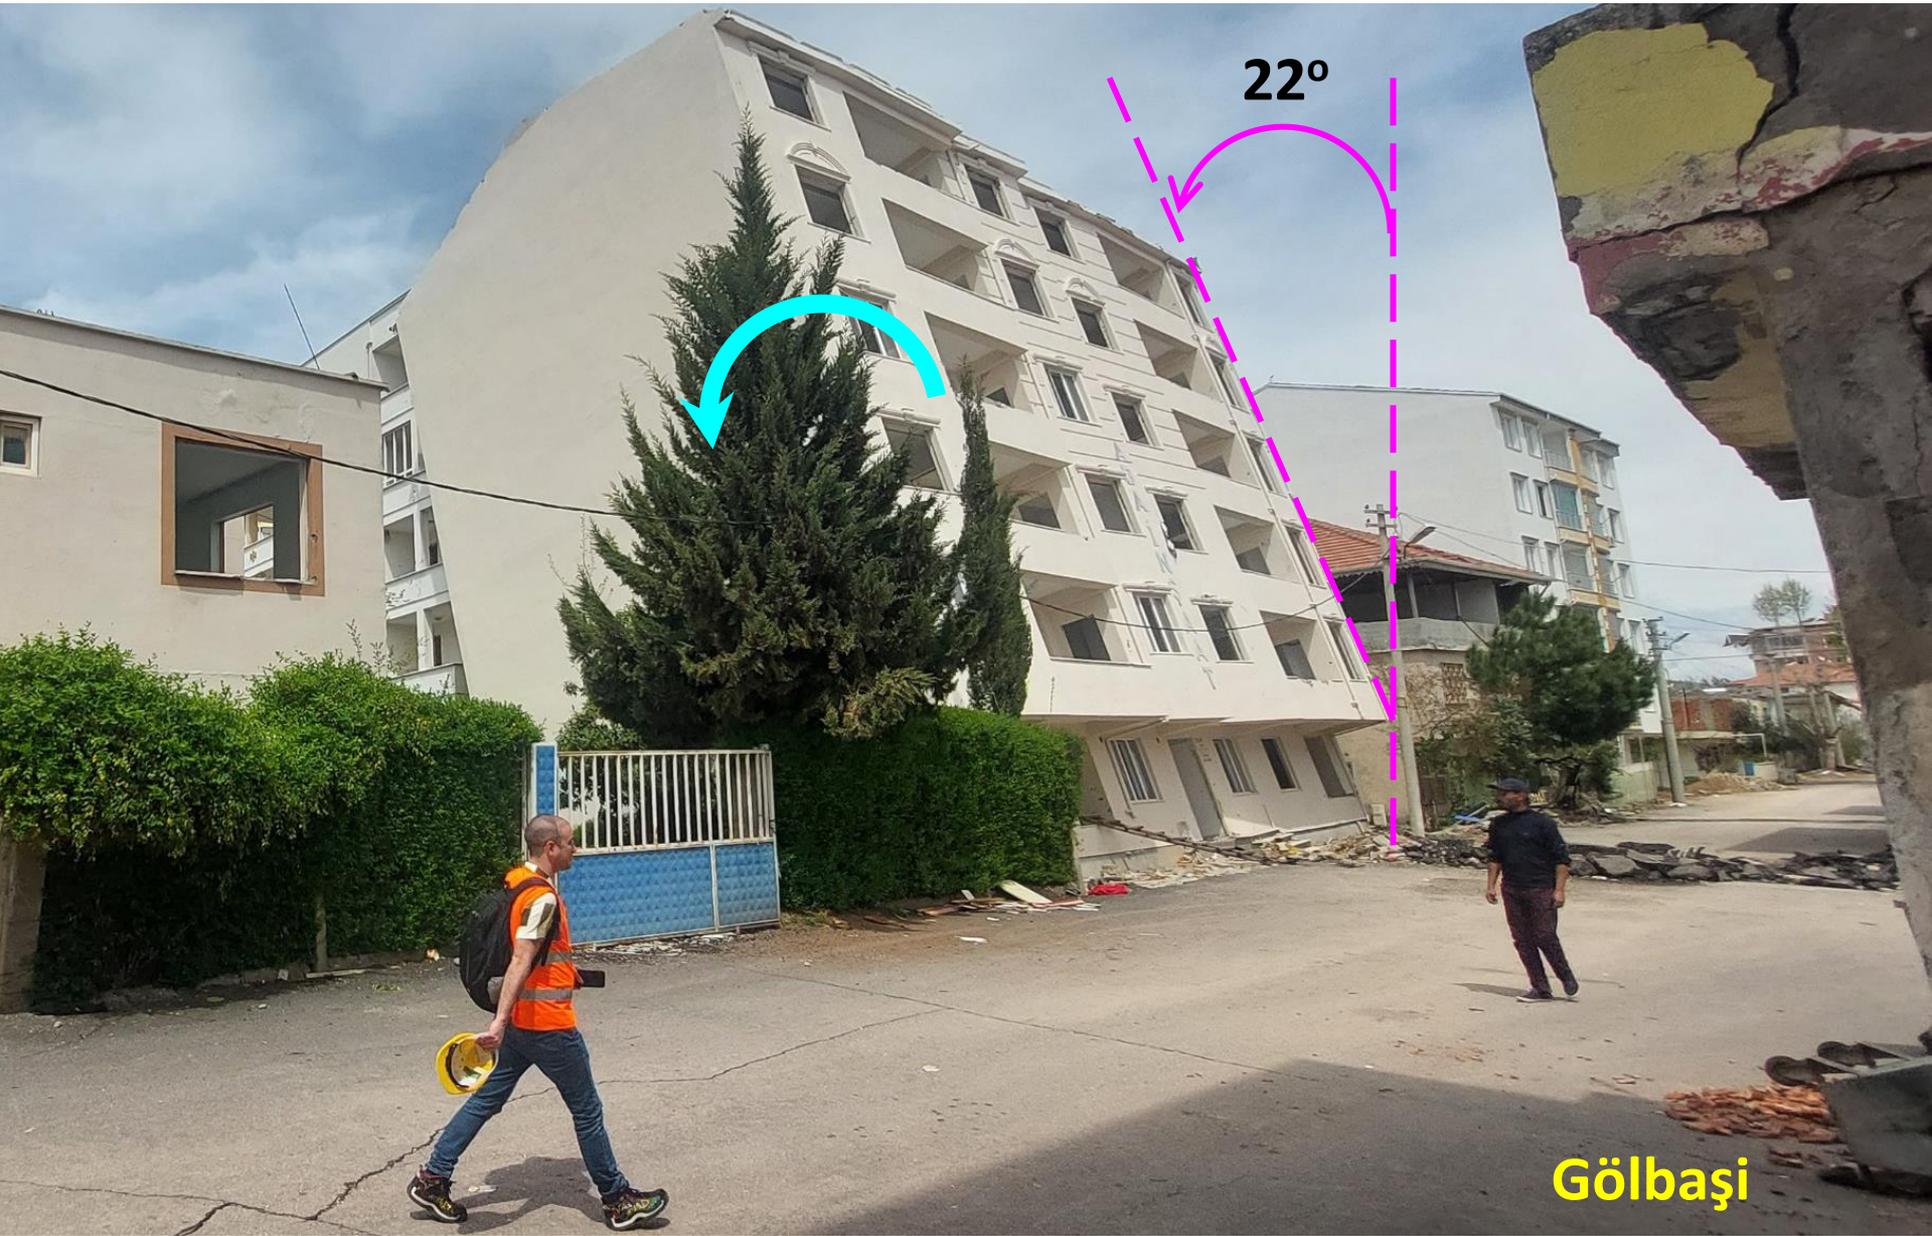
22°

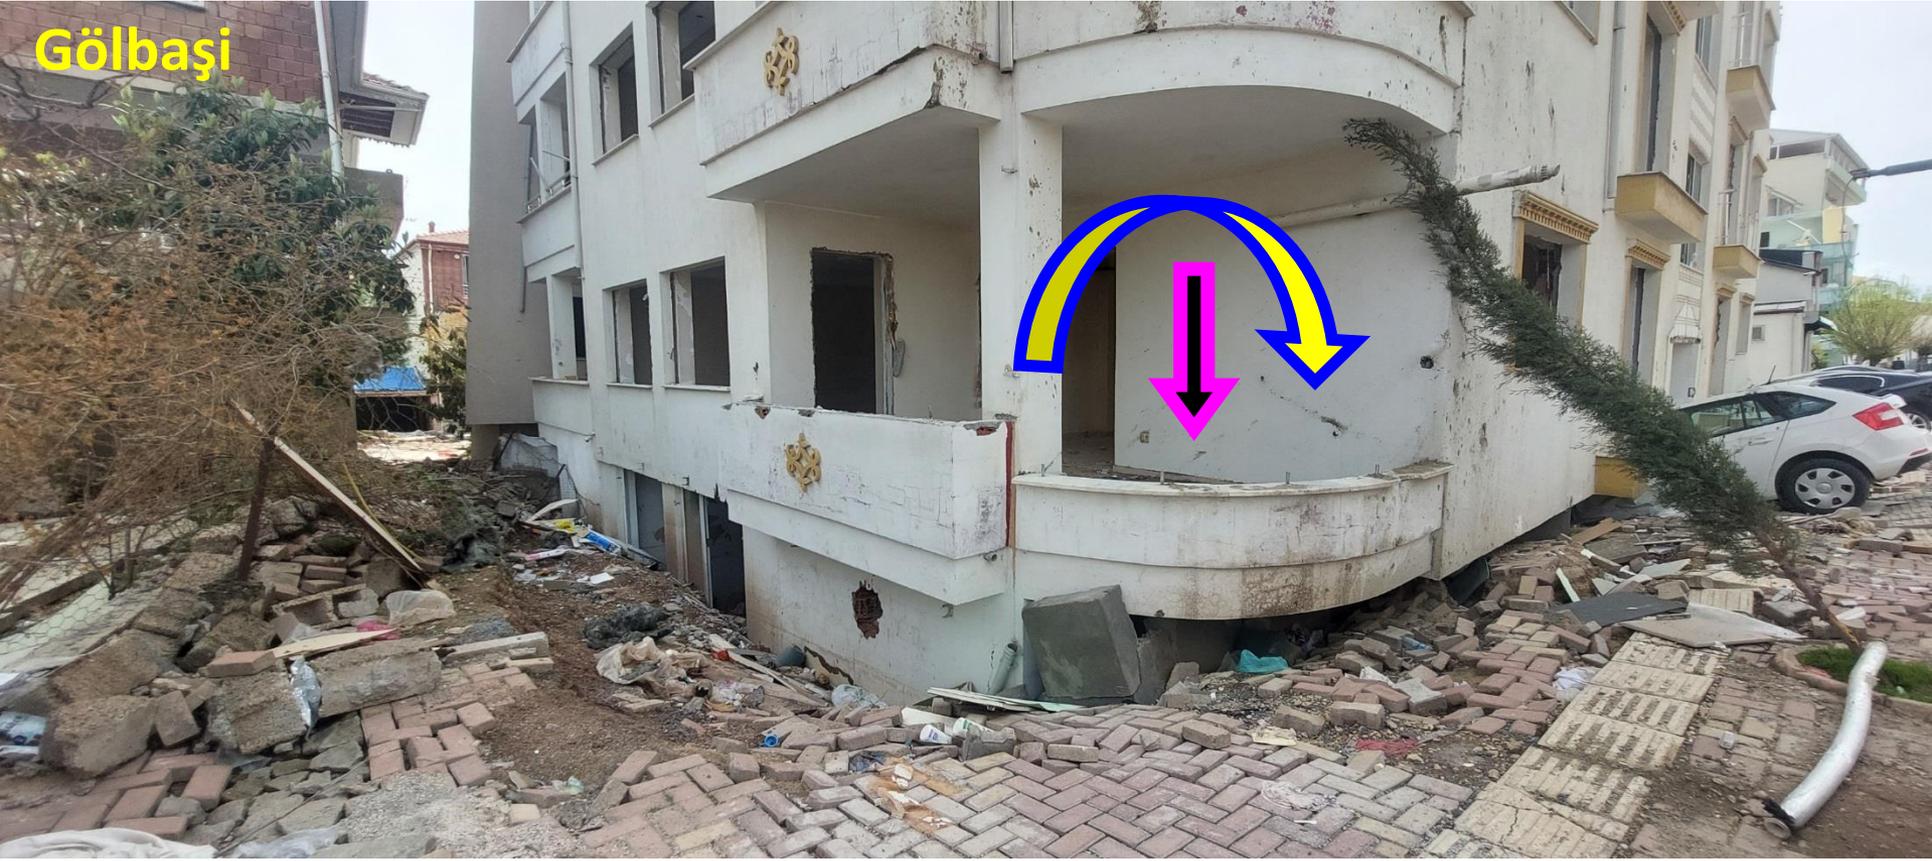
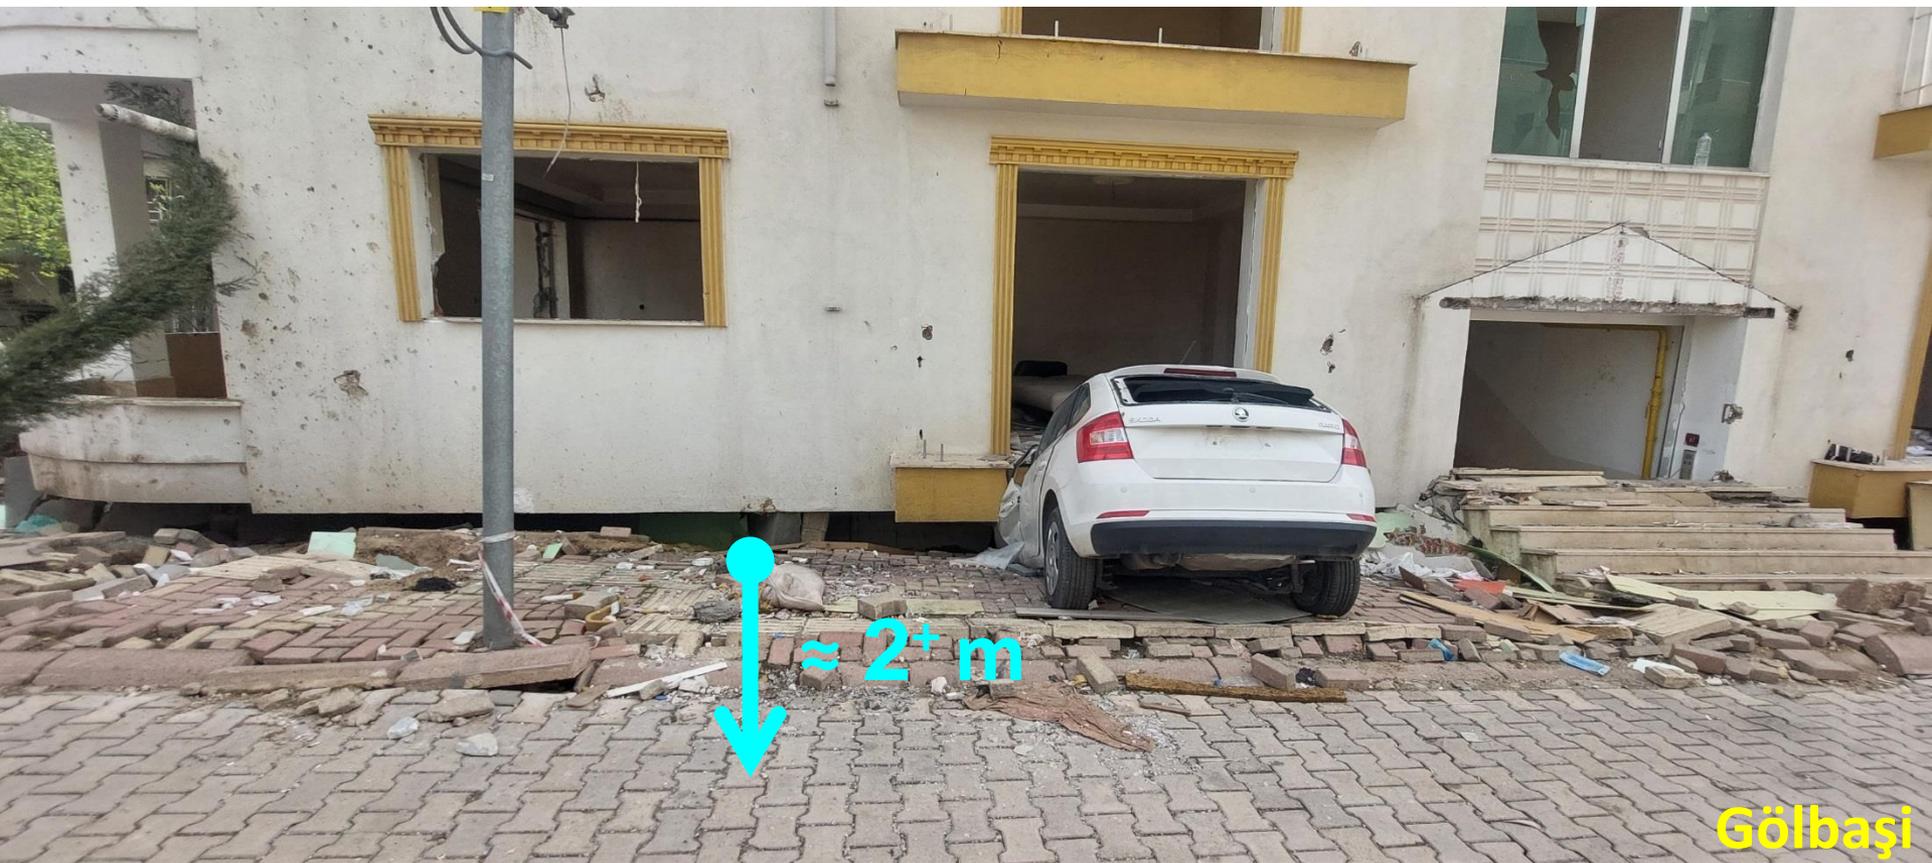
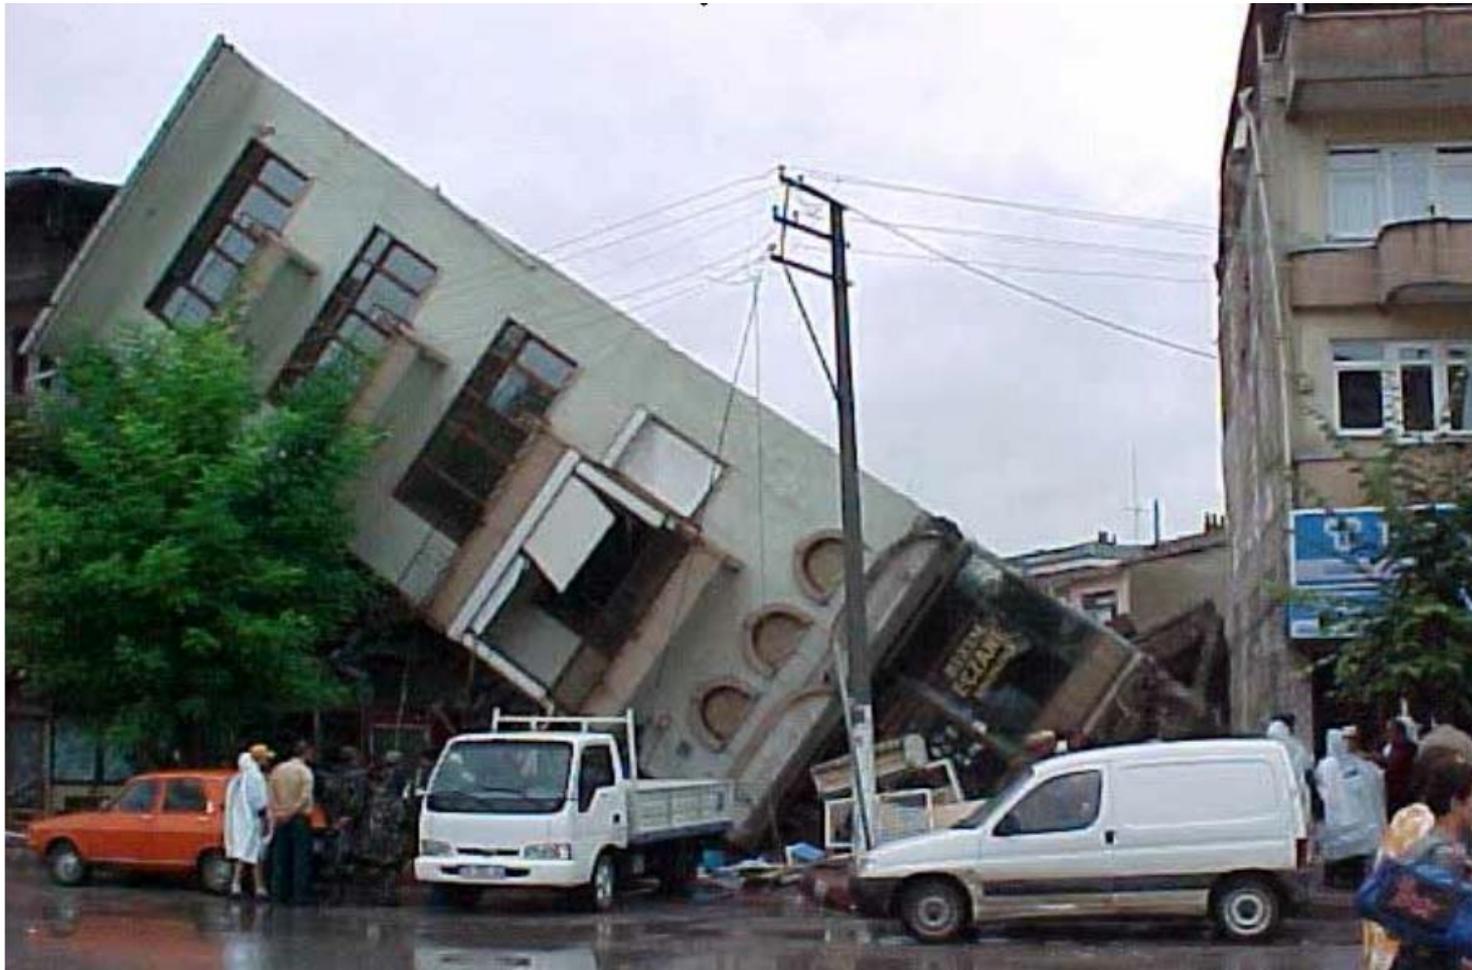
Gölbaşı

This **rocking type** of structural response

is not unusual in Turkey

It happened before: in **1999 Izmit M7.4** earthquake in **Adapazari**

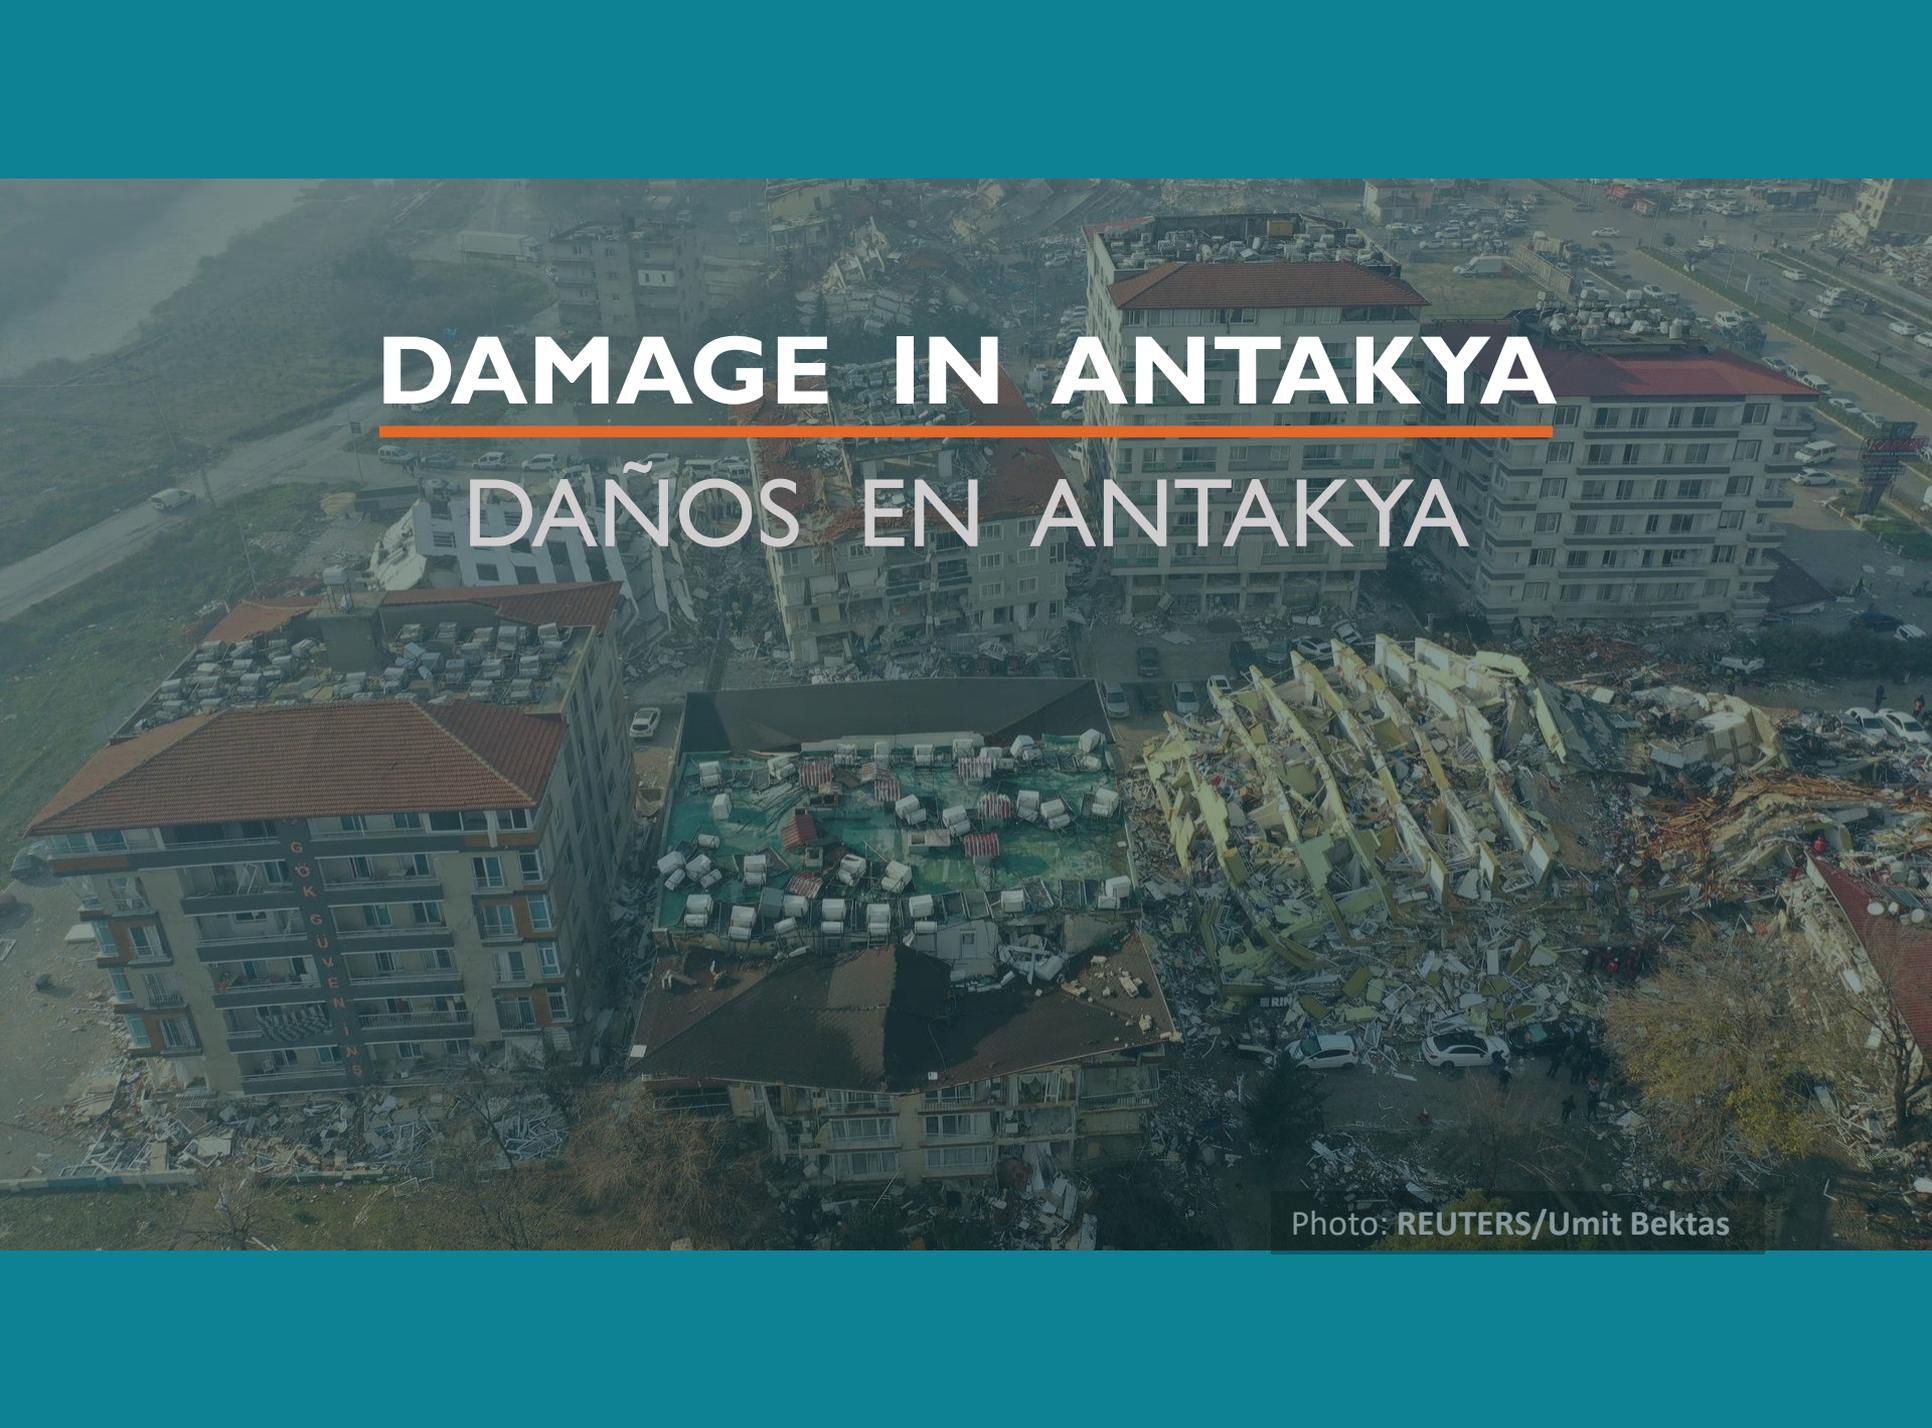
DAMAGE IN ANTAKYA
DAÑOS EN ANTAKYA
