The 2023 Kahramanmaras earthquakes of February 6th in Turkey

Evangelia GARINI and **George GAZETAS**

School of Civil Engineering, Geotechnical Department
National Technical University of Athens, Greece

THE 2023 TURKIYE-SYRIA EARTHQUAKES

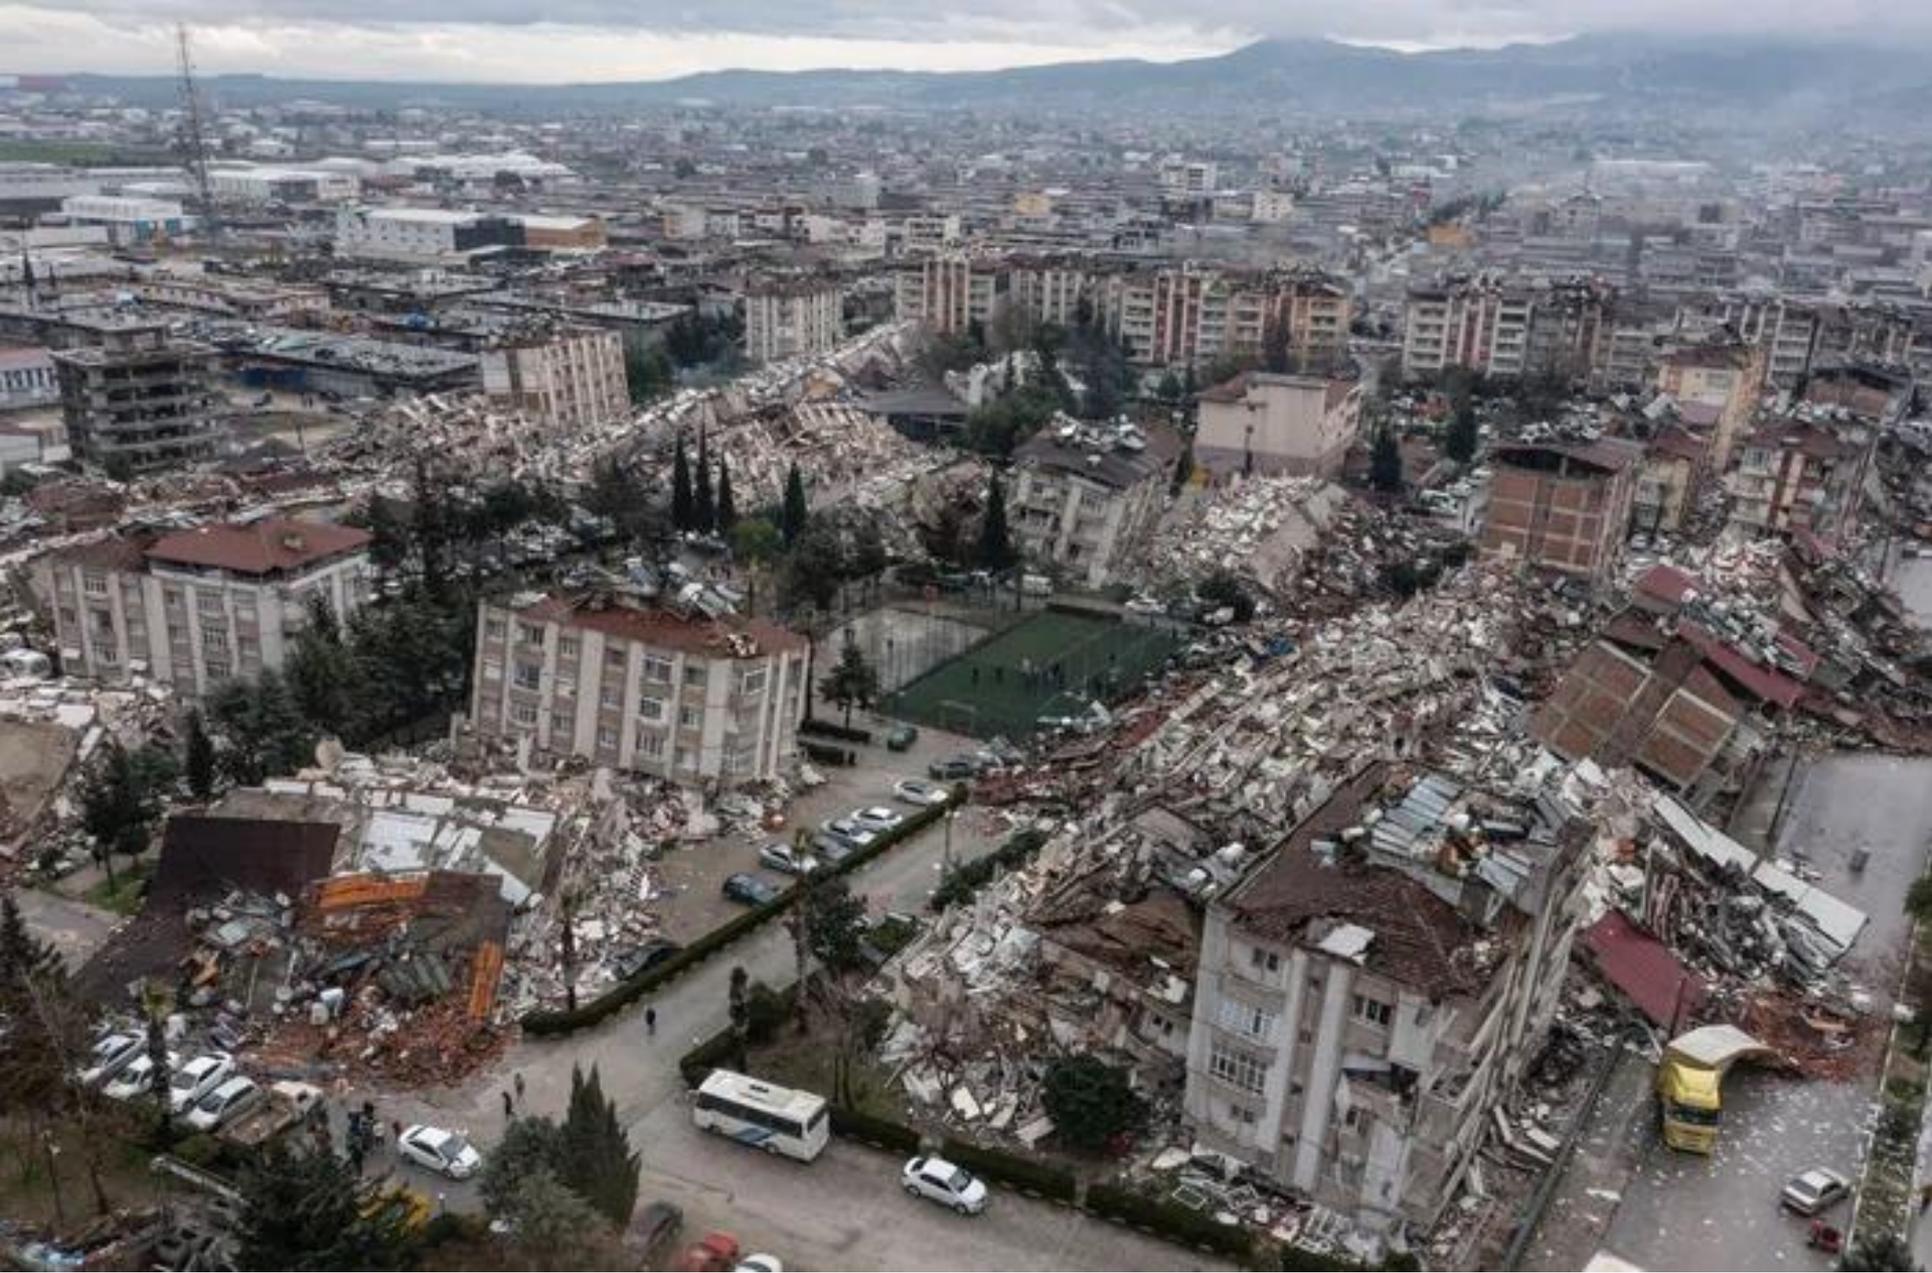
Antakya [Photo: Ercin Erturk/Anadolu Agency via Getty Images]

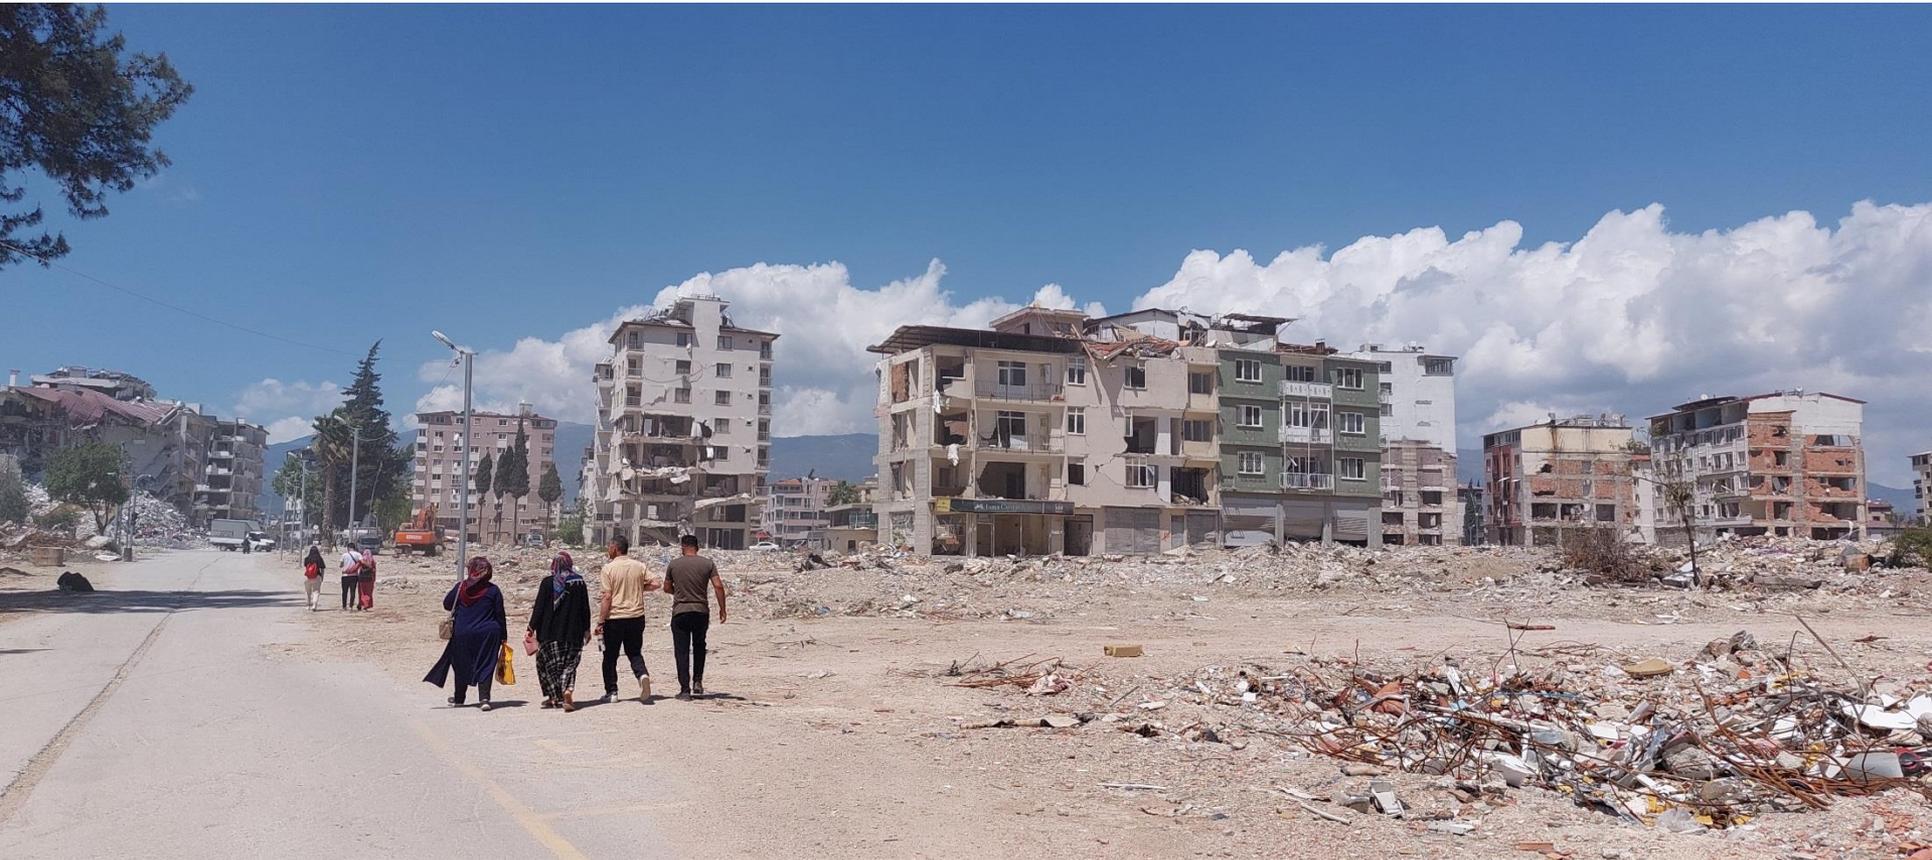
The “modern” part of Antakya is SEVERELY damaged

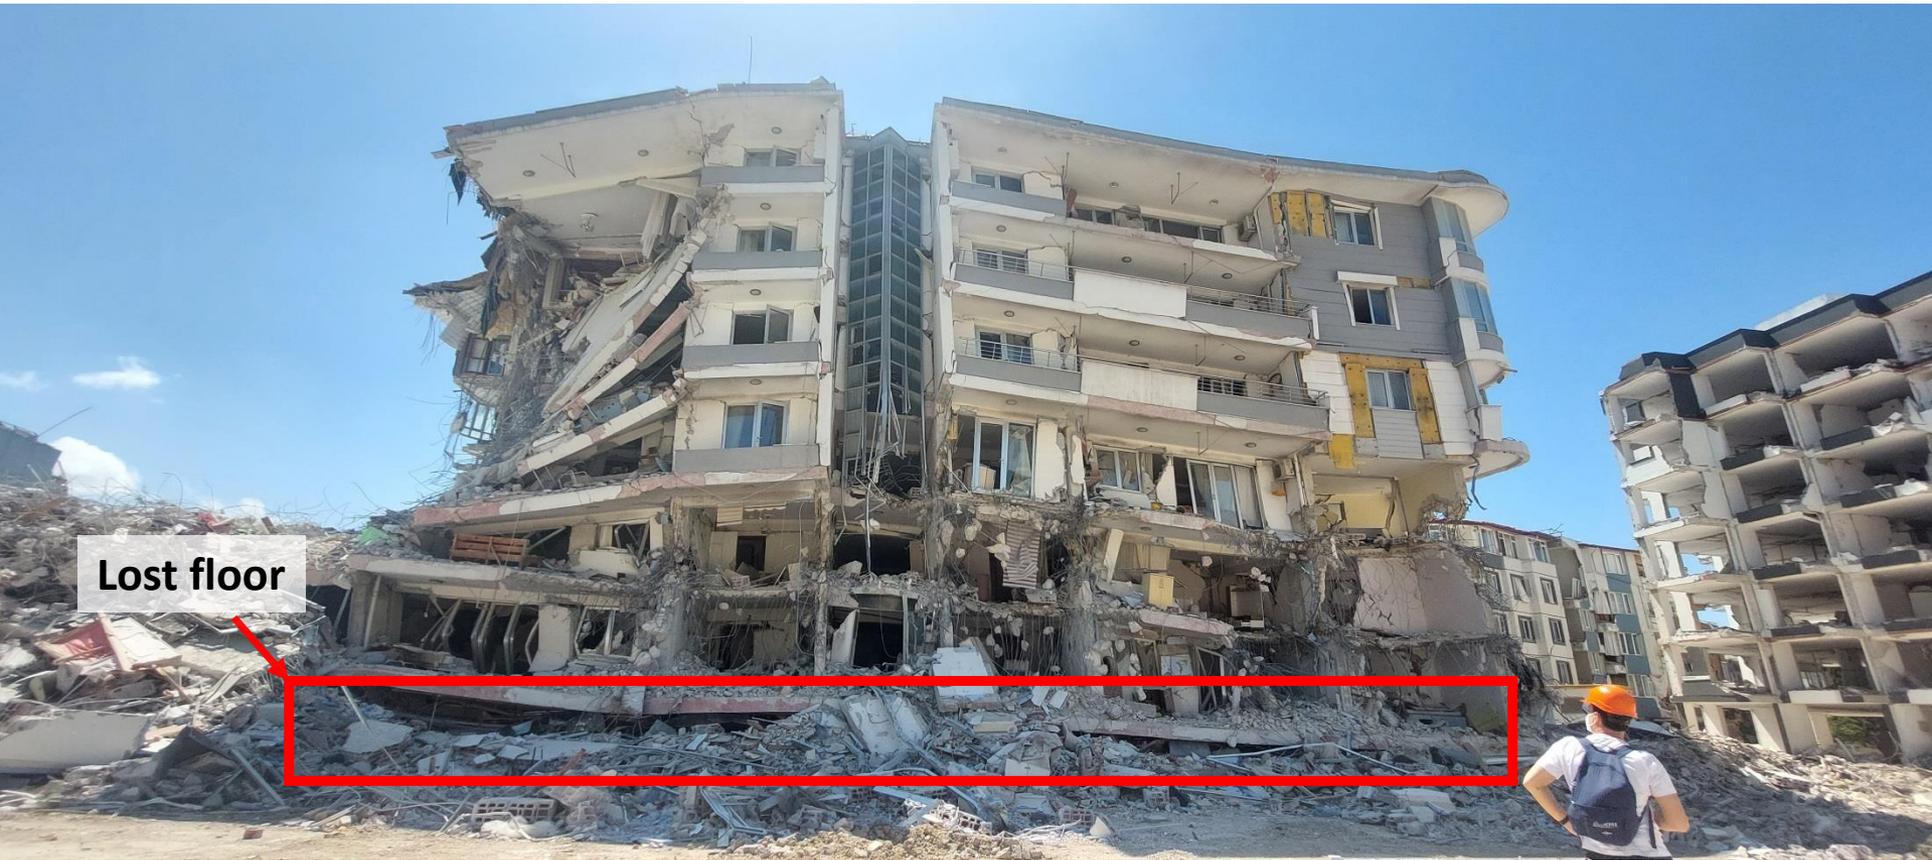
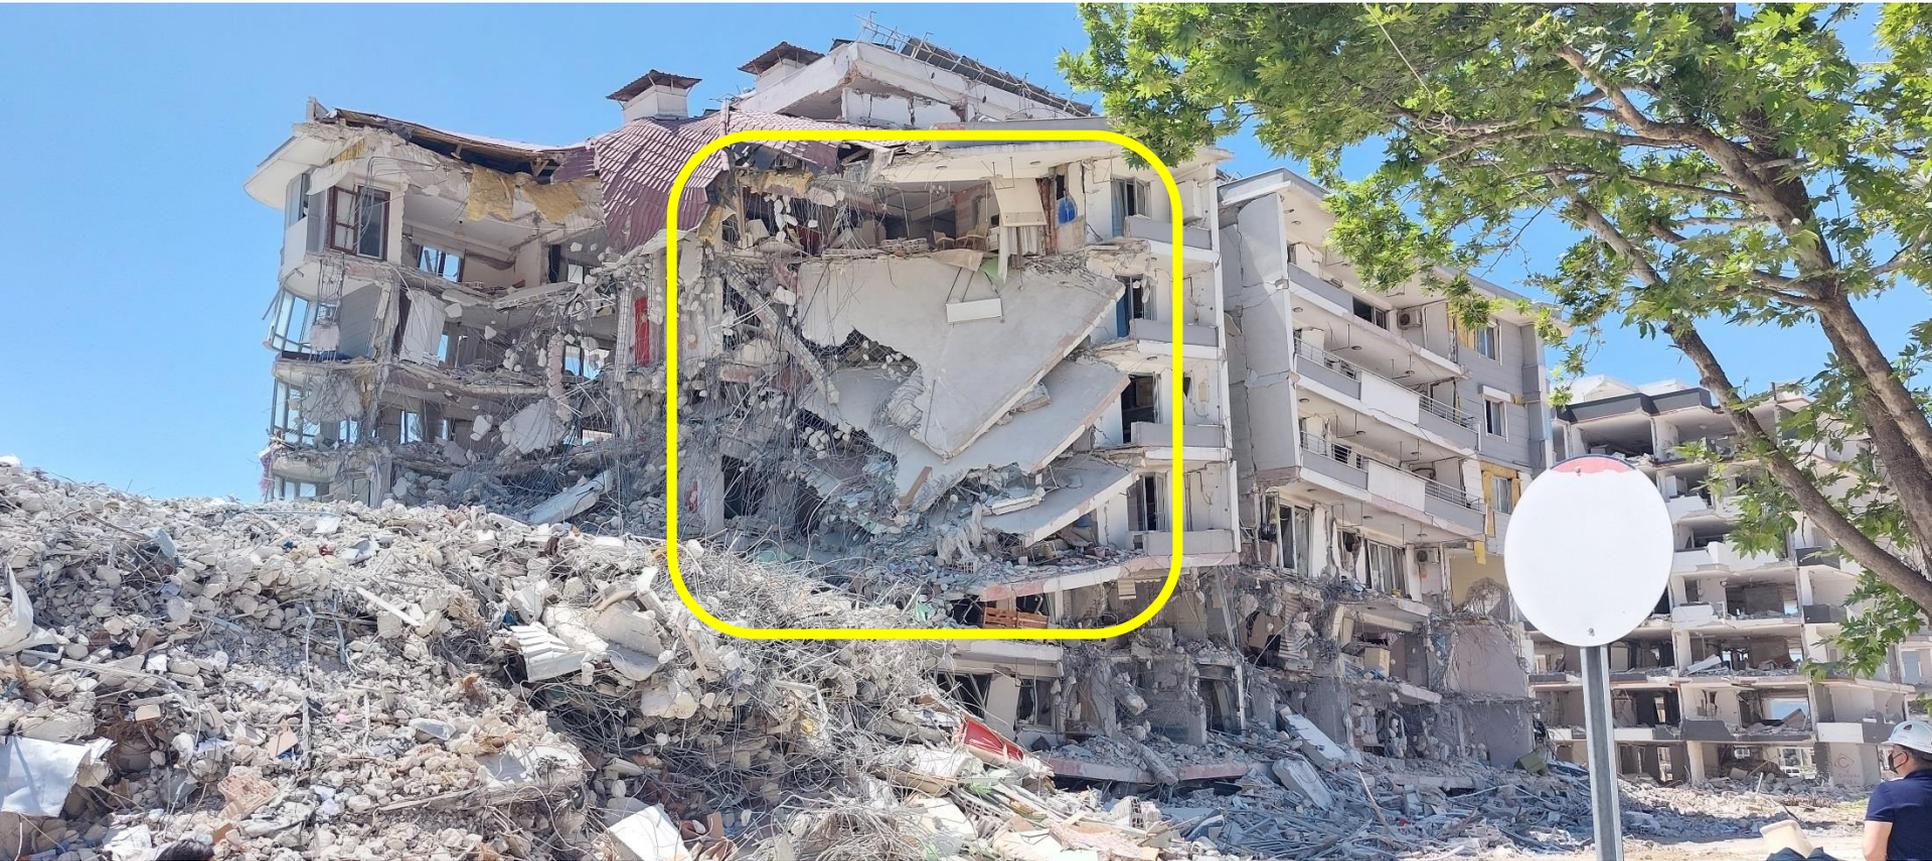
Lost floor

7-story RC building : lost the ground floor

Thick SLABS [LOSAS Gruesas]

**NO BEAMS, POOR JOINTS !
¡SIN VIGAS, JUNTAS POBRES!**

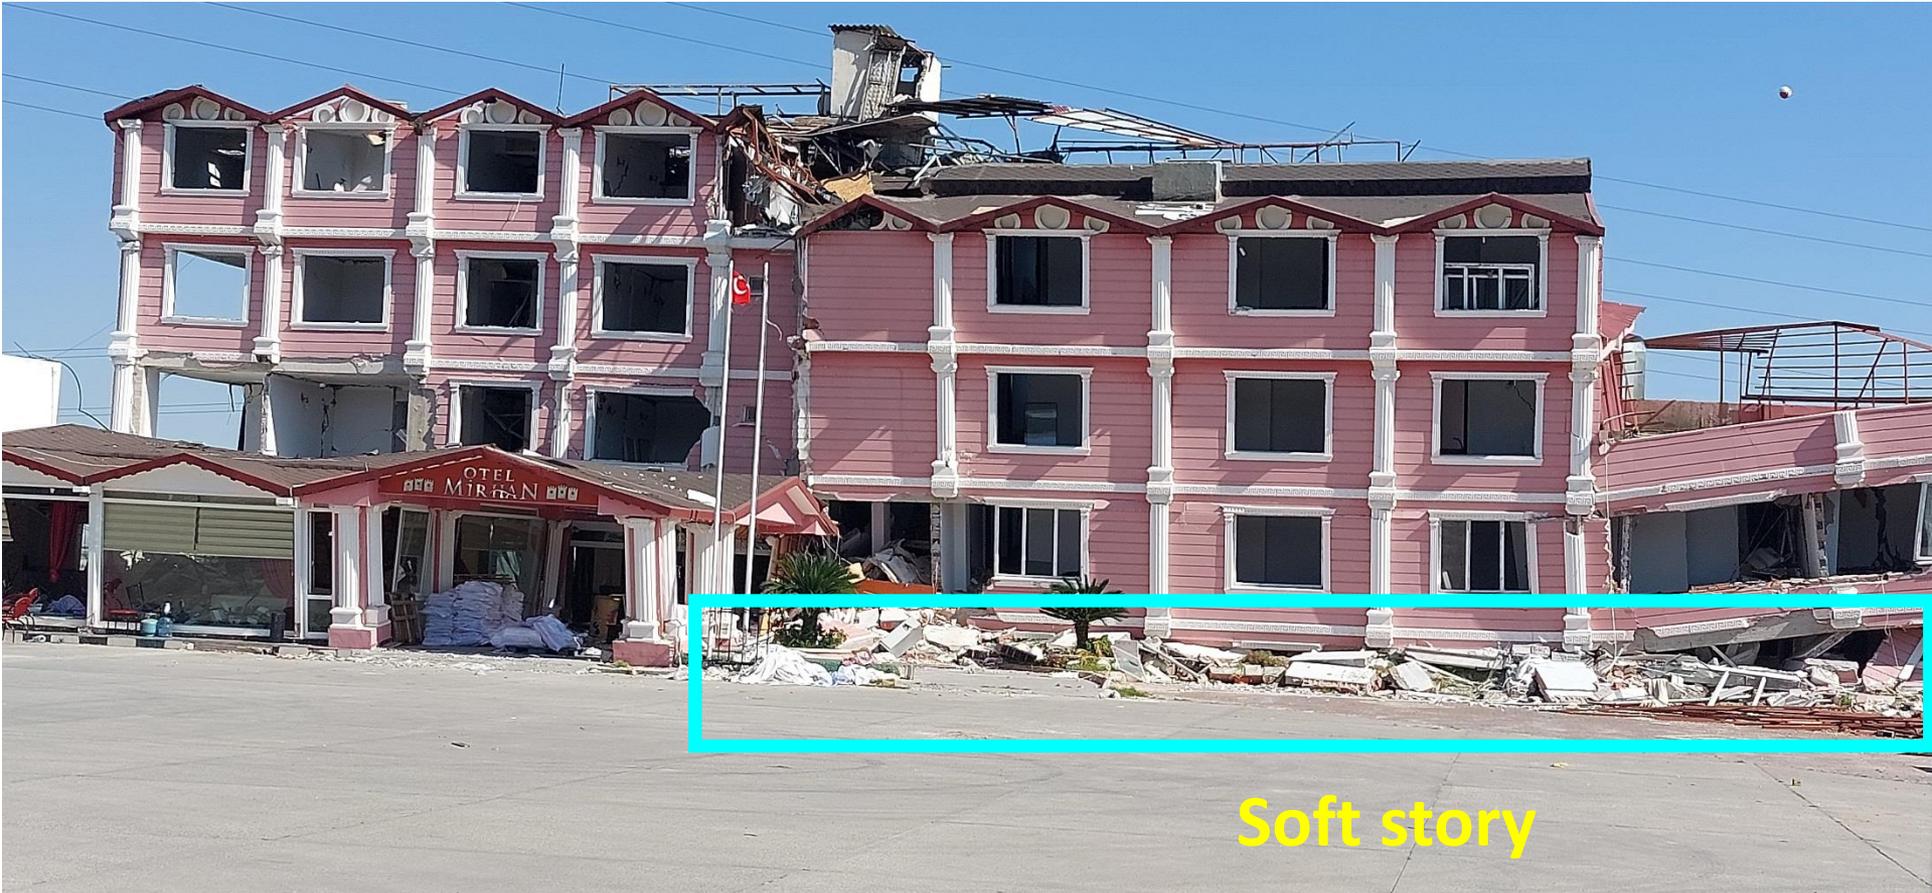
A hotel recently constructed: lost the ground floor

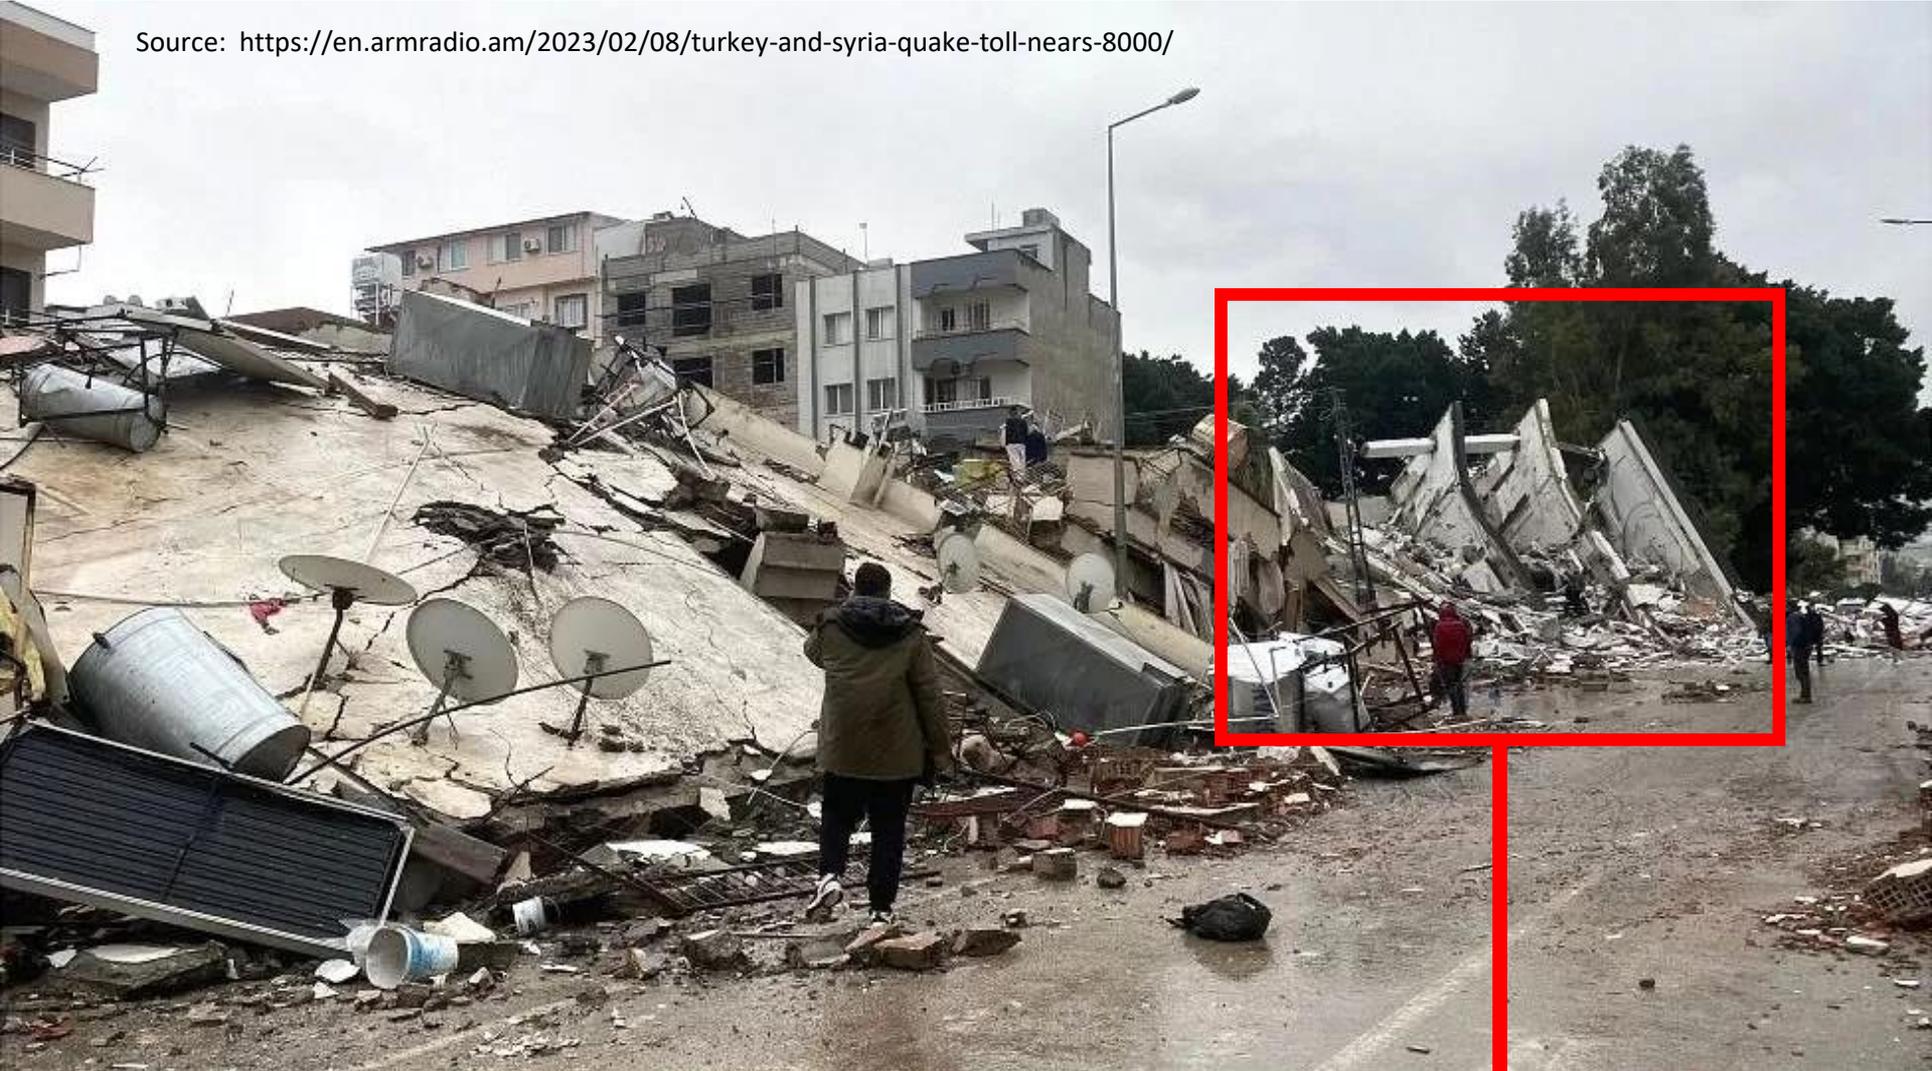
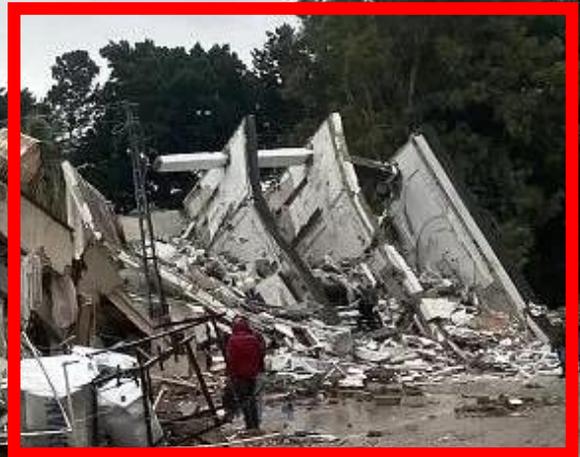
Numerous building without any beam, with small size columns (inappropriate even for 1-story buildings in a region of moderate seismicity).

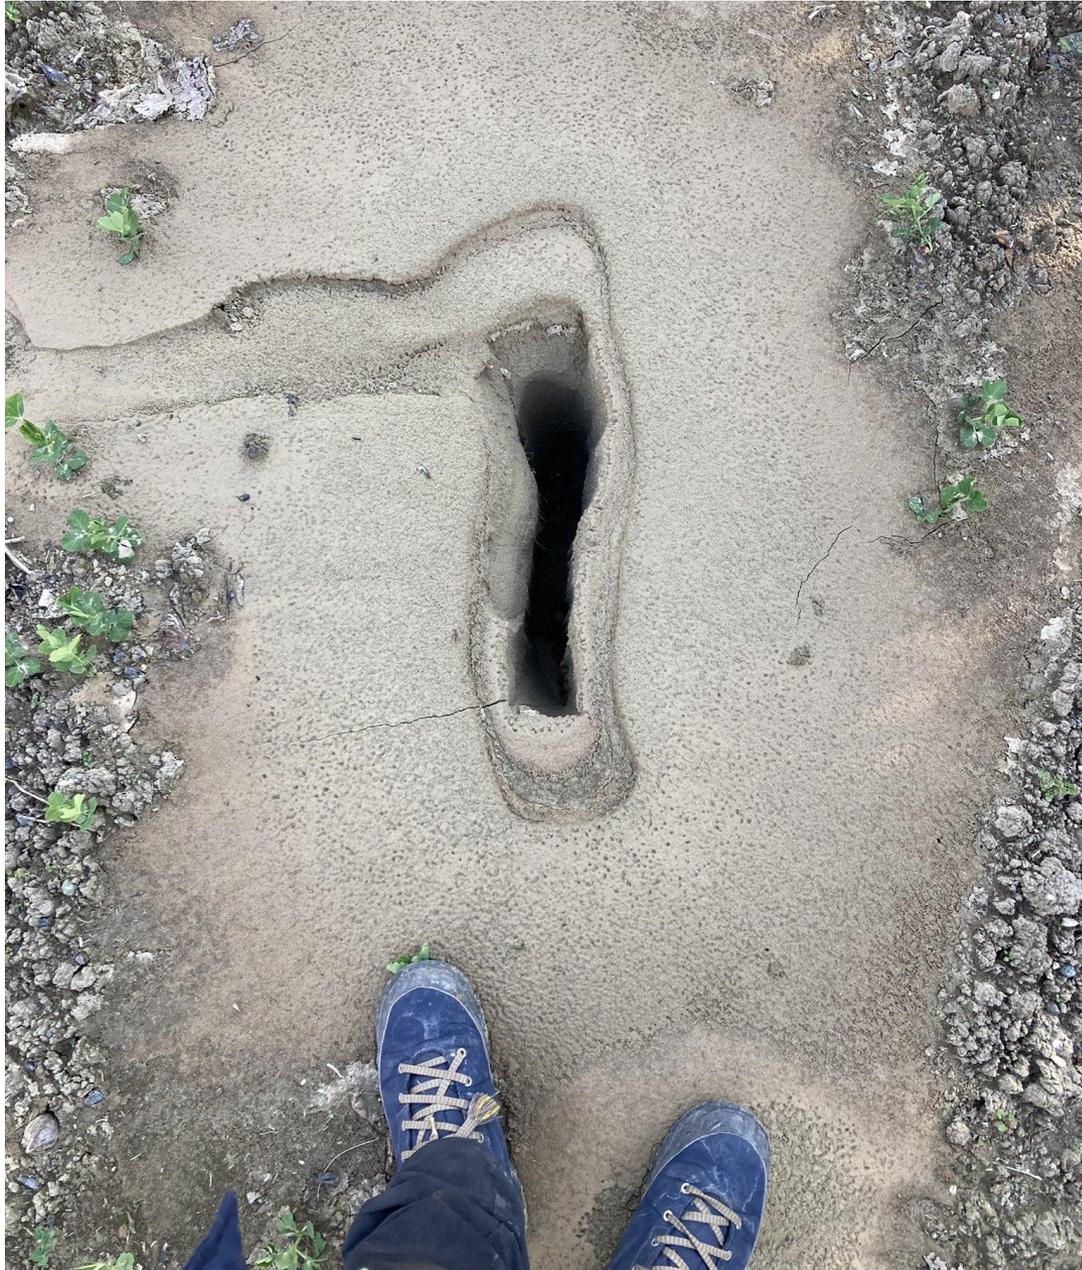
Liquefaction : Sand boil outside Sekerova

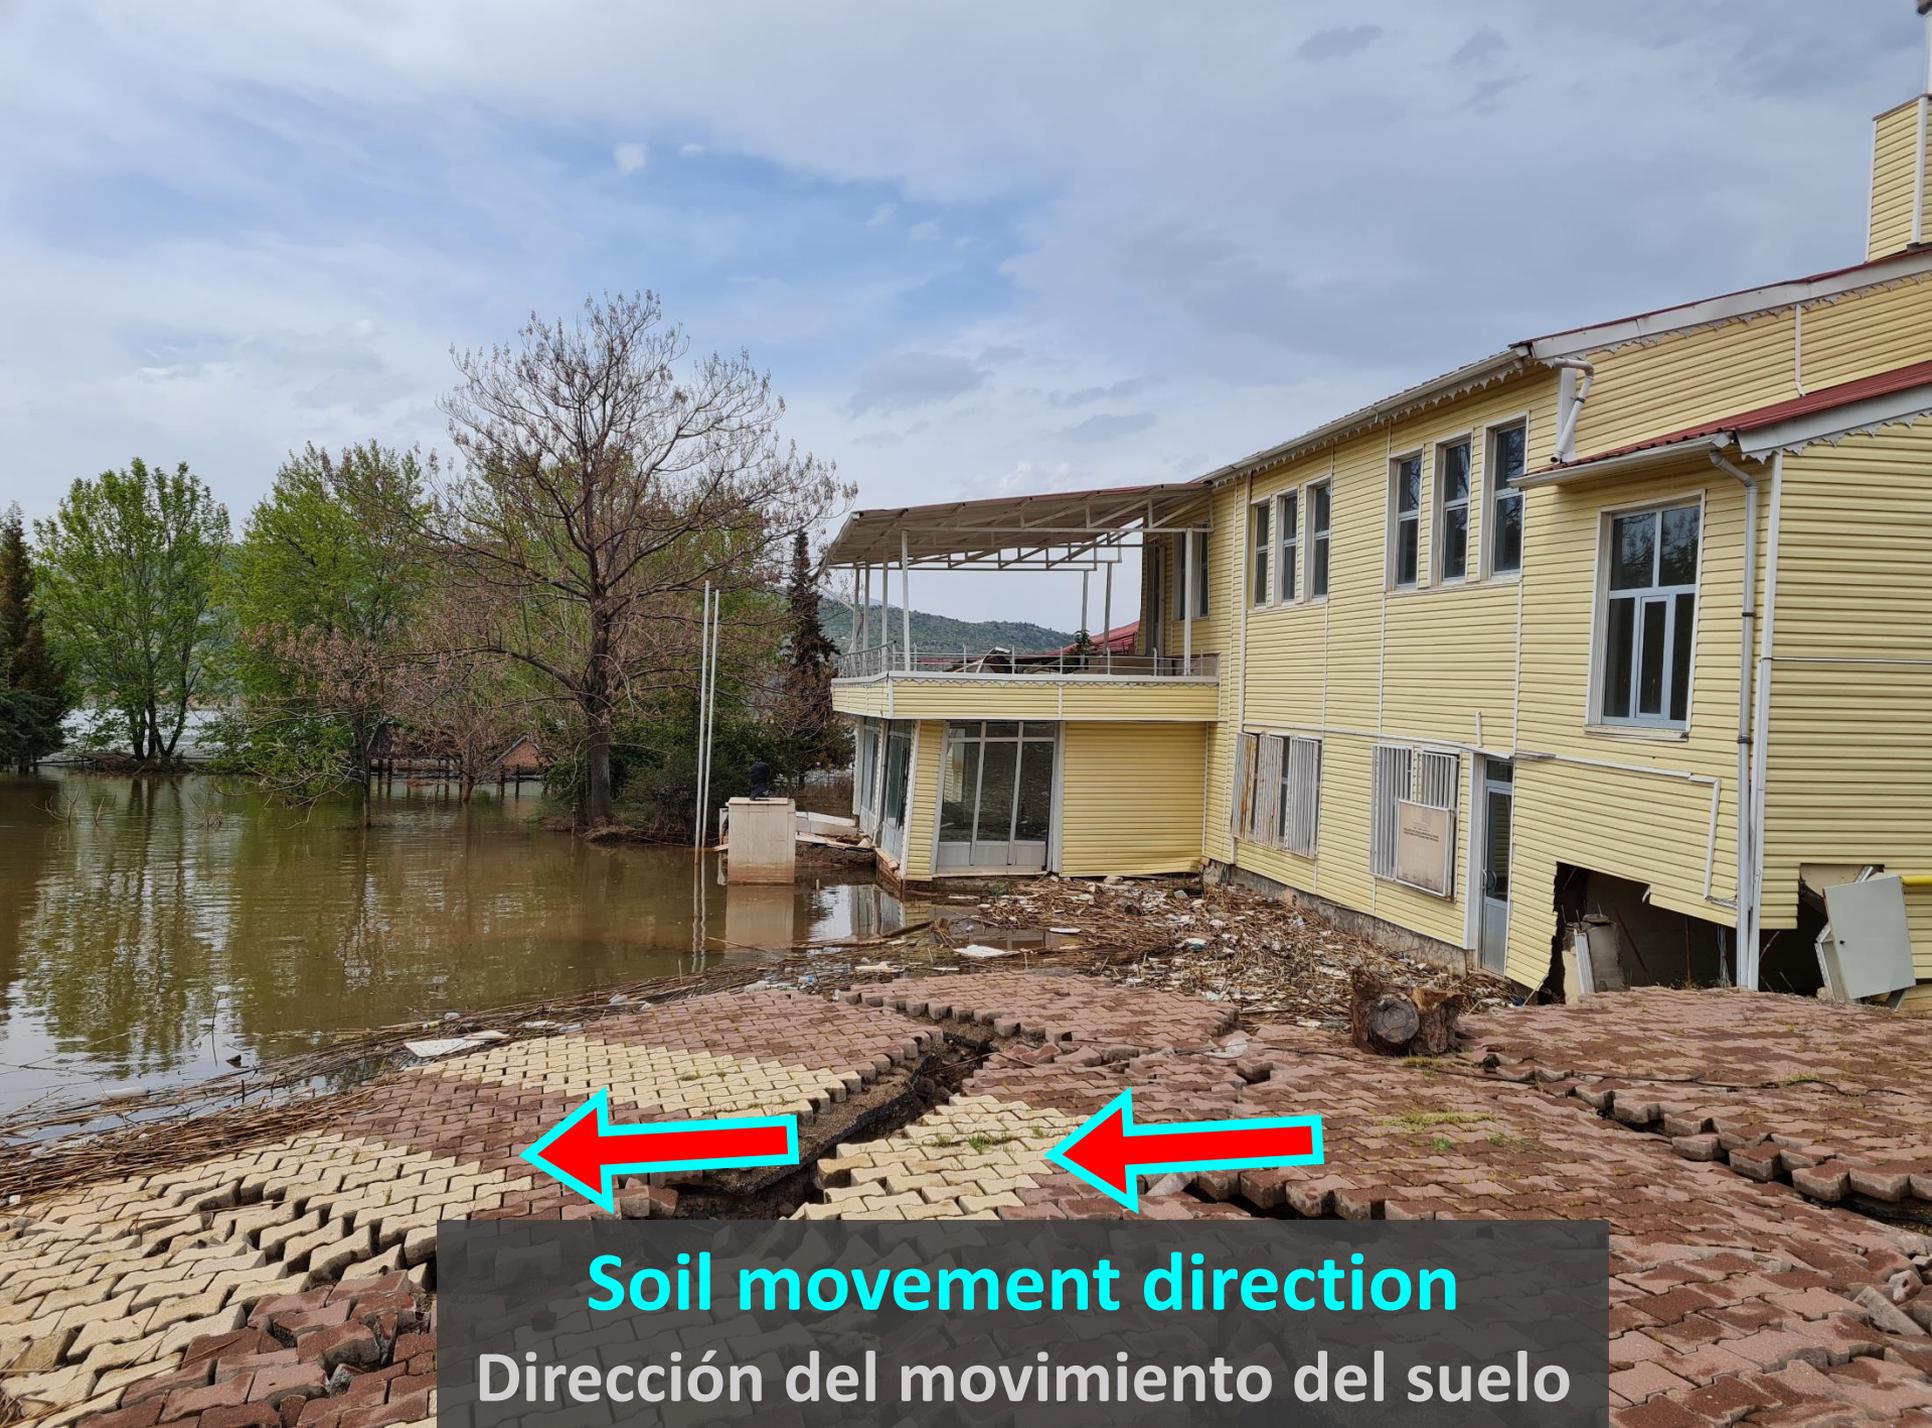
Total submergence of the building due to lateral spreading

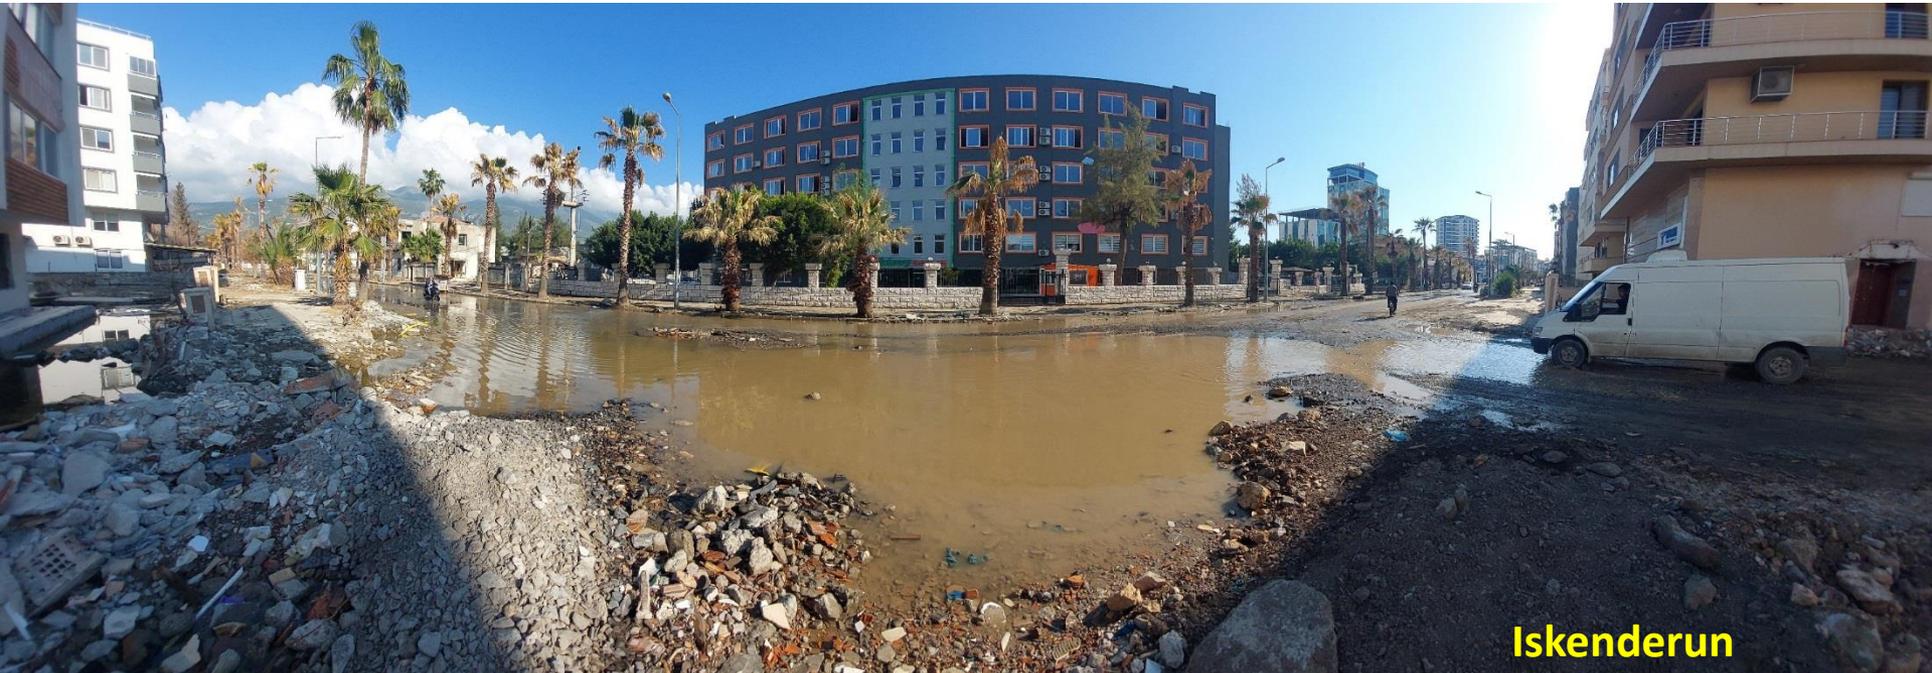
Subsidence in the coastal neighborhoods of Iskenderun
